TECHNICAL REPORT

INFLUENCE OF VOLCANIC ASH ON FATIGUE LIFE OF STEEL WIRE ROPES

Matías Cersósimo / IPH, Buenos Aires, Argentina / mcersosimo@iph.com.ar

Jorge López-Digon / INTI, Buenos Aires, Argentina / jdigon@inti.gob.ar

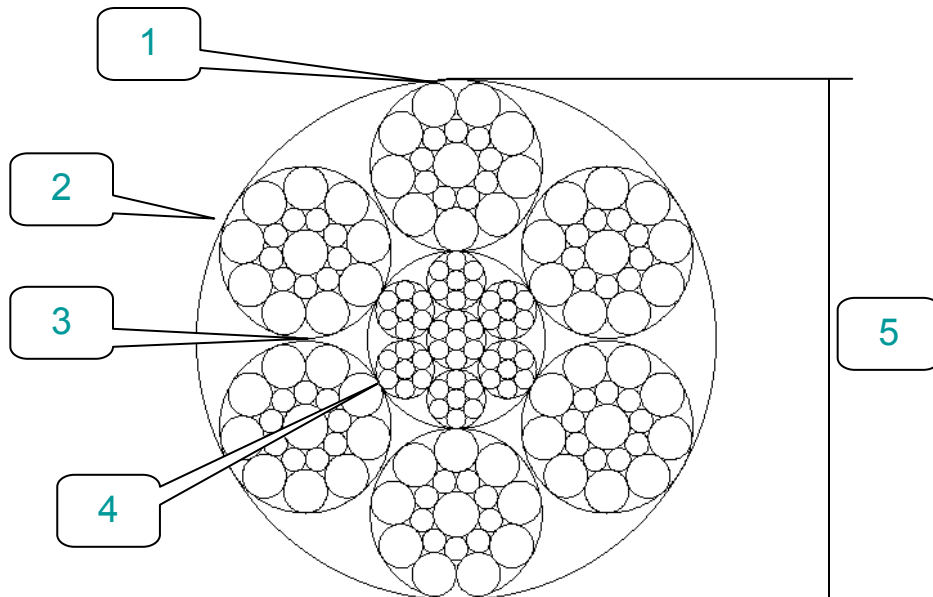
1. Broken wires on ridges due to variation of traction-compression stress generated per flex cycle.
2. Broken wires on ridges due to friction and abrasion against elements of the installation.
3. Broken wires on valleys due to friction between strands
4. Broken wires on valleys due to friction against the steel core.
5. Localized diameter reduction as a consequence of all the above.

Shown below is the cross-sectional view of the tested wire rope, where the failure modes are indicated.

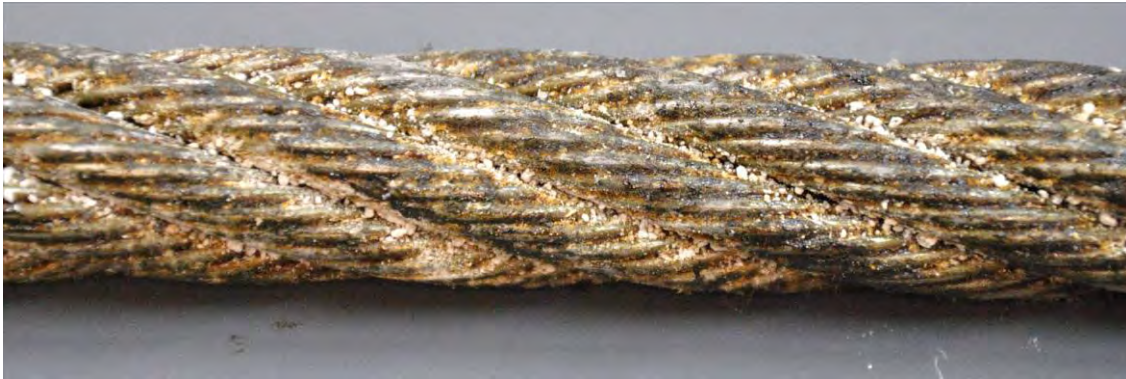
The following is an image of the wire rope after the simulated ash fall:

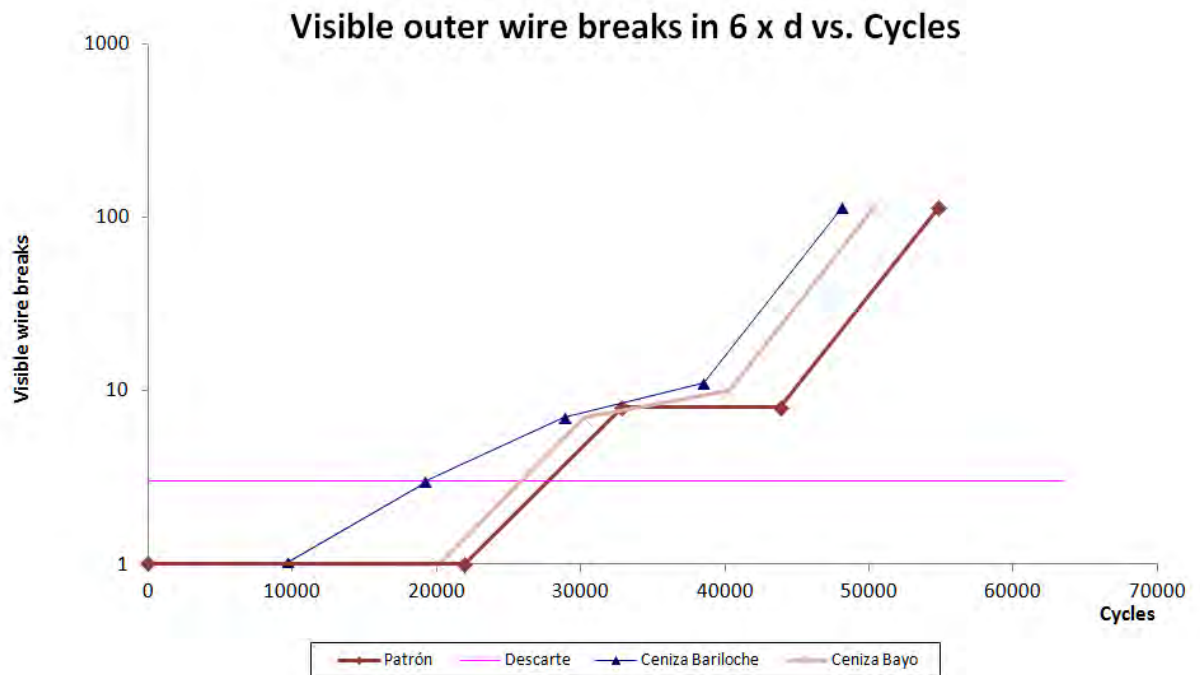
- The discard criteria is reached at 32898 cycles for the reference standard, 30228 cycles for the rope with volcanic ashes from Cerro Bayo, and 19248 cycles for the rope with ashes from Bariloche.

- Up to 37% of the reference standard service life (20000 cycles), there is no evidence of ash influence on the number of broken wires
- After reaching 70% of the reference standard service life (38.000 cycles), the influence of the ash is evidenced in the number of broken wires in each sample (Test piece: 8 WB, Cerro Bayo:10 WB, Bariloche: 11 WB)

- After 80% of the service life of the ropes with ashes, there is a considerable increase of wire breaks due to ash influence.
- Considering the total number of cycles until failure, the rope with ashes from Cerro Bayo suffers a loss of 8.1% of its service life, and the rope with ashes from Bariloche loses 12.3% of its service life, both compared to the reference standard wire rope.

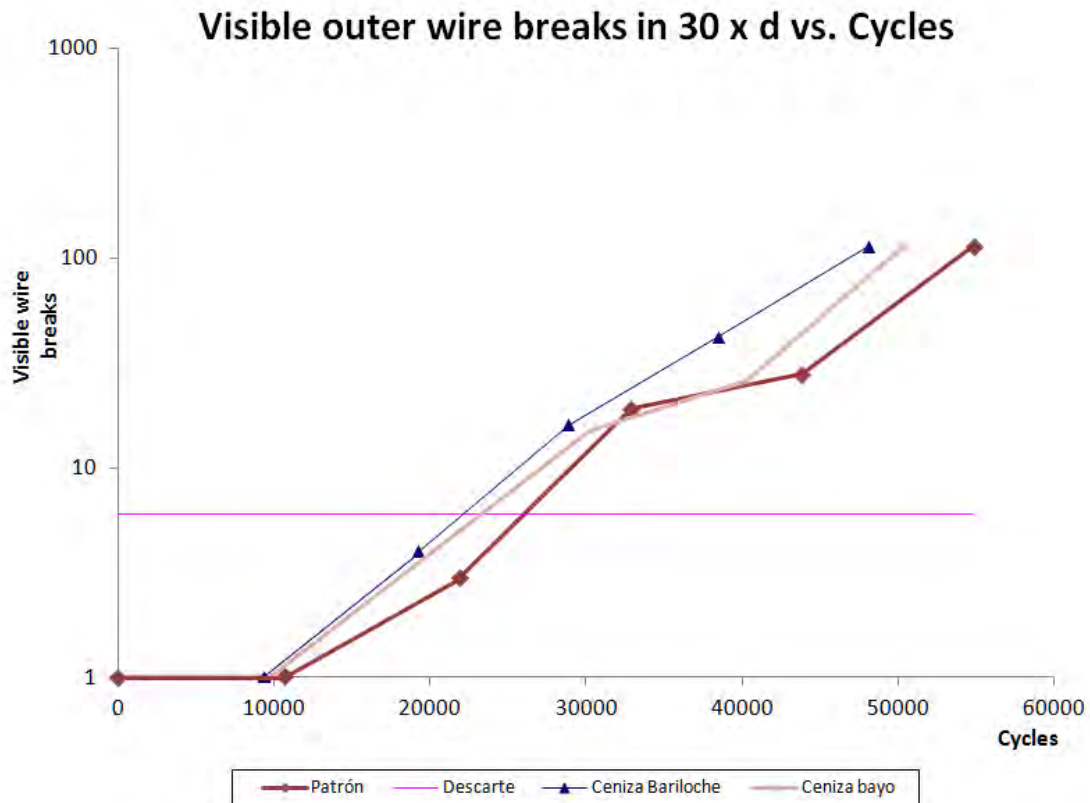
- The discard criteria is reached at 32898 cycles for the reference standard, 30228 cycles for the rope with volcanic ashes from Cerro Bayo, and 19248 cycles for the rope with ashes from Bariloche.
- After reaching 80% of the reference standard service life (43.000 cycles), there is a considerable increase of wire breaks due to ash influence.

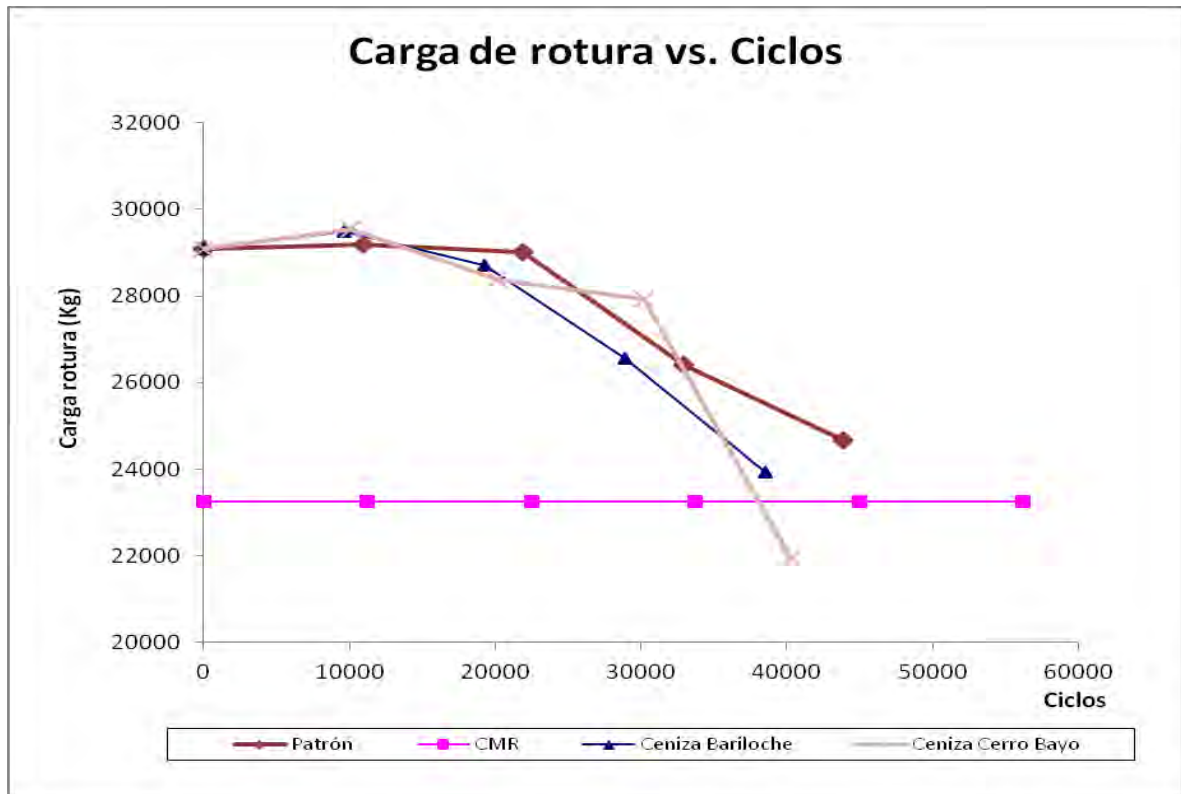
- iv. **Residual breaking load test:** Relating discard criteria and breaking load test graphs, it can be ensured that when the rope reaches discard criteria the safety factor of the installation is unchanged.

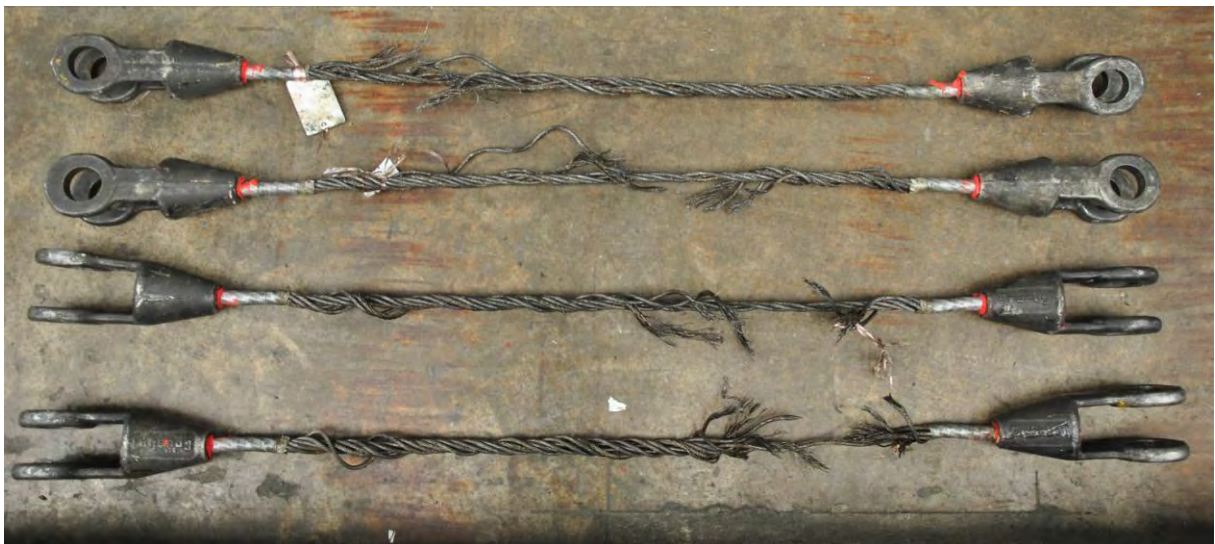
Test pieces after breaking load test:

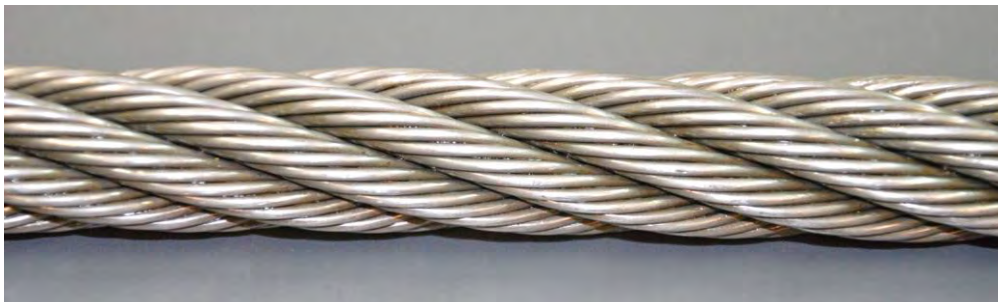
20% bending cycles zone

The decreasing breaking load is due to the accumulation of fatigue wire breaks occurring on both the ridges and valleys. The following images show the increasing number of broken wires against fatigue cycles.
