INFLUENCE OF VOLCANIC ASH ON FATIGUE LIFE OF STEEL WIRE ROPES

Instituto Nacional de Tecnología Industrial
Centro de Investigación y Desarrollo en Mecánica
Programa Medio de Transporte por Cable

TECHNICAL REPORT

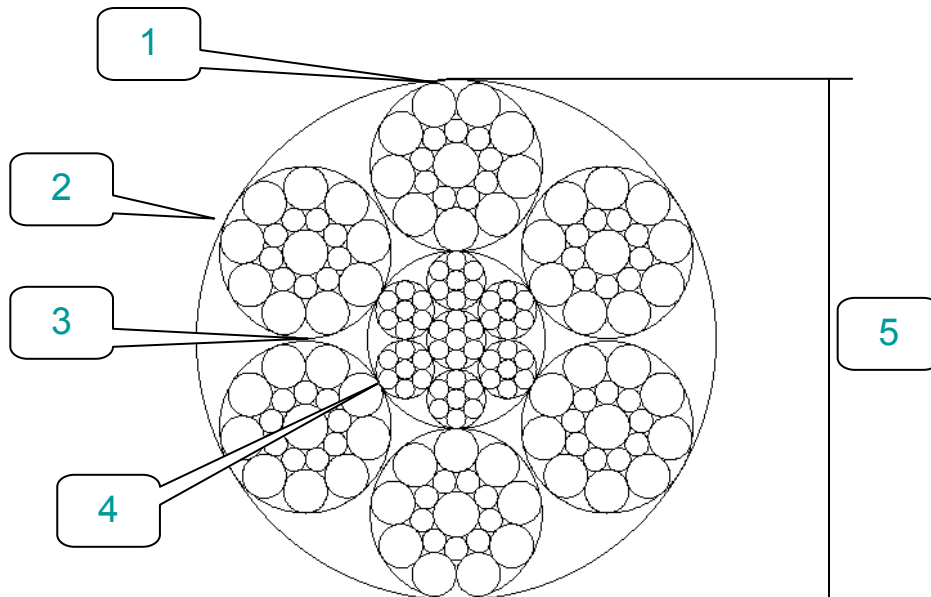
1. Broken wires on ridges due to variation of traction-compression stress generated per flex cycle.
2. Broken wires on ridges due to friction and abrasion against elements of the installation.
3. Broken wires on valleys due to friction between strands
4. Broken wires on valleys due to friction against the steel core.
5. Localized diameter reduction as a consequence of all the above.

Shown below is the cross-sectional view of the tested wire rope, where the failure modes are indicated.

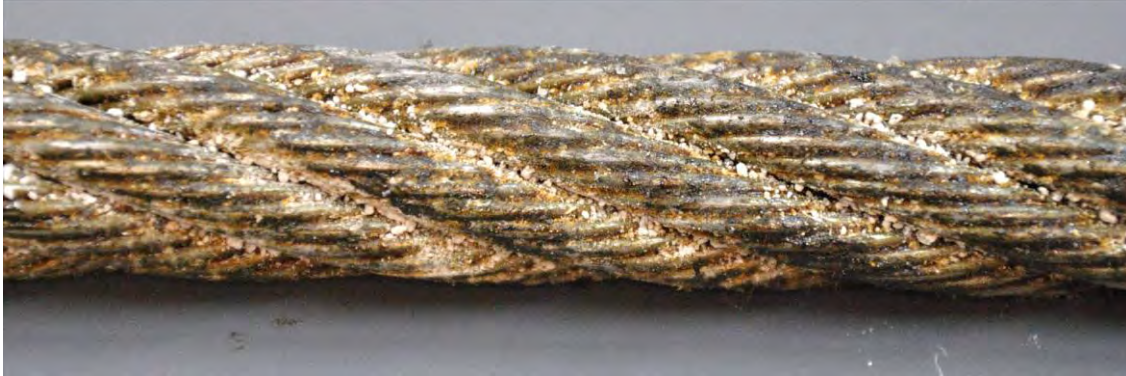
The following is an image of the wire rope after the simulated ash fall:

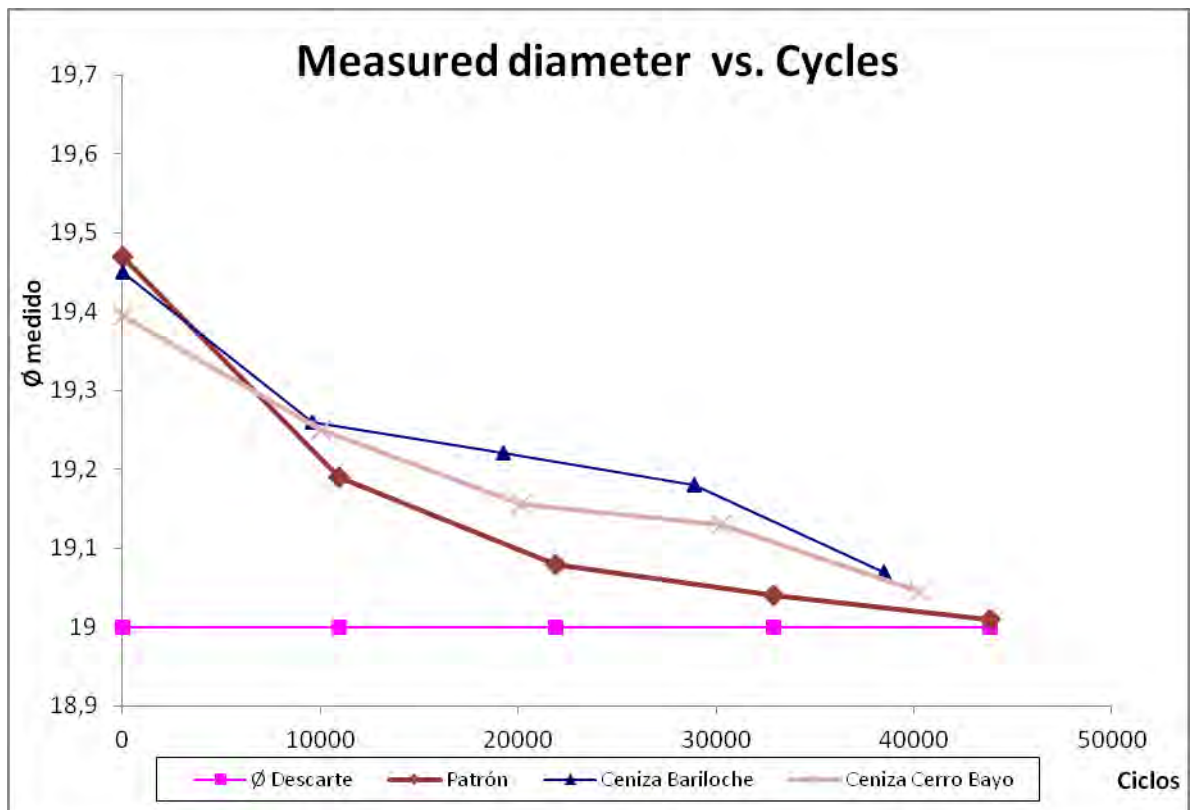
The analysis of this graph shows:

- Diameter decreases with the number of flexion cycles
- Diameter for a 20% severity rating was never reached.

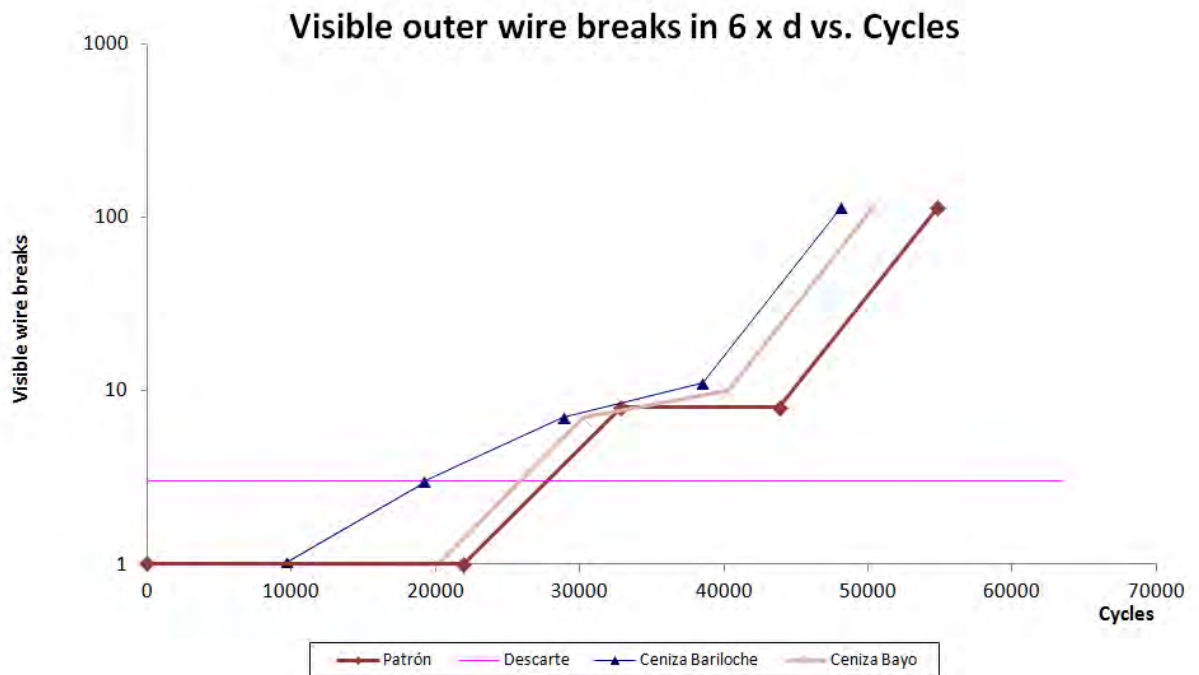
Analyzing the graph, we take to the following conclusions:

- The discard criteria is reached at 32898 cycles for the reference standard, 30228 cycles for the rope with volcanic ashes from Cerro Bayo, and 19248 cycles for the rope with ashes from Bariloche.

- Up to 37% of the reference standard service life (20000 cycles), there is no evidence of ash influence on the number of broken wires
- After reaching 70% of the reference standard service life (38.000 cycles), the influence of the ash is evidenced in the number of broken wires in each sample (Test piece: 8 WB, Cerro Bayo:10 WB, Bariloche: 11 WB)

- After 80% of the service life of the ropes with ashes, there is a considerable increase of wire breaks due to ash influence.
- Considering the total number of cycles until failure, the rope with ashes from Cerro Bayo suffers a loss of 8.1% of its service life, and the rope with ashes from Bariloche loses 12.3% of its service life, both compared to the reference standard wire rope.

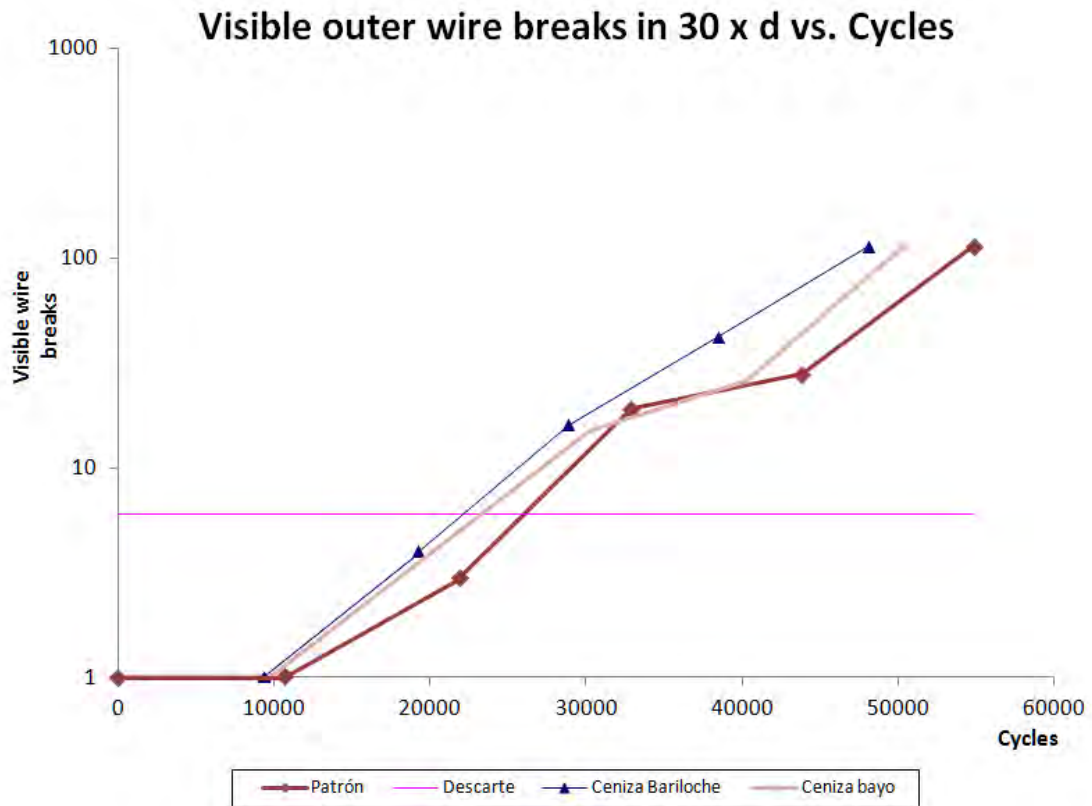
From the analysis of this graph:

- The discard criteria is reached at 32898 cycles for the reference standard, 30228 cycles for the rope with volcanic ashes from Cerro Bayo, and 19248 cycles for the rope with ashes from Bariloche.
- After reaching 80% of the reference standard service life (43.000 cycles), there is a considerable increase of wire breaks due to ash influence.

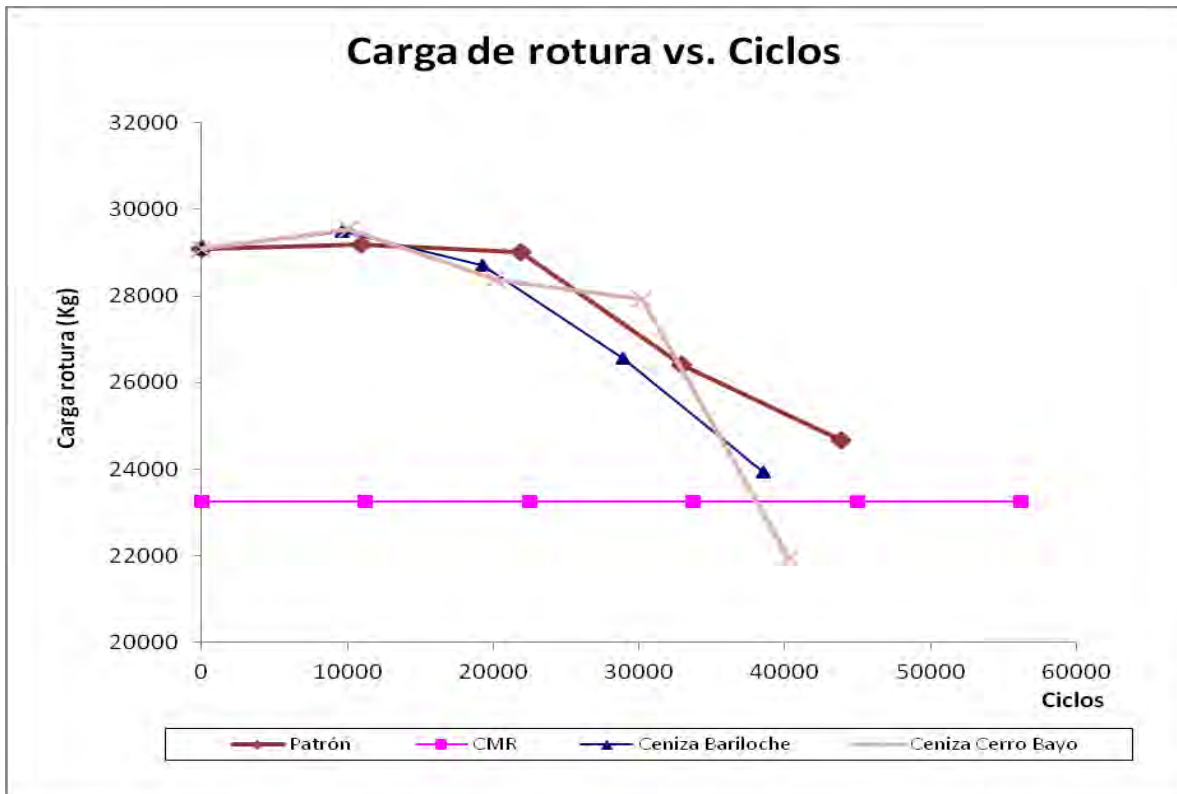
The following graph shows MBL vs. Cycles:

- iv. **Residual breaking load test:** Relating discard criteria and breaking load test graphs, it can be ensured that when the rope reaches discard criteria the safety factor of the installation is unchanged.

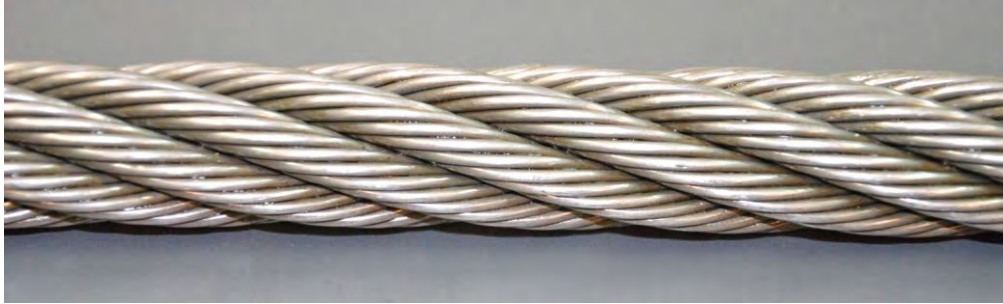
The decreasing breaking load is due to the accumulation of fatigue wire breaks occurring on both the ridges and valleys. The following images show the increasing number of broken wires against fatigue cycles.

20% bending cycles zone

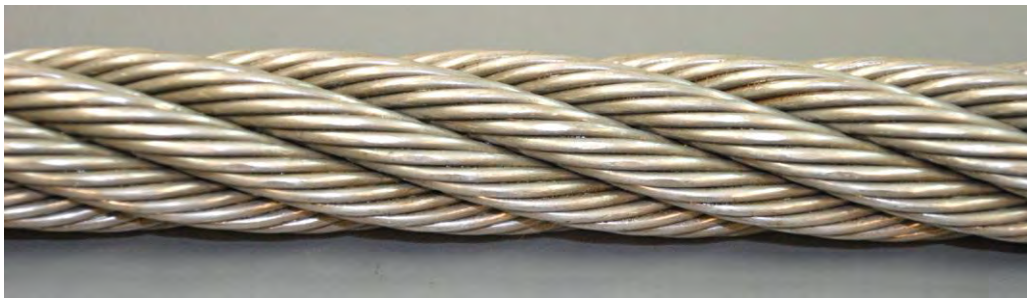
40% bending cycles zone

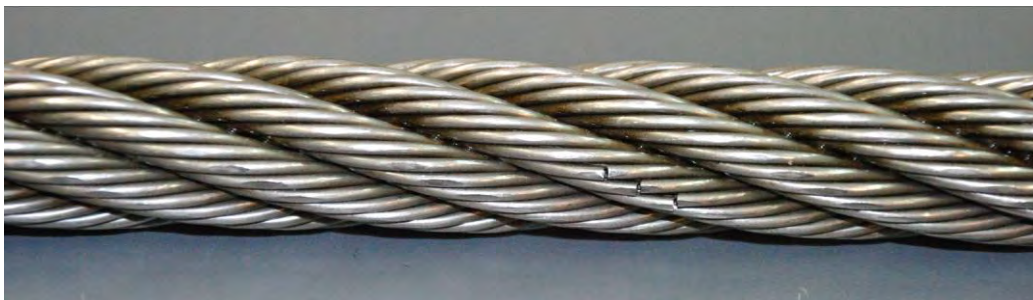
60% bending cycles zone

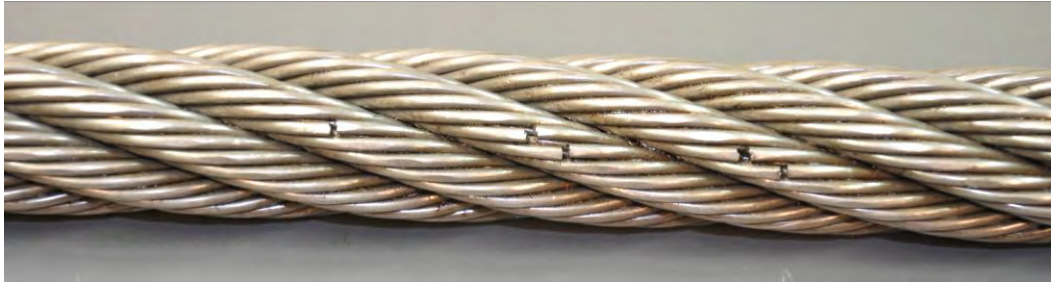
80% bending cycles zone

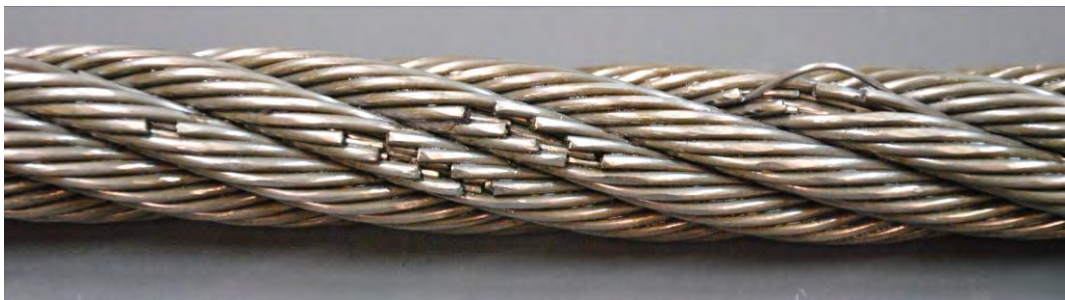
100% bending cycles zone (close to failure)
