OITAF

Bozen/Bolzano
Congress 2017

Open magneto inductive detectors for metallics ropes: analysis and experimental results

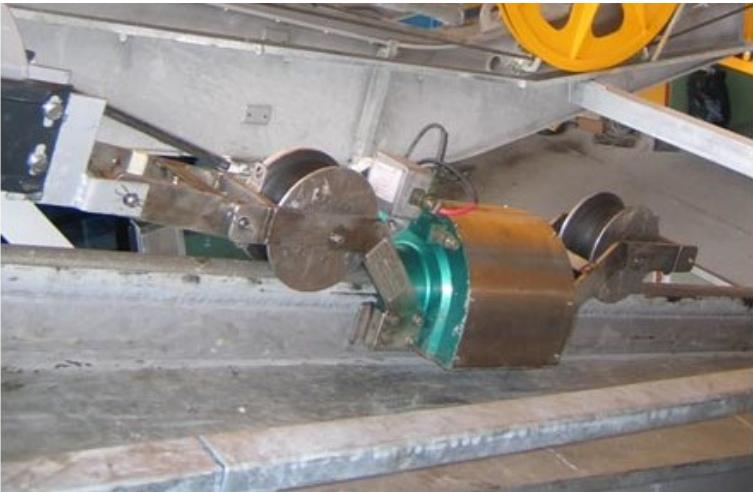
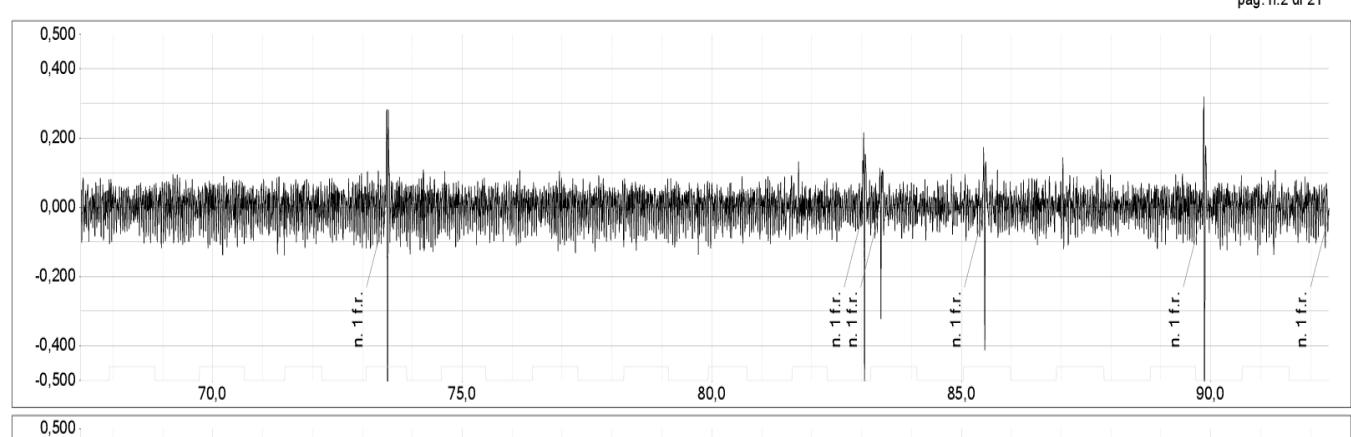
Magneto inductive detectors are specifically constructed to :

- Reduct the risk of injury during ispective operations
- Reduce o eliminate «not inspected» lenght

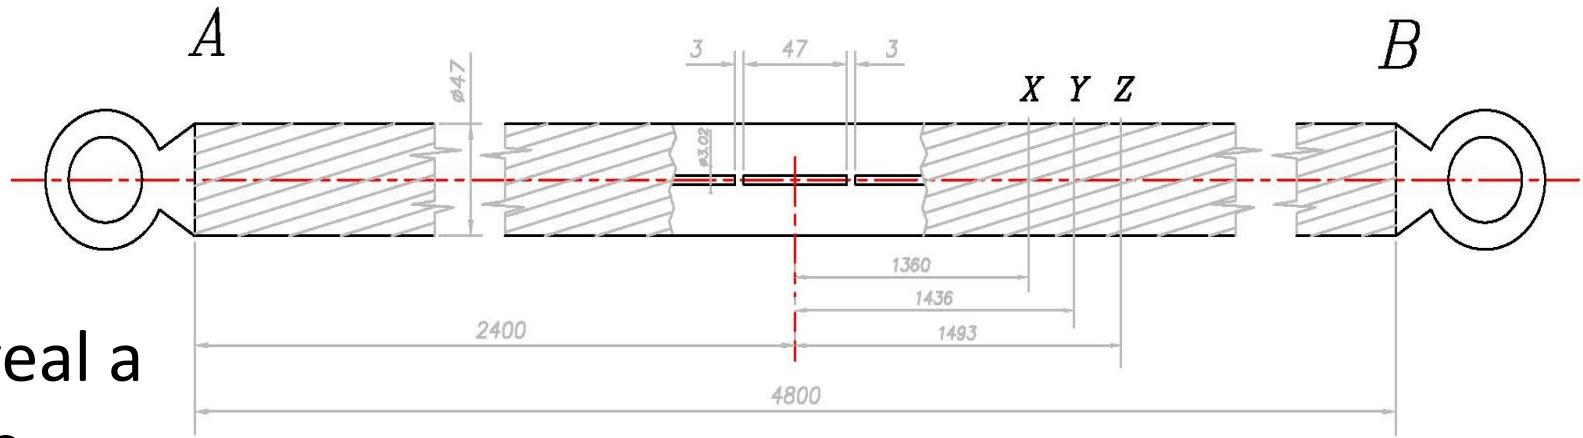
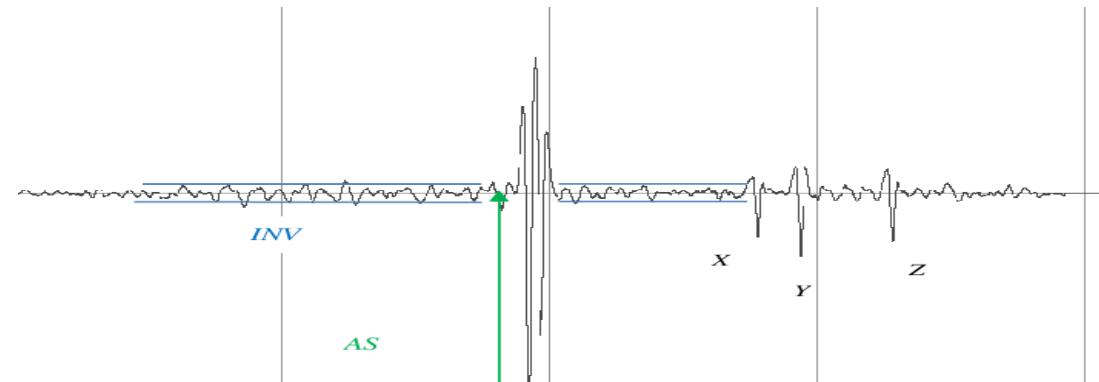
Italian law requires
UNI EN 12927-8 test.

Autorized detectors must reveal a double defect in the rope core with defined SN ratio.
Open detectors normally is able to pass the test.

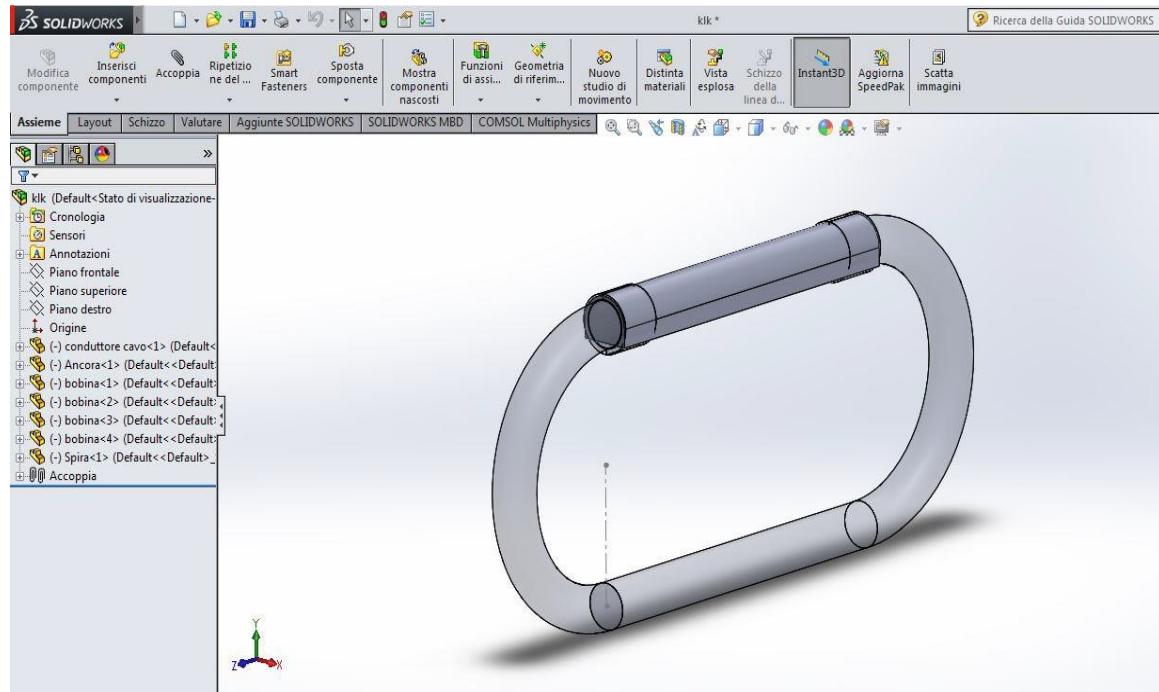
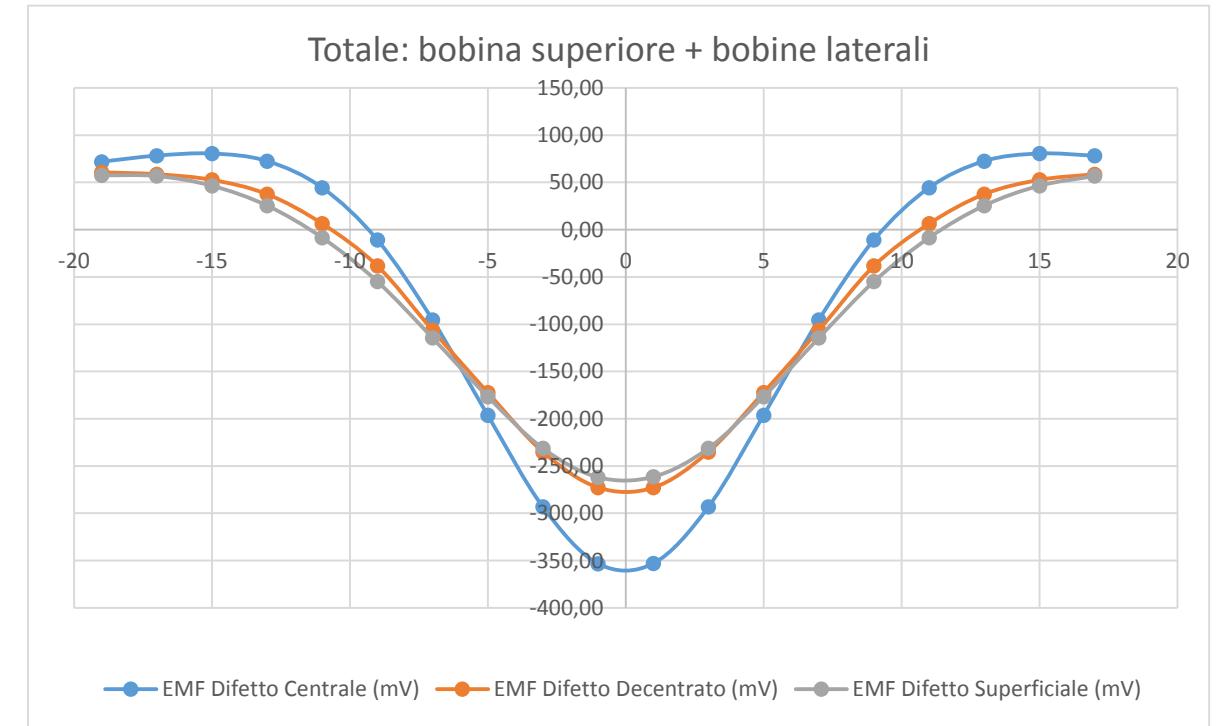
Schematization of a magneto inductive test system

Magnetic field generation: request for magnetic saturation of the rope

Scattered field detection (sensors): The sensors can not be disposed fisically all around the rope.

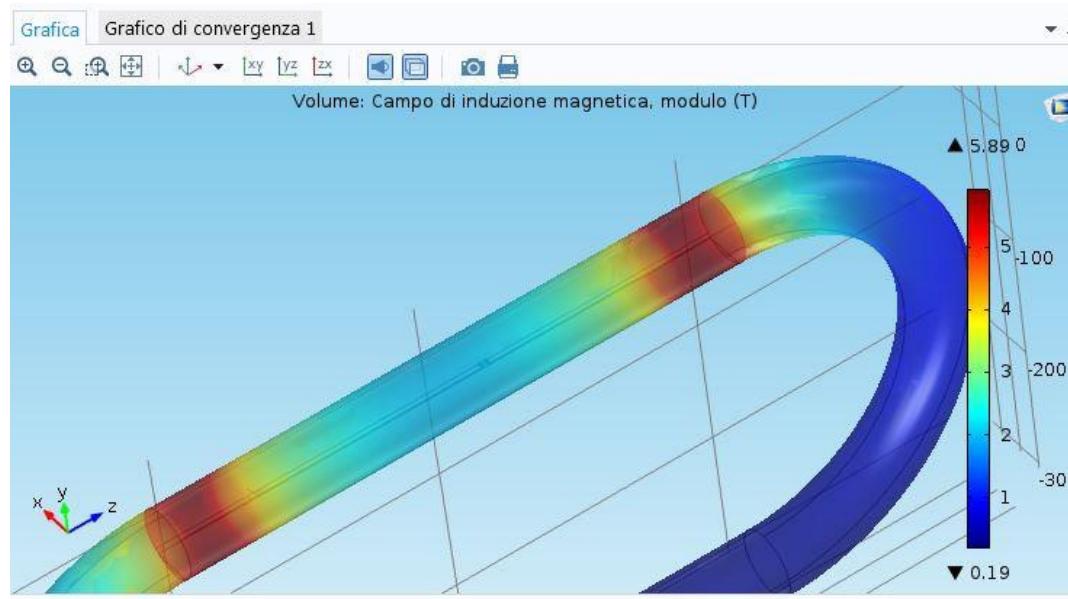
First part: magnetic rope saturation.

The first work (*Ezio Santini²*) suggests a magnetic field value of 2 T to reach the rope magnetic saturation.

This value becomes a project request for the detector.

In this situation the expected relative magnetic permeability is around 30.

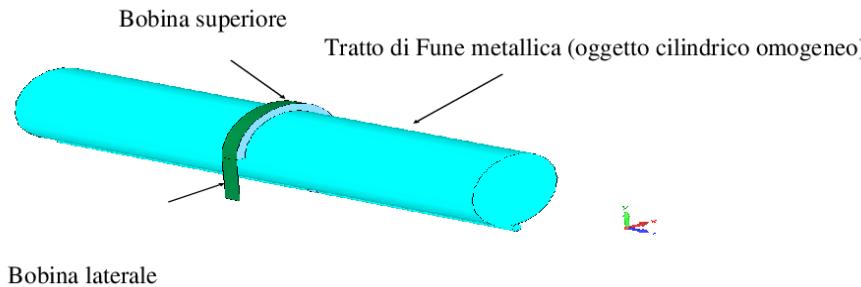
In the first simulation, the defect is positionated in the center of the rope.

The test is similar to the UNI 12927 standard request.

In the second simulation the defect is moved along a diameter until an external position.

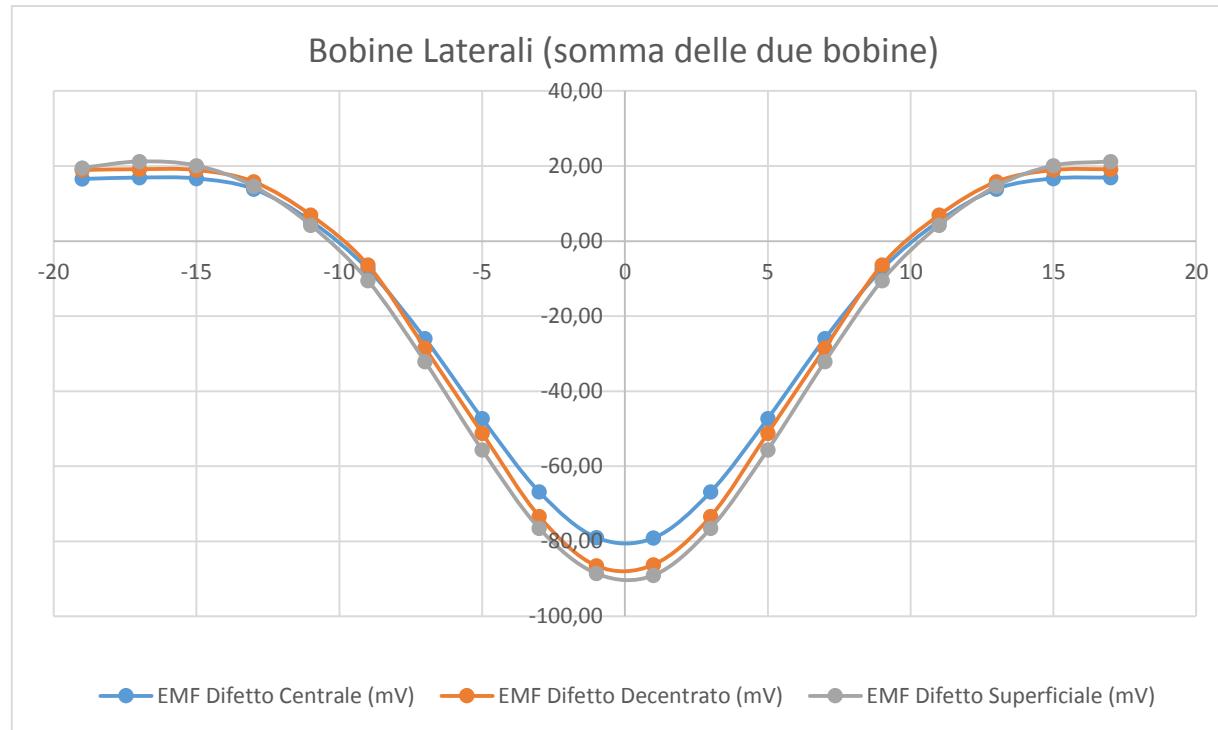
This figure illustrates the response of the lateral part of the sensor.

There is no practical difference when the defect is moved.

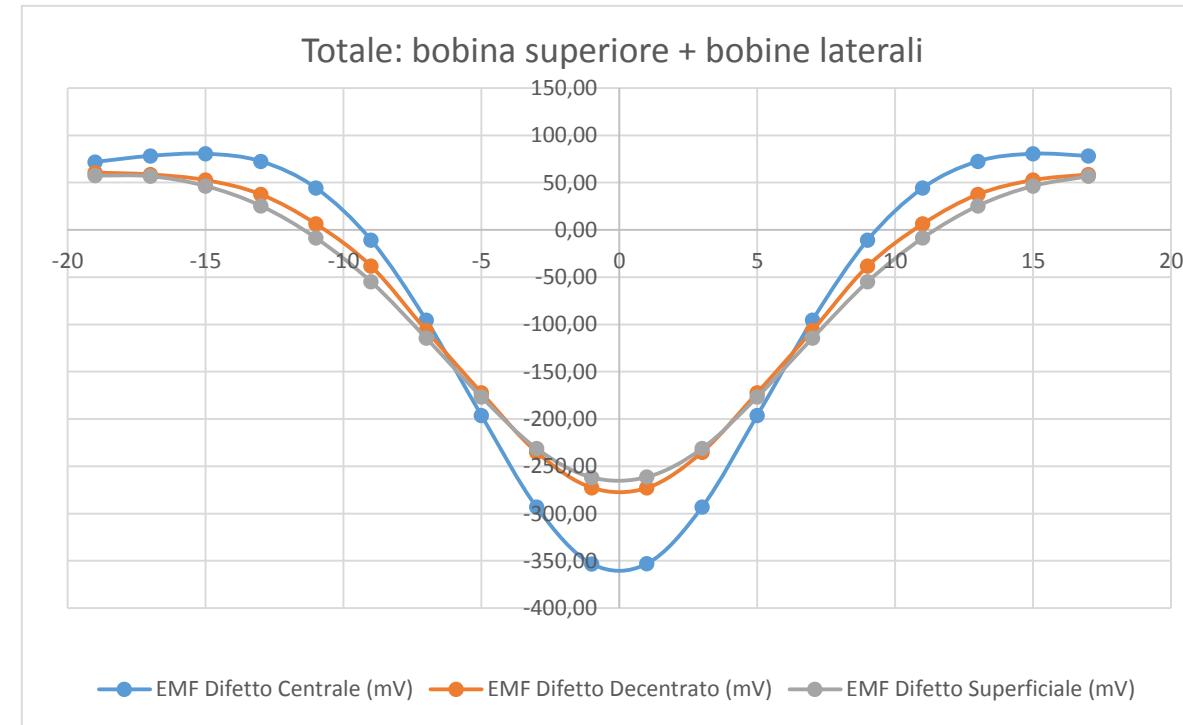
This figure illustrates the total response of the sensor. The author demonstrates that:

- 1) The output of the sensor decreases when the defect is moved from the central position;
- 2) The worst case is a superficial defect in the opposite face respect to the field generator

- 3) The defect is detected anyway with a 30% output decrement.

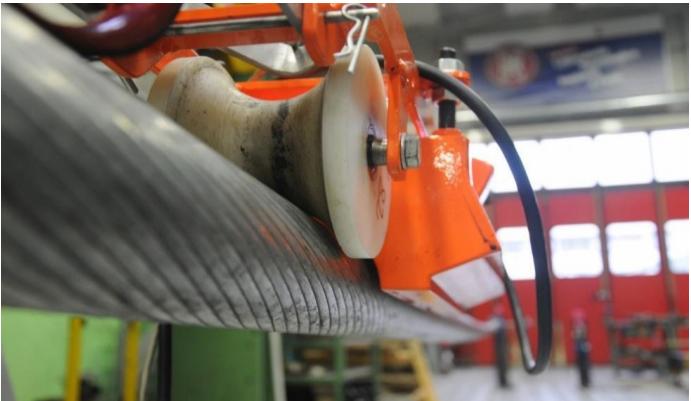
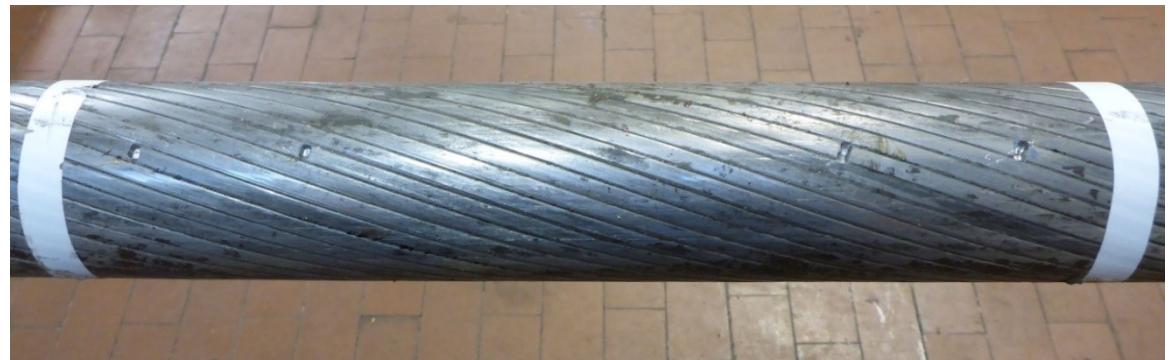
Definition of open detector: test head whose sensors enveloping the rope less than 75%.

The rope is a 6-meter part of a commercial rope with the realizations of artificial defects in the «worst case» position. The defect cause a local section loss of 0.5 % and 0.9%.

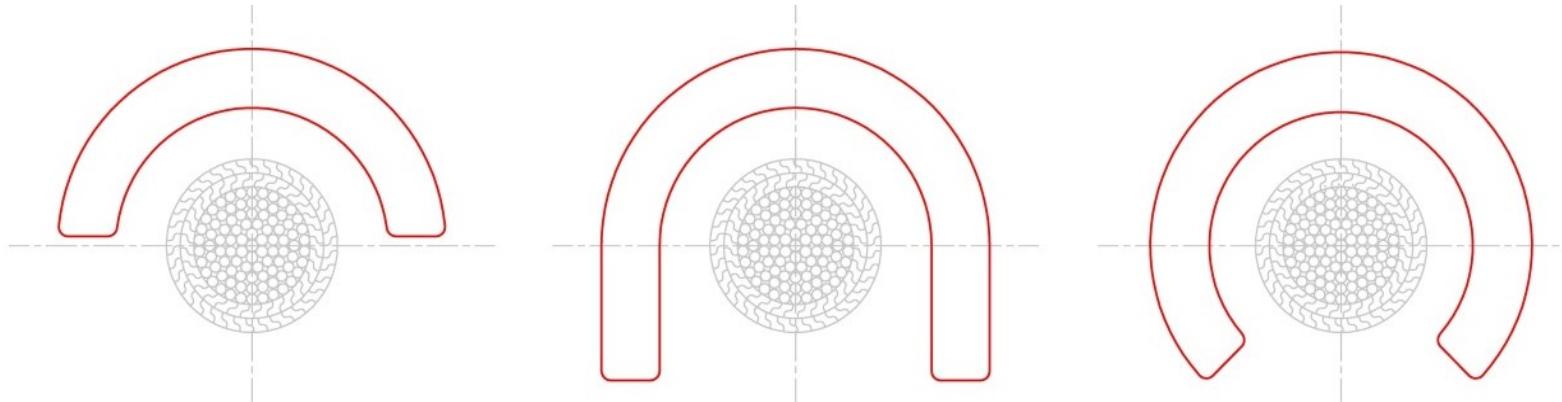
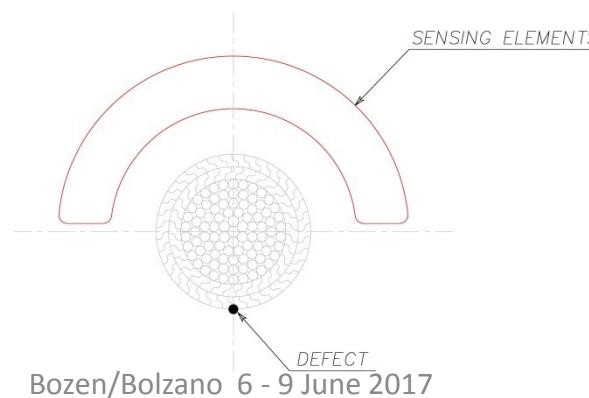
The theoretical analysis confirms that the worst position is in the most distant point from the sensors:

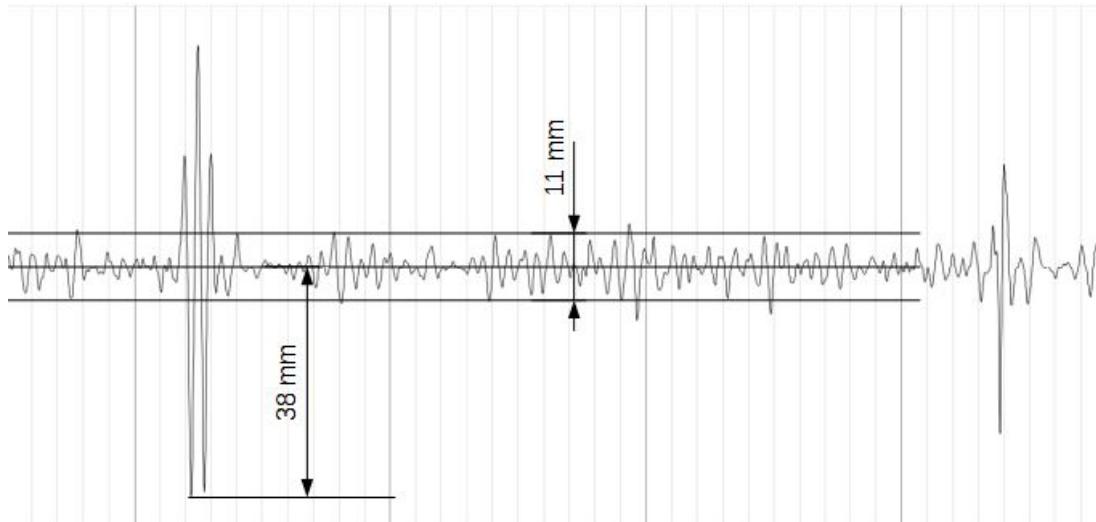
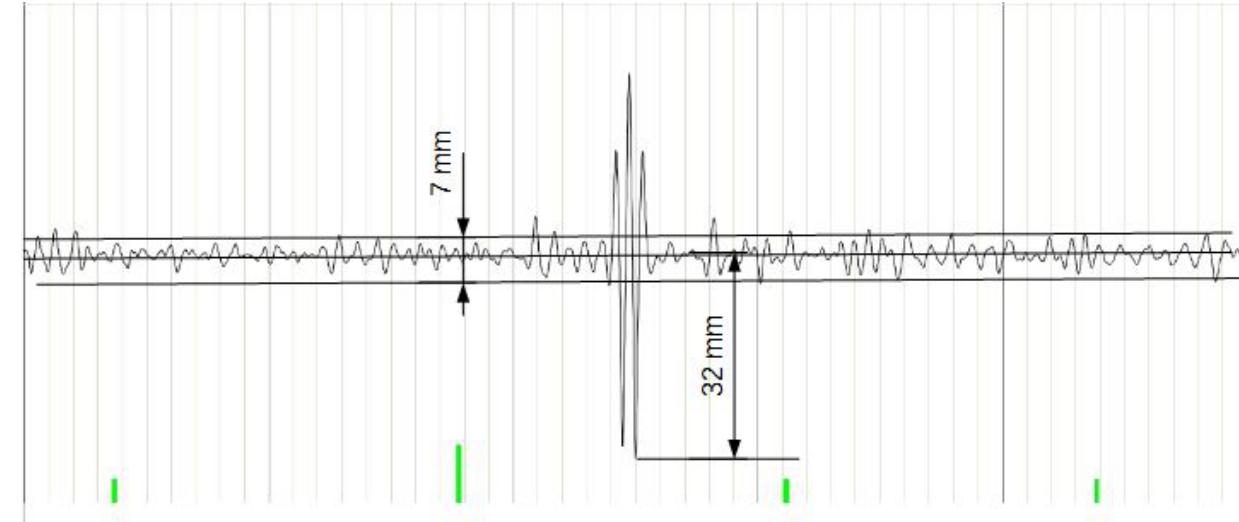
In the first laboratory test a new construction detector about a typical range of ropes. In figure, the result about a 51 mm and 64 mm diameter rope. The double peaked signal in the centre corresponds to the artificial perimetral defect.

The test results was a SN ratio (in the UNI 12927 definition) ≥ 2 in all inspected cases.

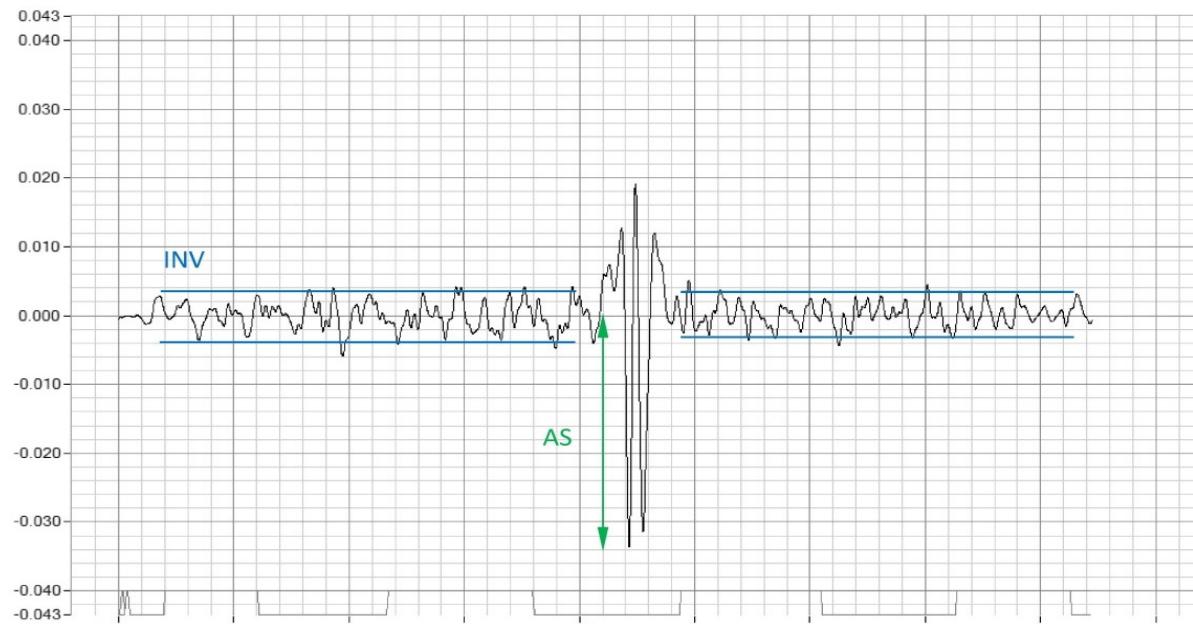
The first picture illustrates the result of the open detector on a UNI 12927 test. The detector obtains a positive result (63 mm diameter rope).

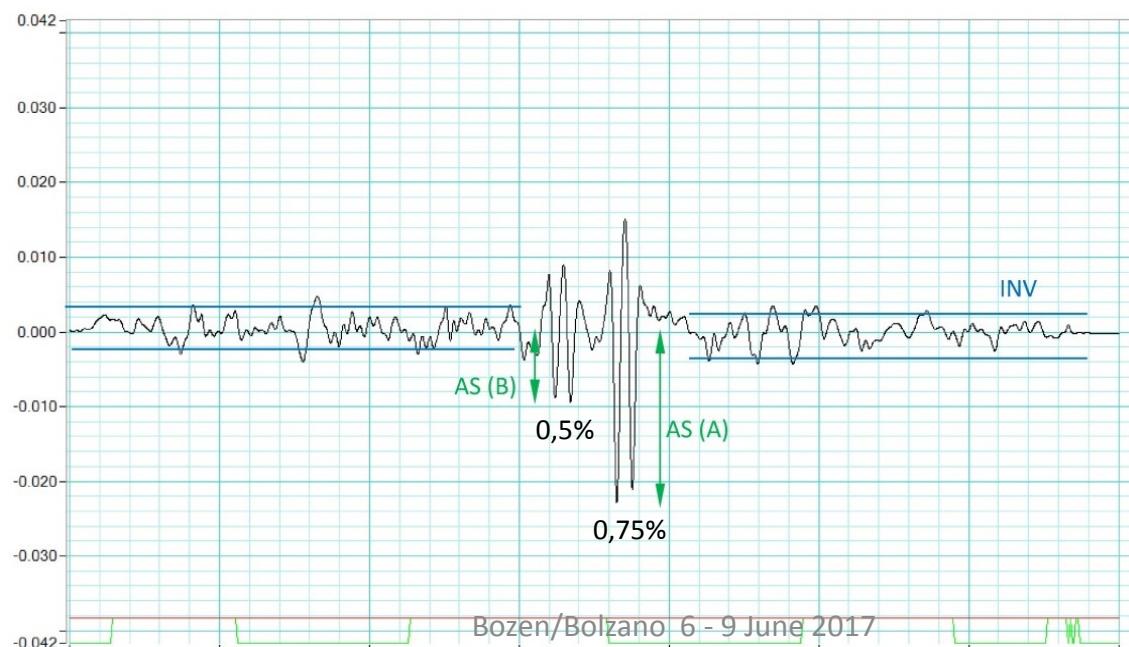
The second picture illustrates the result of the open detector on a pair of external defects that realizes 0.5% and 0.75 % section loss. The defects were located ed in the «worst case» position.

The detector provides sharp and clear signals in both conditions.

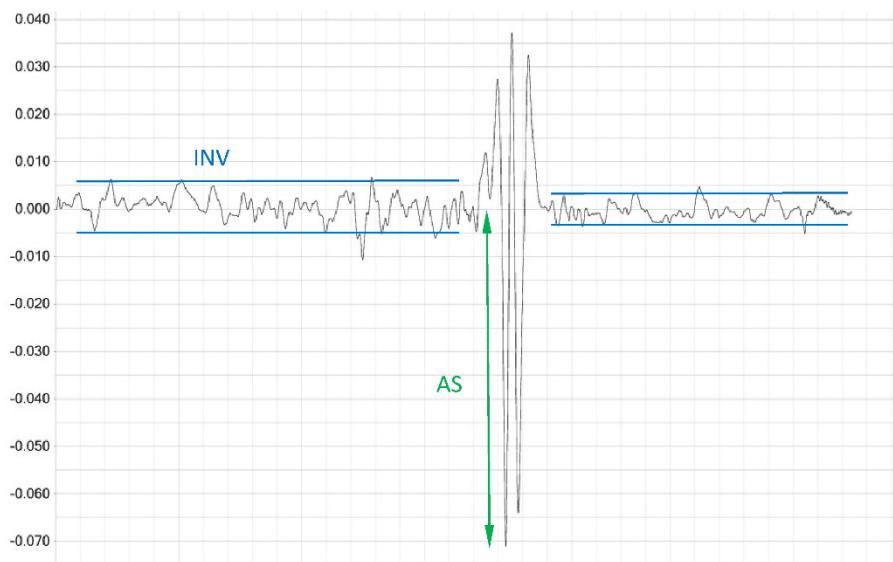
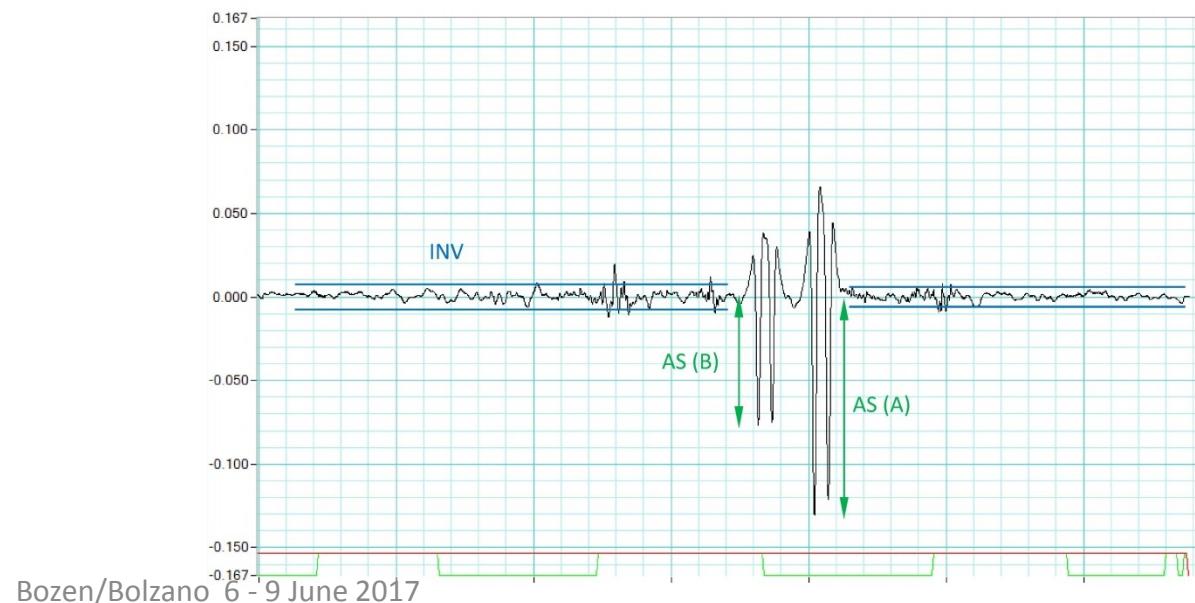
The third couple of pictures illustrates the result of the closed detector in the same previous test conditions.
The detector obtains a positive result in UNI 12927/8 terms in all conditions.

1. external defects certainly represent a valid auxiliary test for the verification of the «open» detector; these tests may be integrated with the aid of the test leads.
2. The two tested detectors provide reliable indications in the defined configurations:
 - 1) Central defect;
 - 2) External defect 0.75%
 - 3) External defect 0.5%
