O.I.T.A.F.
Work-Committee No II
Characteristics and Inspection of Ropes

Gains and Limits of Magnetic Rope Testing

24. April 2014

OITAF Seminar Grenoble

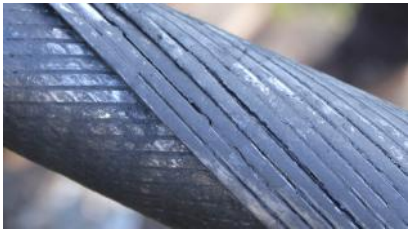
6-month old track-rope

lack of lubricant, indentation of Z wires

Failures of internal layers

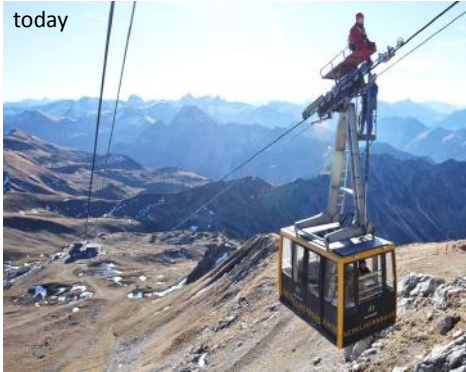
Origin: Invention of magneto-inductive coil by Prof. Richard Woernle in 1930s
Today: Research institute for MRT and rope technology, service provider for rope inspections, damage analysis, approval tests and regular inspection of ropeways

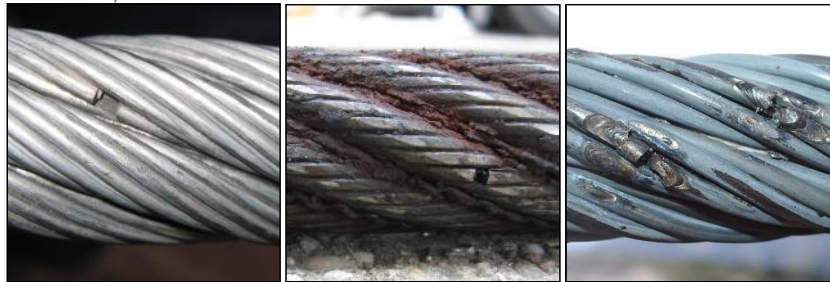
- Bending cycles: rope wear and material aging by repeated flexion over sheaves
- Corrosion: Material surface turns brittle and initiates cracks and wire breaks
- External influences: lightning strokes, accidents within construction works, derailments,...cause deformation, structural changes or wire breaks
- ...and many more reasons

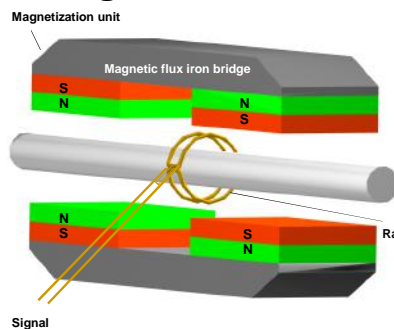
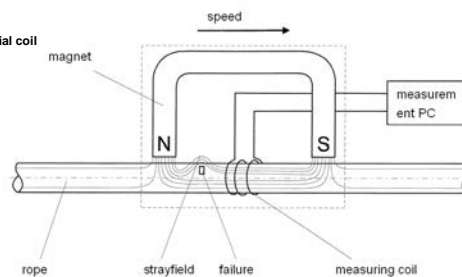
$$U = - n S v \frac{dB}{dx}$$

Lenz-Faraday law

- Permanent magnets create a saturating magnetization of the steel wire rope
- Resulting leakage field generates a voltage in the measurement coil

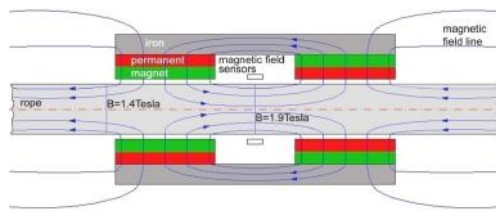
Magnetic field circuits forming homogeneous magnetic flux all over the rope's cross section. The wire material has to be magnetically saturated by at least 1.9 up to 2.3 Tesla.

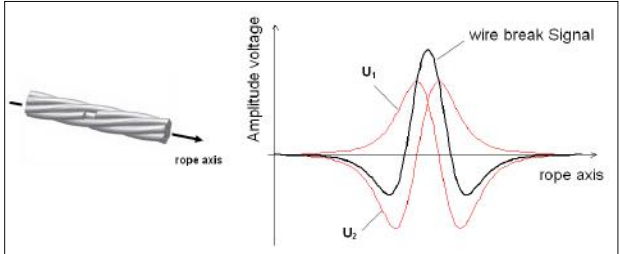
Theory:

Damage Signals:

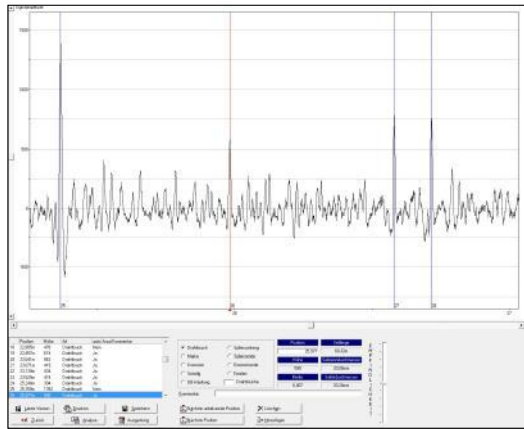
Software-Application:

- Automated labelling of suspicious patterns
- Evaluation by expert user
- Automated report creator
- Relating of damages to discard criteria (loss of tensile capacity on specific reference lengths)

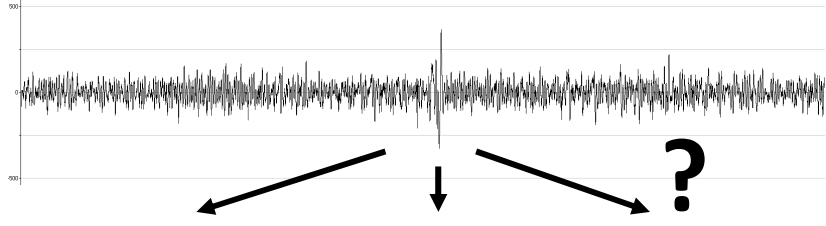
Magnetic signals are only a 1D image of the real damage. Signals can be ambiguous, so every pattern of doubt has to be clarified by visual inspection:

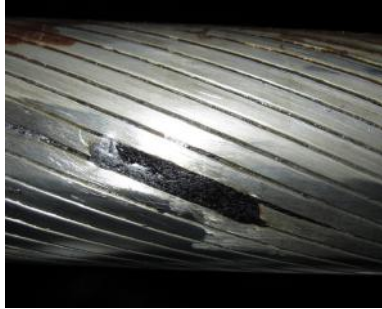
Fill-up of wire break gap using plastics:

- Protection of inner layers against moisture
- Stabilizing of surface wire compound

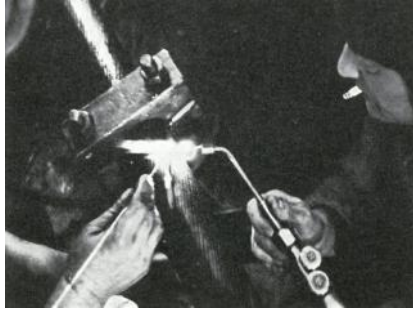
Shifting of wire breaks by brazing:

- Separation of two neighboring wire breaks
- Creation of distance to discard criteria

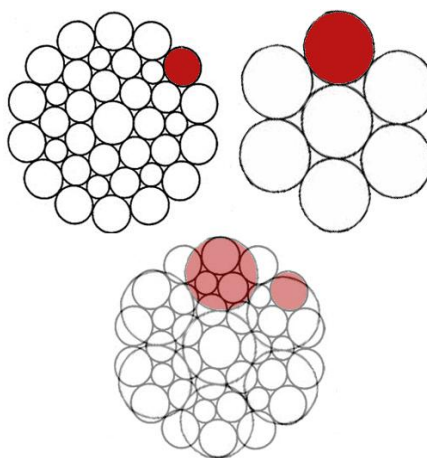
Number of maximum allowed wire breaks on reference lengths depends on rope type:

Example: number of broken outer wires at point of discard on 6xd according to EN 12927-6:

Rope Type	Number broken outer wires
6x7	3
6x19 Seale	4
6x36 Warr.-S	9

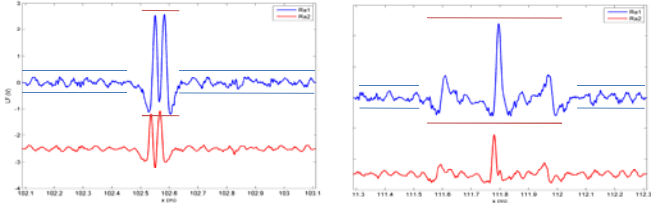
WB signals:
LF 1 / LF2

Masking effects: ill-separated WB's

■ WB's
■ Ground signal

- a) Unknown → MRT history is required to analyze the development of WB's during rope operation
- b) WB ? Missing wire ? : No → splice knot
→ rope visual verification is required

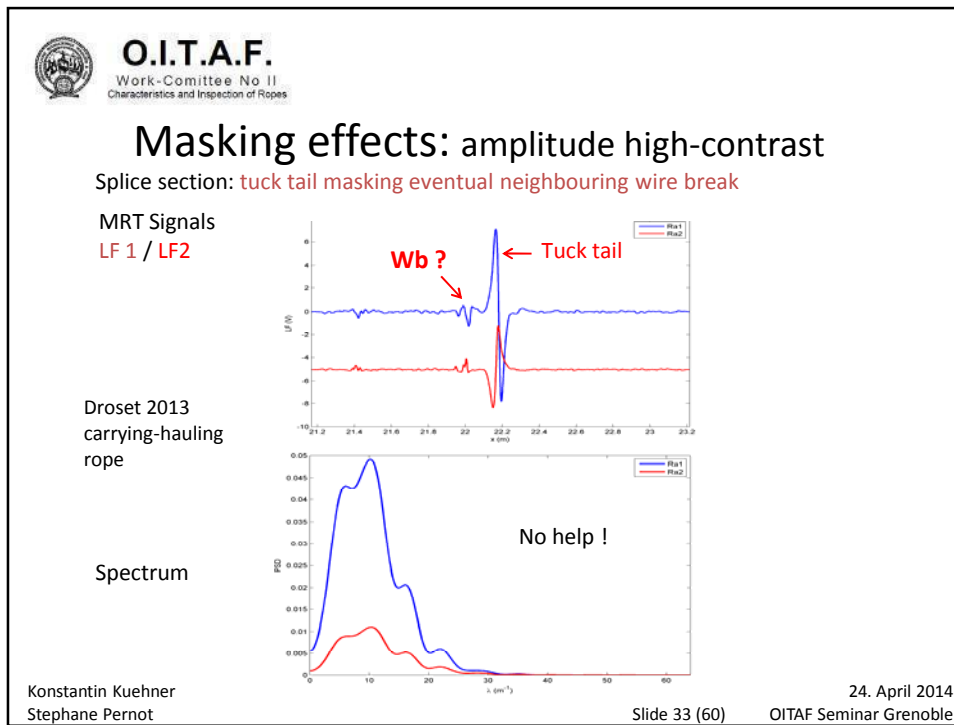
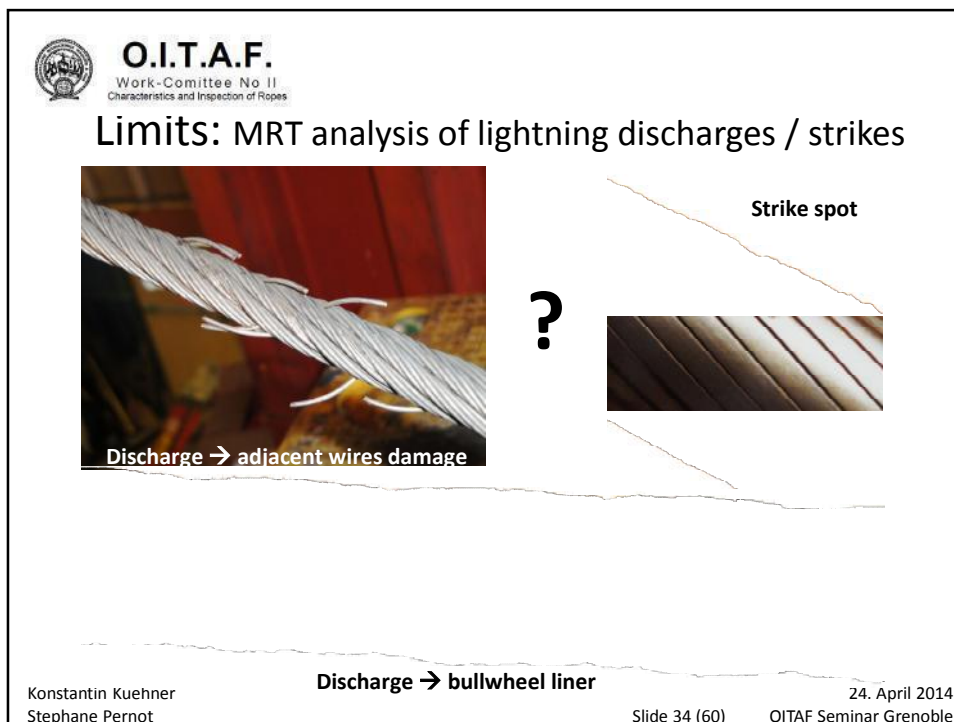
Limits: MRT analysis of a lightning discharge

Melted adjacent wires **Broken melted wires**

Broken melted wires

- similar with wire break signals
- noisy ground signal
- slow spectrum decay

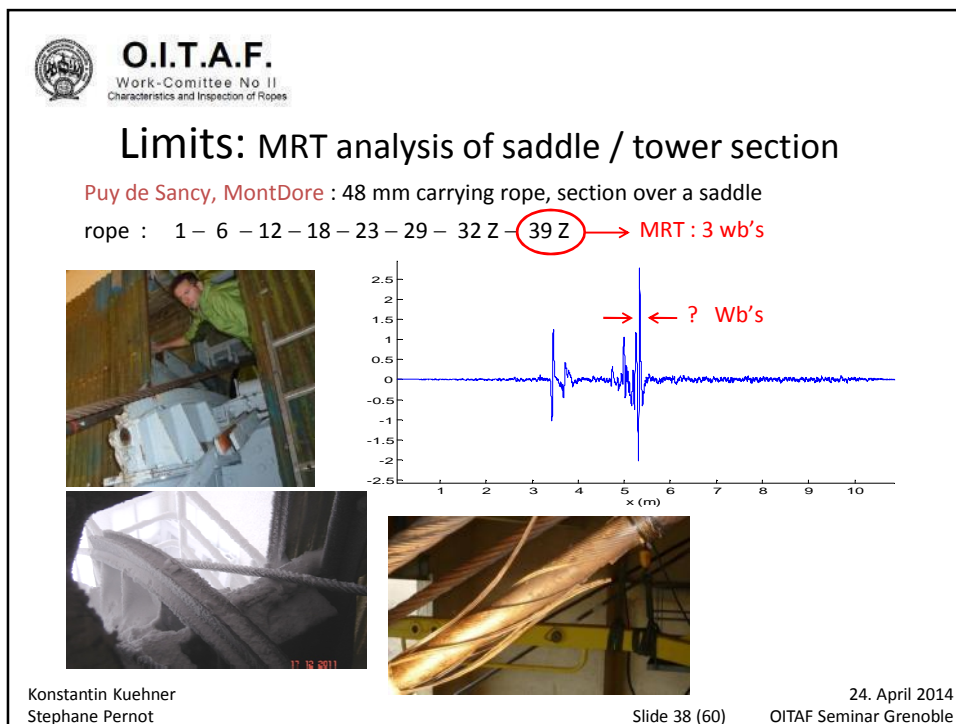
Limits: MRT analysis of saddle / tower section

Failure : fretting-corrosion

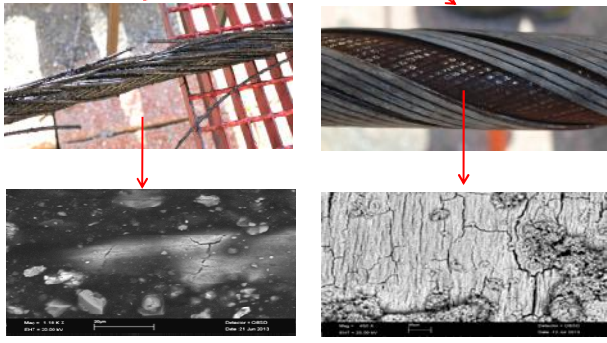
TrpH Ruillans, La Grave : 51 mm tension rope, section over a sheave
 rope : 1 – 7/7 – 7 – 14 – 24 – 30 – 33 Z – 38 Z
 opening: 1 – 7/7 – 7 – 14 – 23 – 2 – 33 Z – 38 Z

○ wb
rusty - dry

Konstantin Kuehner Fatigue-cracking corrosion Microfractures 24. April 2014
 Stephane Pernot Slide 41 (60) OITAF Seminar Grenoble

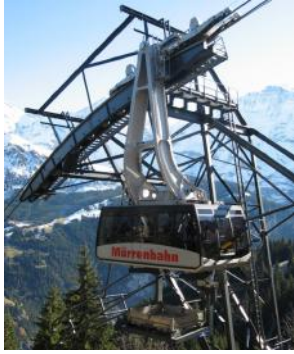
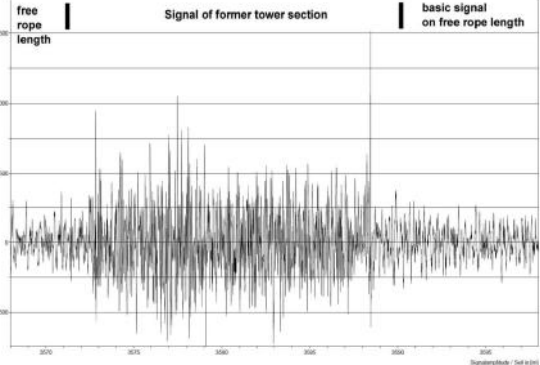
Problem: Corrosion-/wear-signals can cover wire break signals, e.g. in former tower sections
 → Another more-dimensional inspection-method is needed to clarify the state of the rope

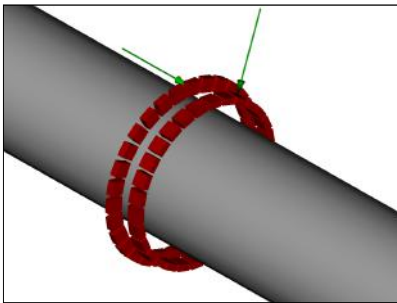
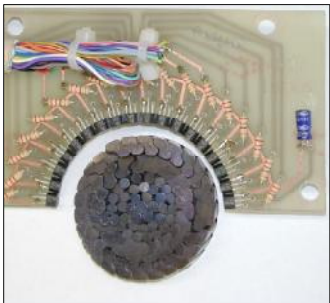
- Instead of an averaging coil, a large amount of hall-effect sensors is installed around the rope
- By recording each sensor as a measuring channel, the defect can be better localized in the cross-section of the rope
- This allows to separate wire breaks from wear or corrosion
- Cheaper, less dangerous alternative to x-ray examination

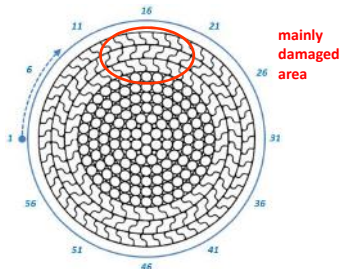
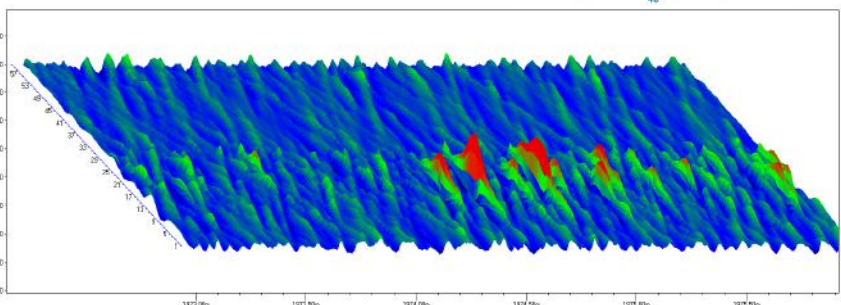
- Software-Application allows to rescale color-scheme and amplification to work out points of interest
- Damage can be closely localized and evaluated to plan further special treatment, inspection and repair

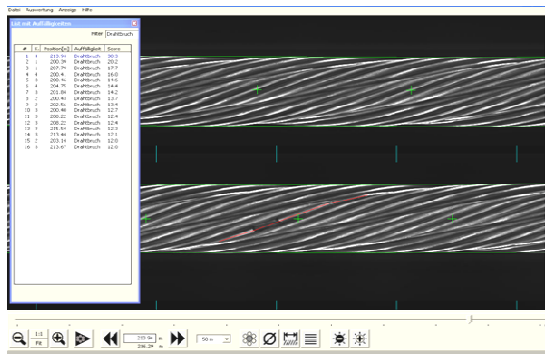
Analyze of the wires and rope surface:

Diameter and rope lay length along the rope

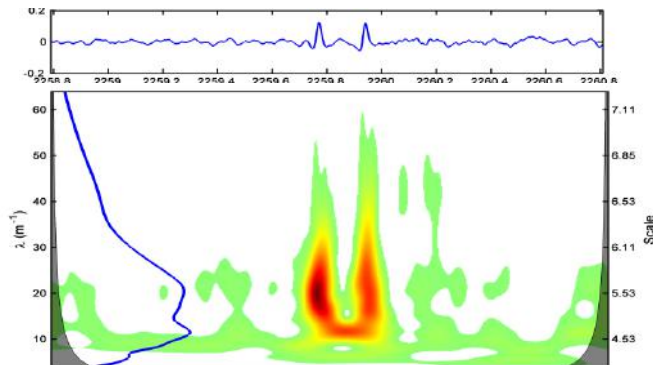
MRT signal : splice knot

Wavelets : mathematical entity Ψ aimed to analyze main signal components

Transform :
$$W_{\psi}^s(a, b) = \frac{1}{\sqrt{a}} \int_{-\infty}^{+\infty} s(t) \psi\left(\frac{t-b}{a}\right) dt$$

Scalogram : colormap of wavelet representation

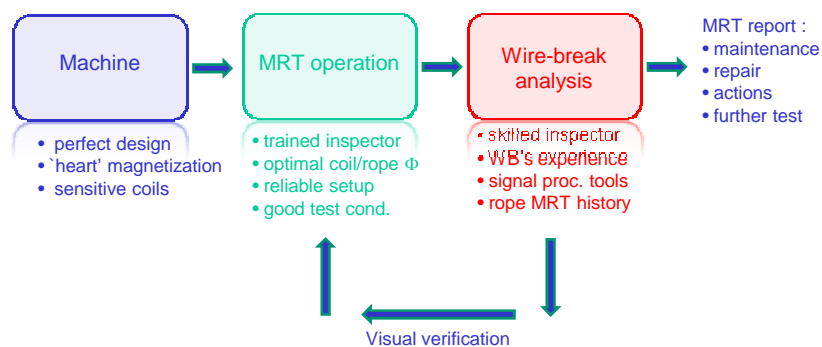
Prerequisites for efficient MRT

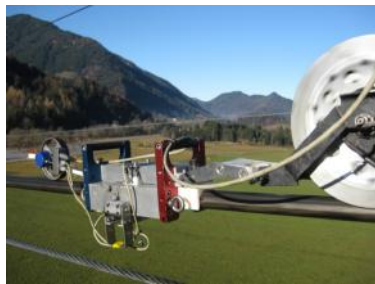
MRT

Heavy corrosion	inner wire breaks
Heavy wire damage	
Outer wire breaks	Wire breaks in strand touching zone
Former clamping areas	
Lightning strokes
