INFLUENCE OF VOLCANIC ASH ON FATIGUE LIFE OF STEEL WIRE ROPES

TECHNICAL REPORT

In order to quantify the influence of the presence of volcanic ash on the steel wire ropes in their useful life, the field working conditions of these wire ropes were replicated under laboratory conditions.

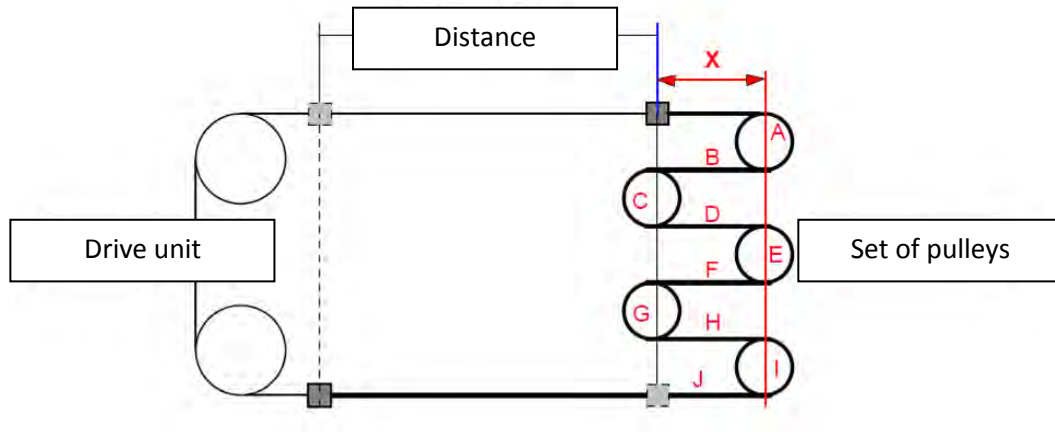
The tractor wire rope drives the test piece through the pulley system. Throughout a complete cycle of the machine the most fatigued area (in the middle of the test piece) travels forward and backward, flexing a total of 10 times (5 times forwards and 5 times backwards). Identified in the following figure as Zone J or Zone 10, it is in this section where the wire rope will show greater signs of fatigue wear. To each side of this zone we find zones that have undergone 8, 6, 4 and 2 flexion cycles, each of which receives 80%, 60%, 40% and 20% of the total cycles performed by the test bench.

After the test, a sample of zone 10 and two samples from each 8, 6, 4 and 2 zones are obtained. A sample of each zone is analyzed in the laboratory to determine the number of broken wires. The other is put through a tensile test to determine how the residual breaking load of the wire rope varies depending on the number of fatigue cycles..
