# INFLUENCE OF VOLCANIC ASH ON FATIGUE LIFE OF STEEL WIRE ROPES

Instituto Nacional de Tecnología Industrial  
Centro de Investigación y Desarrollo en Mecánica  
Programa Medio de Transporte por Cable

## TECHNICAL REPORT

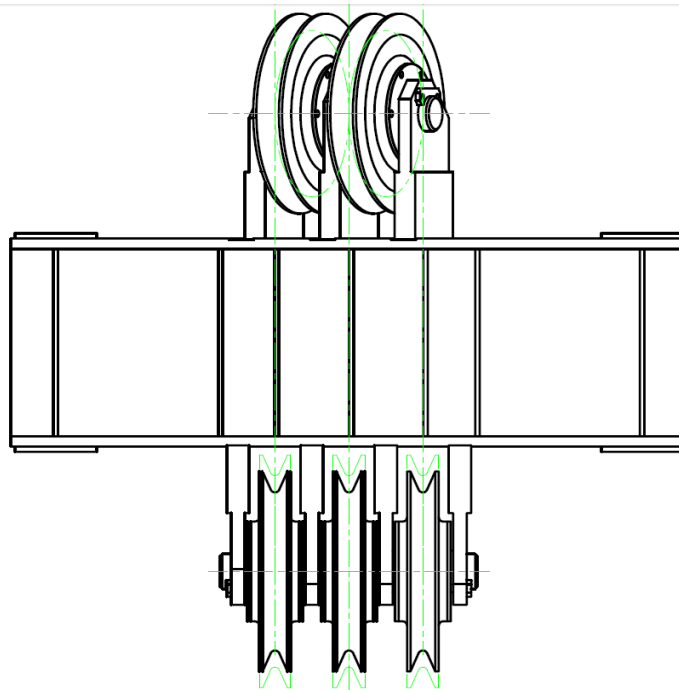
5 Set of pulleys: it represents the main difference between this test bench and traditional ones. Both sets have 5 pulleys each and its configuration avoids torsioning the wire rope due to deflection angles (as in real operating conditions). The configuration of the set of pulleys used is shown:

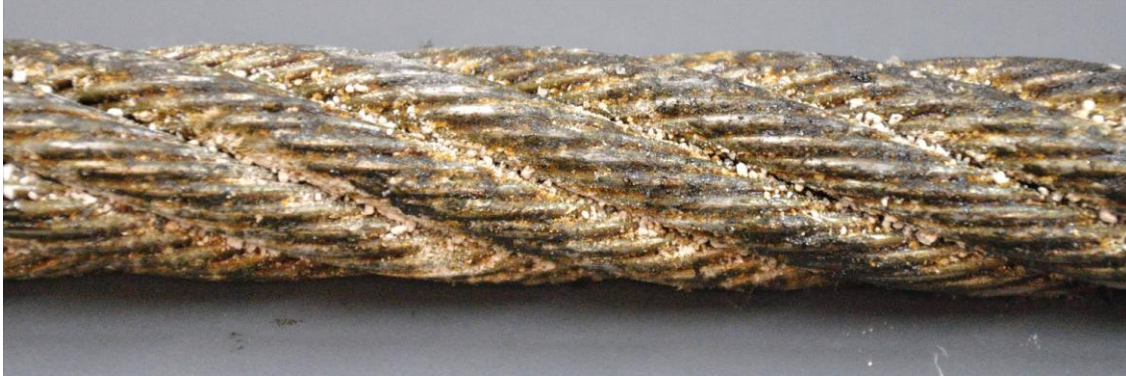
The following is an image of the wire rope after the simulated ash fall:

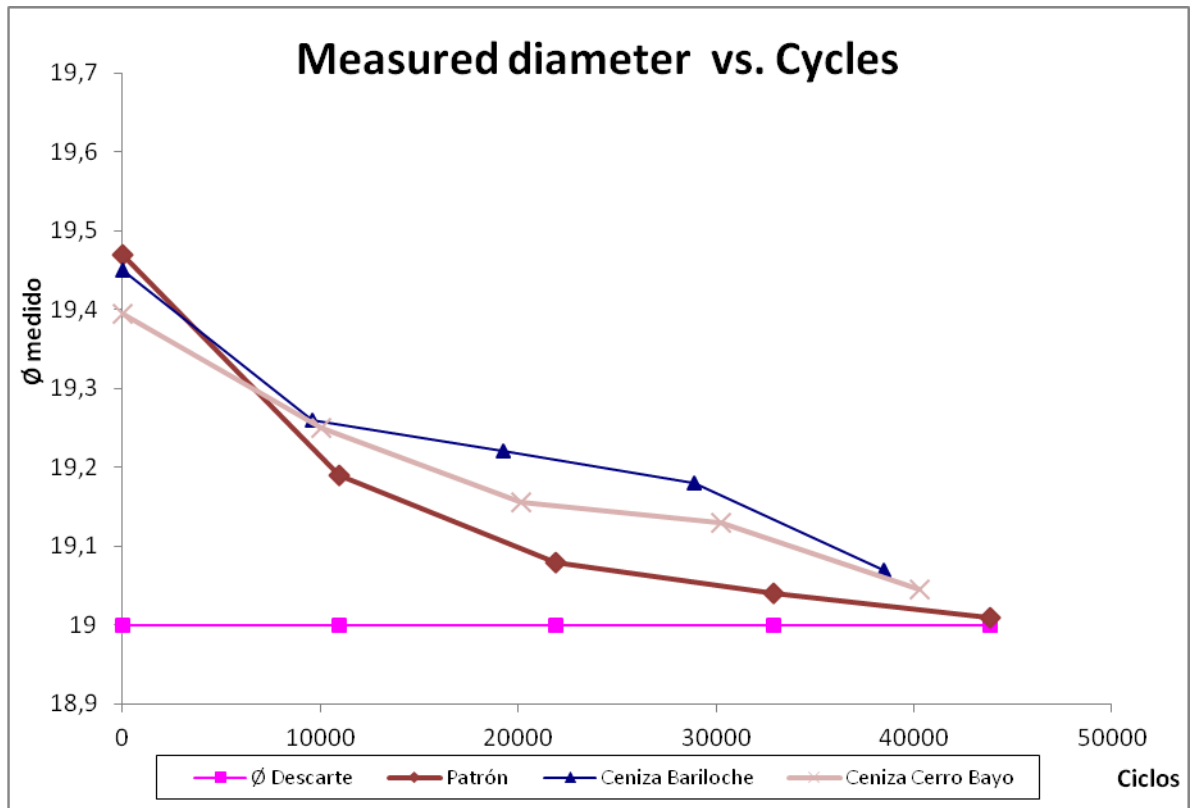
Obtained results are shown in the following graph.

The analysis of this graph shows:

- Diameter decreases with the number of flexion cycles
- Diameter for a 20% severity rating was never reached.

- i. **Wire rope diameter reduction:** Ashes had no influence on the measured diameter
- ii. **Number of wire breaks in  $6 \times \varnothing$ :**
  - a. After reaching 70% of the reference standard service life, the influence of the volcanic ash is evidenced in the number of broken wires.
  - b. From the 80% of the service life of the ropes with ashes, there is a considerable increase in the number of wire breaks.
- iii. **Number of wire breaks in  $30 \times \varnothing$ :**
  - a. From 80% of the reference standards service life there is a considerable increase on the amount of wire breaks in the ropes with ashes.

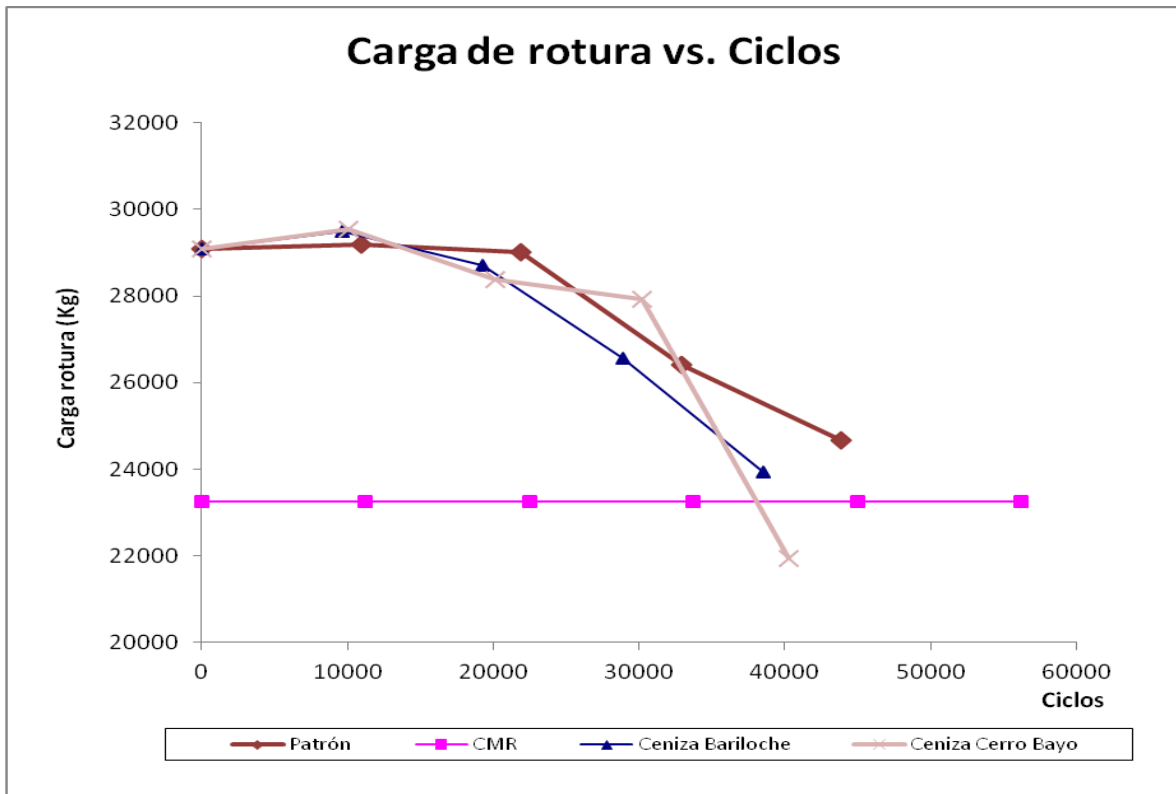
The following graph shows MBL vs. Cycles:

- iv. **Residual breaking load test:** Relating discard criteria and breaking load test graphs, it can be ensured that when the rope reaches discard criteria the safety factor of the installation is unchanged.

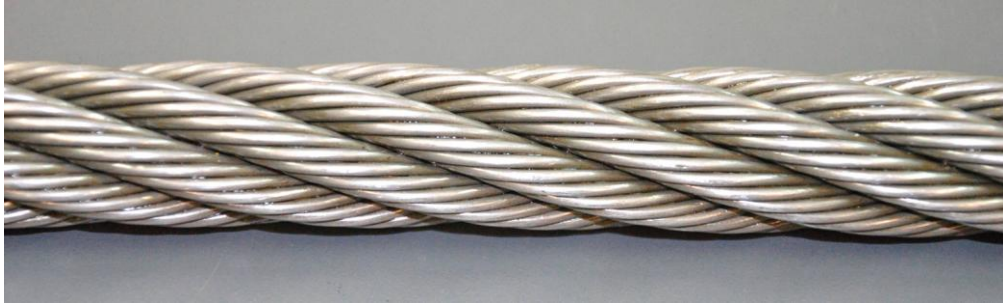
The decreasing breaking load is due to the accumulation of fatigue wire breaks occurring on both the ridges and valleys. The following images show the increasing number of broken wires against fatigue cycles.

*20% bending cycles zone*

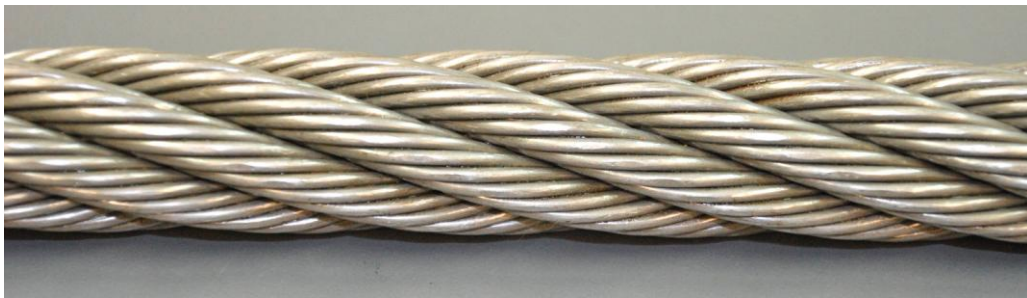
*40% bending cycles zone*

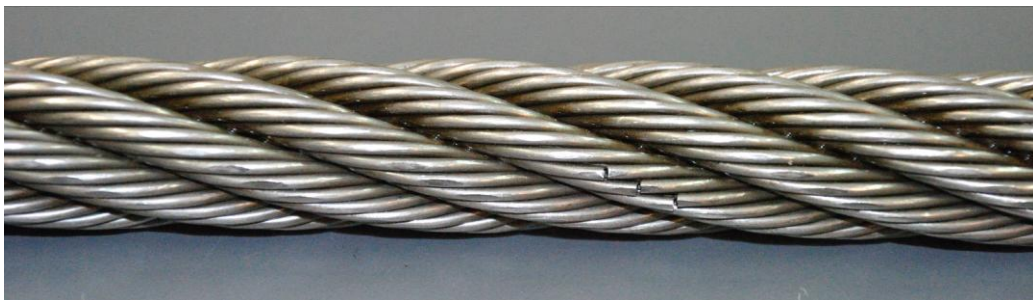
*60% bending cycles zone*

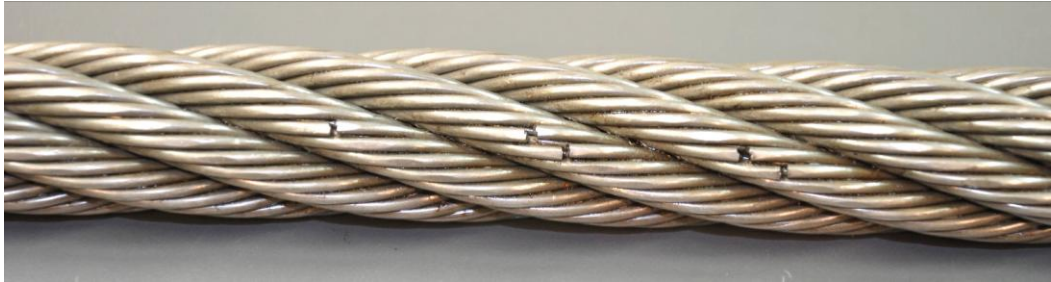
*80% bending cycles zone*

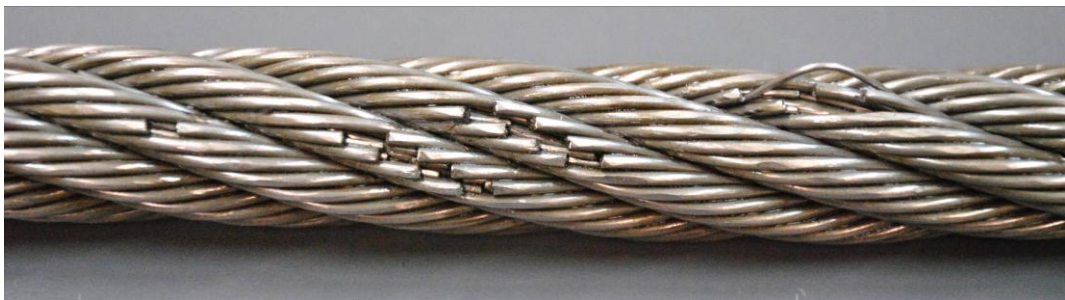
*100% bending cycles zone (close to failure)*
