**BOOK N 30
(Edition 2019)**

Possibilities to improve visual rope inspection (VI)

Written by Work Committee No. II

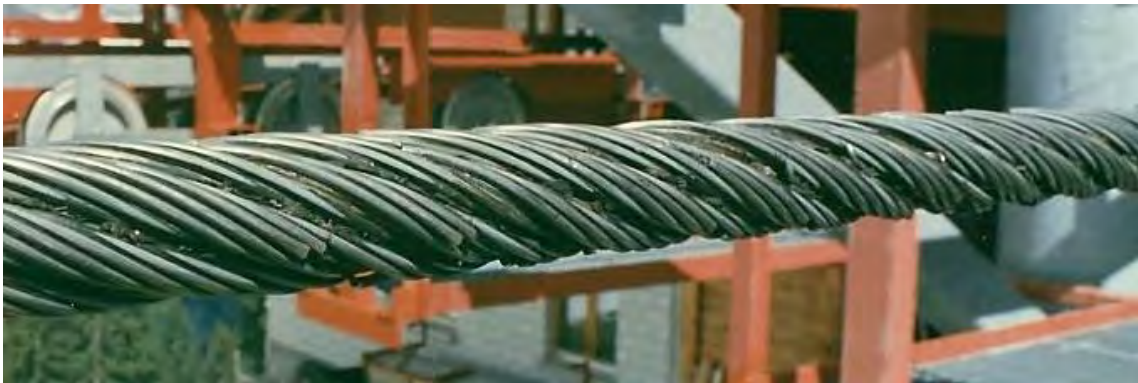
This case shows that a slipped mounting clamp can cause huge damages (e.g. by friction martensite) through surface embrittlement leading to wire breaks, if the damage is not detected in time. Since visual rope inspection was not executed, the damage, which occurred at a length of 41 cm, had not been detected until the next MRT-Testing. The loss of metallic-area has already reached 40 % in the reference length of 30 d.

Figure 2-1: Damages of slipped mounting clamp

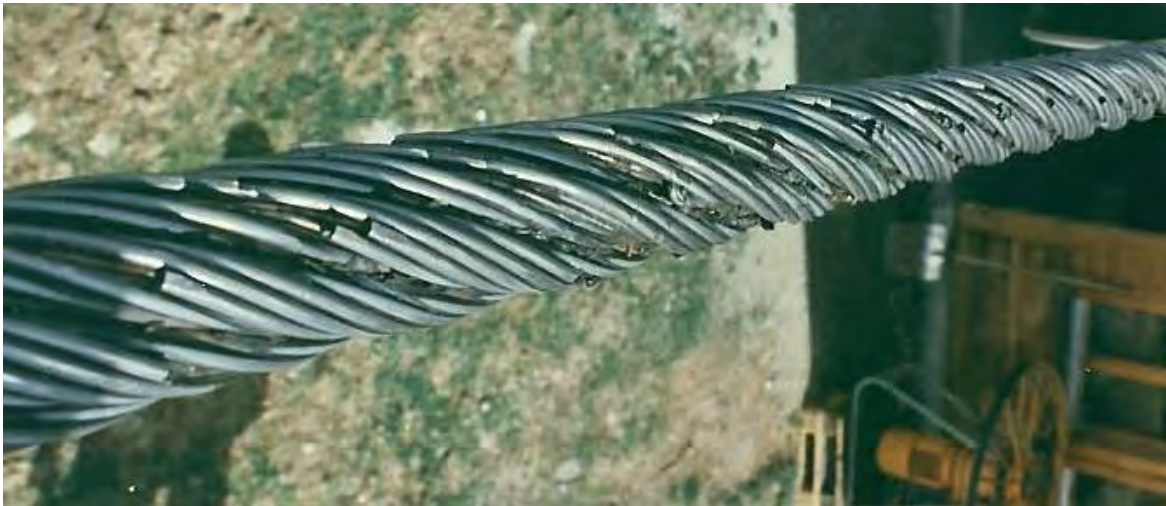
Figure 2-2: Damages of slipped mounting clamp

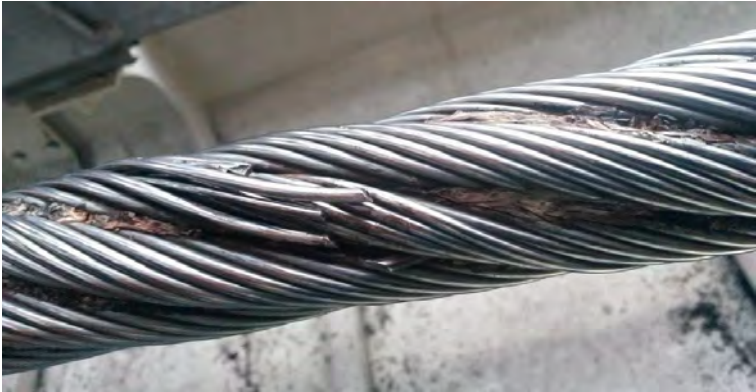
In this case a shrunken tuck tail end was not detected and lead to wire breaks in the strand touching zone. As the damage was detected, a regular restructuring was not possible any-more and an additional strand had to be spliced-in. The rope had to be replaced soon after that occurrence.

Figure 2-3: Shrunken tuck tail ends with several wire breaks

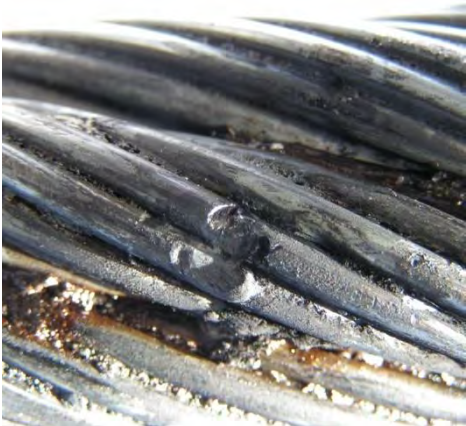
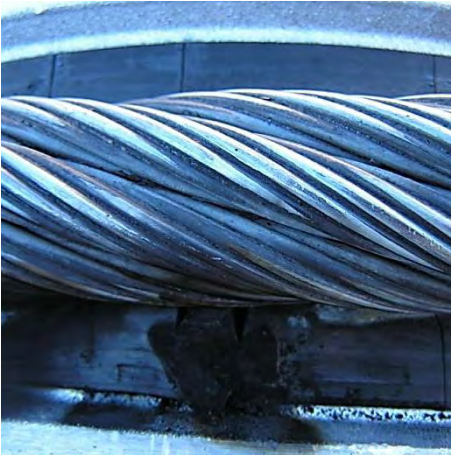
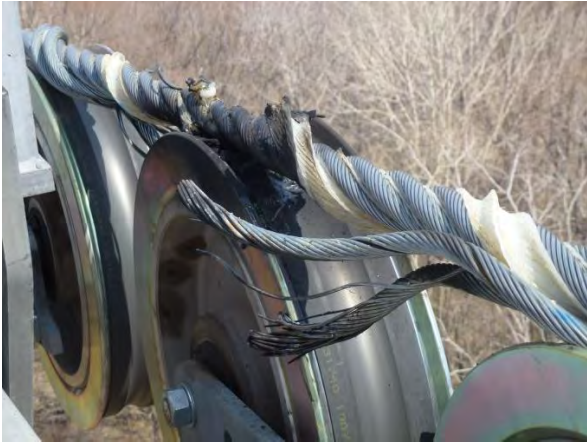
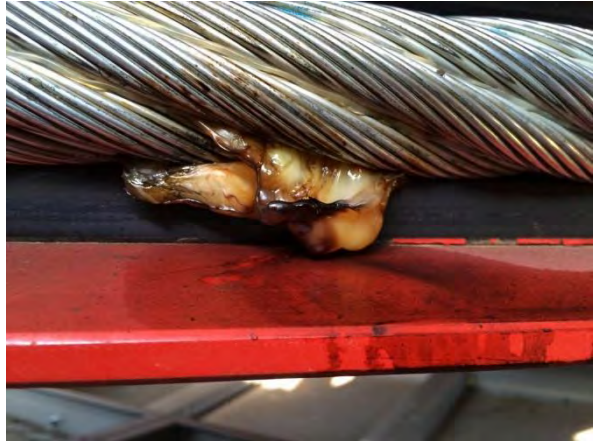
Current flow can cause huge rope damages. Whereas Figure 2-4 and Figure 2-5 show comparatively small damages, Figure 2-6 and Figure 2-7 show massive damages caused by current flow. If current flow occurs, an unscheduled inspection has to be executed to detect possible damages immediately and initiate repair measures, if necessary. Even apparently small damages can have a great impact, if they are not detected and can lead to discard criteria.

Figure 2-4: Damage by current flow

Figure 2-5: Damage by current flow

Figure 2-6: Damage by current flow

Figure 2-7: Damage by current flow

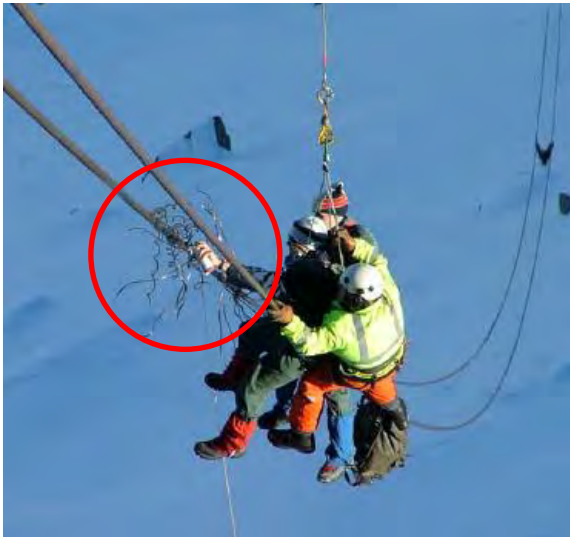
Figure 2-8 shows track rope damage where profiled wires came out of the rope. The damage occurred during the moving process of the track rope when it suddenly slipped over a steel saddle with small D/d-ratio.

Figure 2-8: Track rope damage [6]

The fundamental finding of this accident is that the rope surface has to be thoroughly inspected after moving the rope to detect and repair damages early.

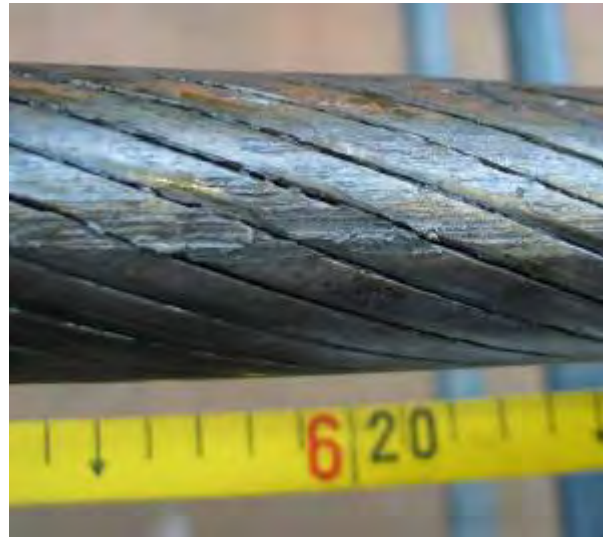
The rope was mechanically damaged during the slipping. Figure 2-9 shows fretting marks, grinding and corrosion marks. Caused by hydrogen induced stress corrosion in the area of the damage forced ruptures occurred, caused by micro cracks. The damages did not show up during MRT-Testing. [6]

Figure 2-9: Track rope damage – detail [6]

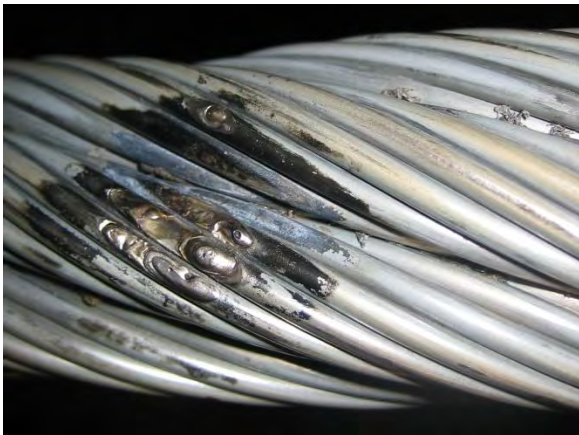
Figure 2-10, Figure 2-11, Figure 2-12 and Figure 2-13 show damages caused by lightning strikes on stranded ropes and locked coil ropes in various extent of damage.

Figure 2-10: Lightning strike at strand rope

Lightning strike can lead to loss of wire material, sharp-edged surfaces and structural changes such as martensite and therefore will gradually cause wire breaks (detailed description see chapter 4.3.1). If it is known that lightning strikes often occur at an installation, an unscheduled visual rope inspection has to be performed to detect possible damages after every thunderstorm.²

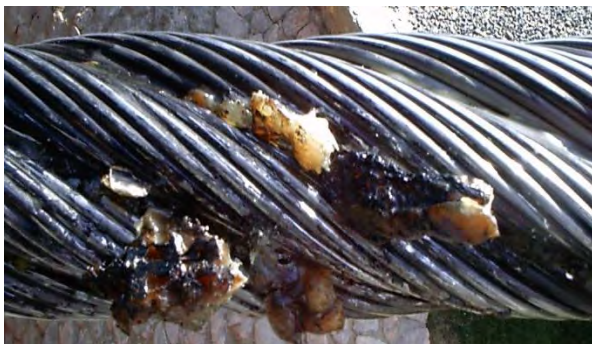
Figure 2-12: Lightning strike with huge damage at strand rope

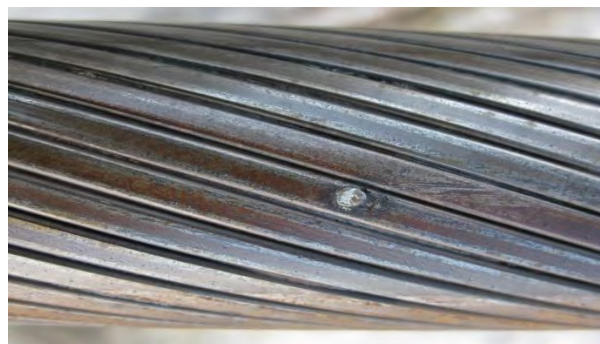
Figure 2-13: Lightning strike at locked coil rope

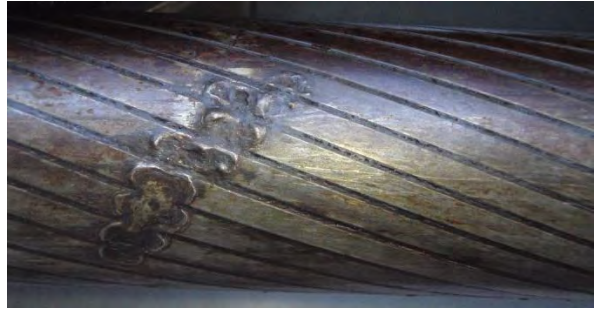
Figure 2-14 shows the point of impact of a lightning strike at a track rope at the bottom of the rope. The point of discharge is shown in Figure 2-15. Both places did not show any visible wire damage, however, MRT-Testing showed inseparable, asymmetrical amplitudes, which would usually indicate two inner wire breaks. Although the position was mentioned in the report, its risk potential was only detected at a second MRT-Testing, which also included a random visual inspection. Operation had to be stopped afterwards and the rope had to be replaced since the attempt of repairing the rope failed.

Figure 2-15: Point of escape at the side of the rope

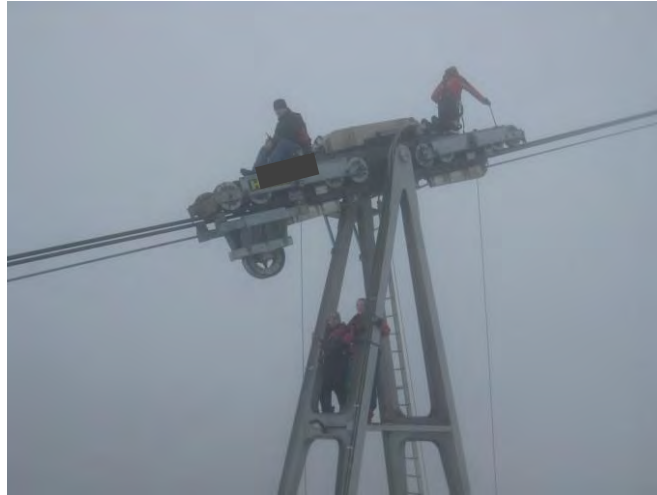
Figure 3-3: Fog during track rope inspection

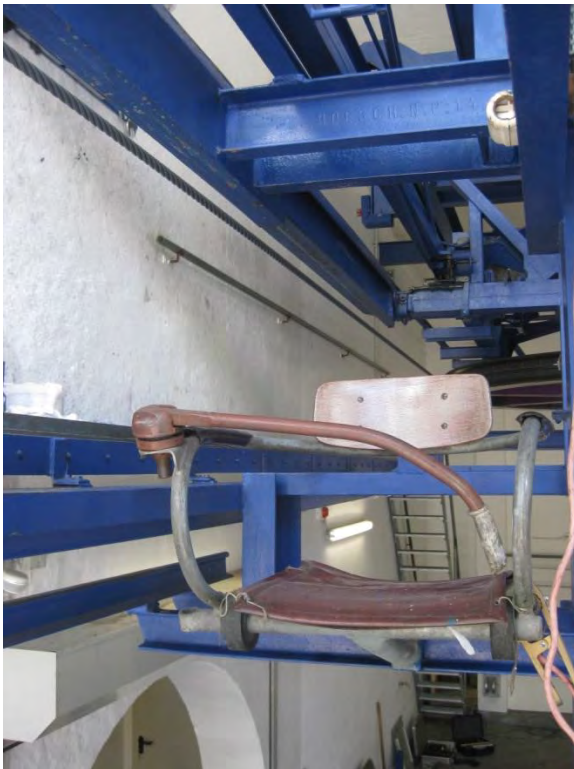
Next to confined space conditions that are shown in Figure 3-1 and Figure 3-2 there are also installations, which are equipped with special seats or benches for visual rope inspection and therefore allow more comfortable working conditions. Examples are shown in Figure 3-4 and Figure 3-5.

Figure 3-4: Special chair for inspections

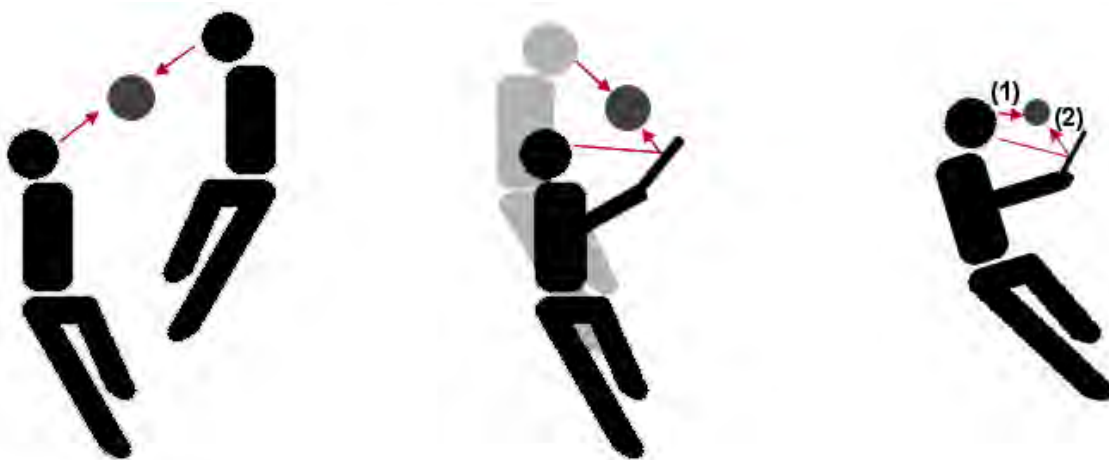
Important information: If only one person is doing an inspection, the inspection has to be executed twice. The first time: to inspect the upper half of the rope. The second time: to inspect the bottom half of the rope (with the help of a mirror). This method should only be used during track rope inspection because of the inevitable rotation of the rope while going over rollers and sheaves.

Figure 3-7: Possible viewing directions of inspectors during an inspection

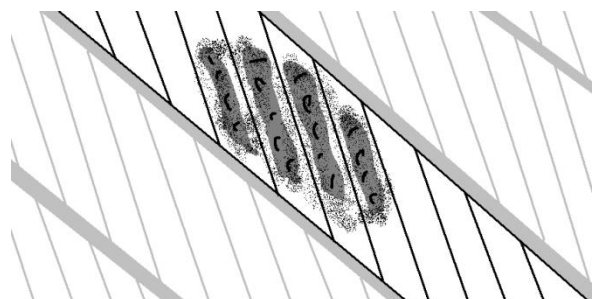
An orange varnish was chosen to create the artificial damages. To make the corrosion in the strand touching zone look as real as possible the varnish was edited with a wire brush to remove the sharp contrast between rope and varnish.

Figure 4-20: Corrosion on several strands abstracted

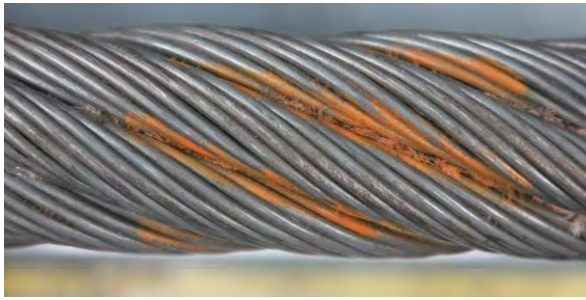
Next to strand touching zone corrosion (compare Figure 4-21) there were points with a diameter of 0.5 x strand diameter, 1.0 x strand diameter, and 1.5 x strand diameter applied on the again (compare Figure 4-22 to Figure 4-24).

Figure 4-21: Corrosion in strand touching zone

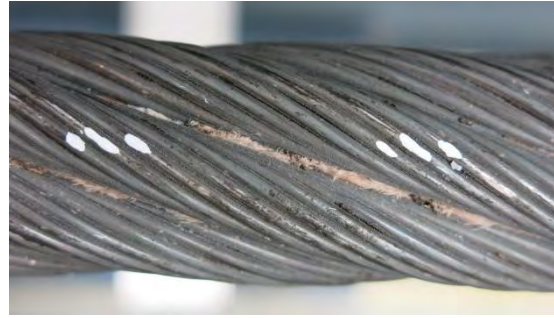
Hair lines and notches are often difficult to differentiate during visual inspection. Therefore, there was no differentiation of these two damages for the artificial reproduction and the goal was to at least detect these fine damages.

Figure 4-28: Artificial hair lines/ notches

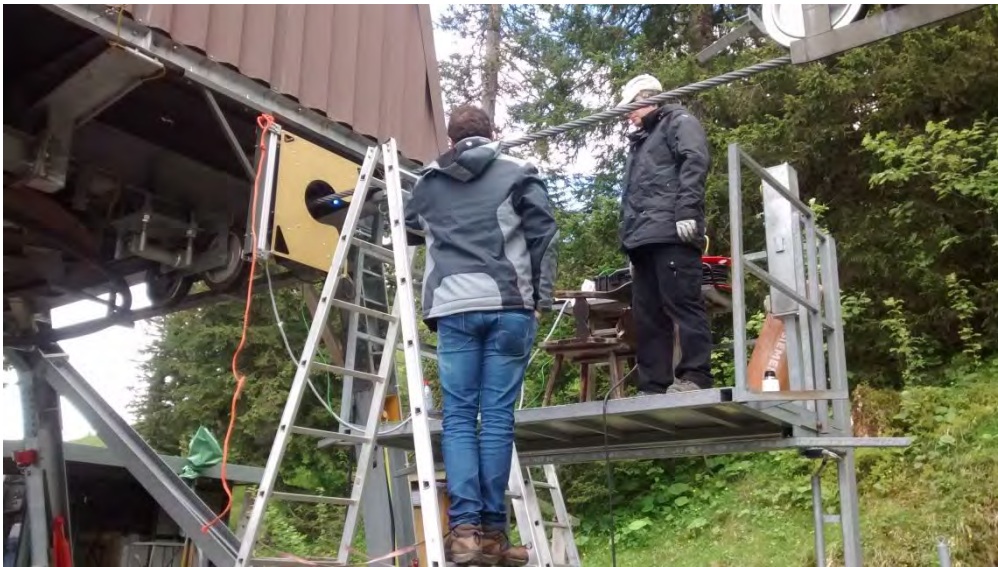
Figure 4-29: Workplace environment at first installation

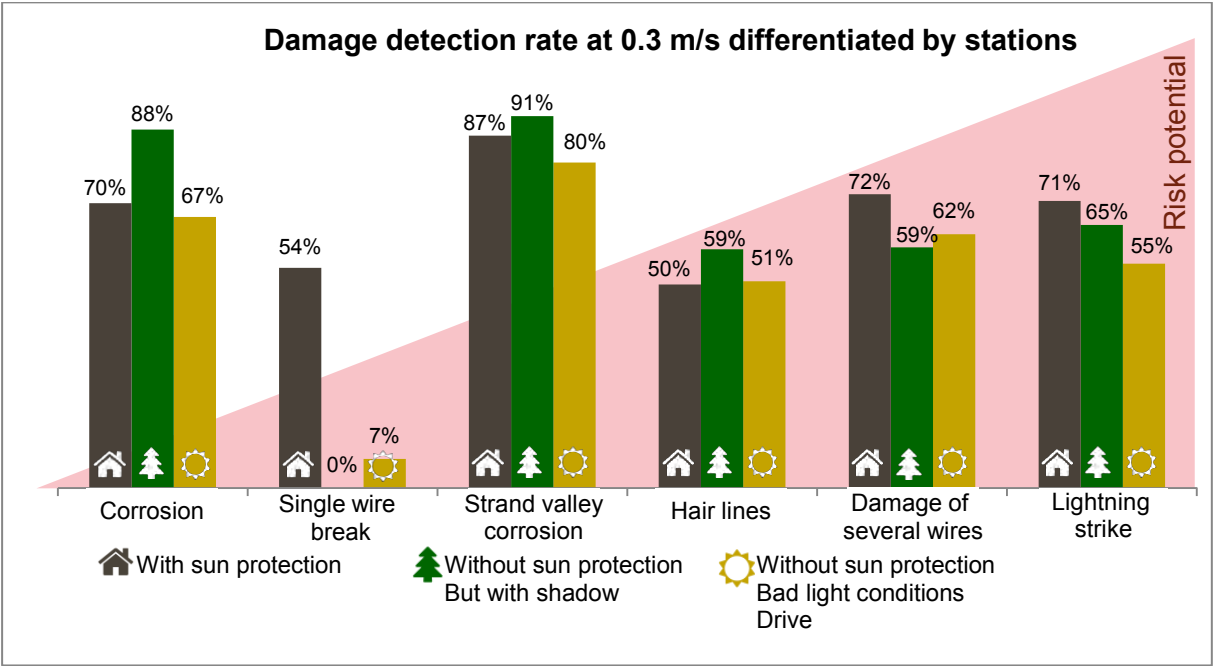
One installation (brown) was protected from direct sunlight by a roof during inspections. At the top station of the second installation (yellow), the worst illumination conditions could be found, according to the participants of the field trial. Additionally, the drive was located at this station, which caused noise and therefore caused an additional distraction. The combination of bad light conditions and the drive noise lead to a damage detection rate, which is considerably below the damage detection rate of the installation with a roof. The possibilities to improve workplace and illumination conditions for visual rope inspection are introduced with the rating system in chapter 6.

Figure 5-10: Damage detection rate at 0.3 m/s differentiated by stations

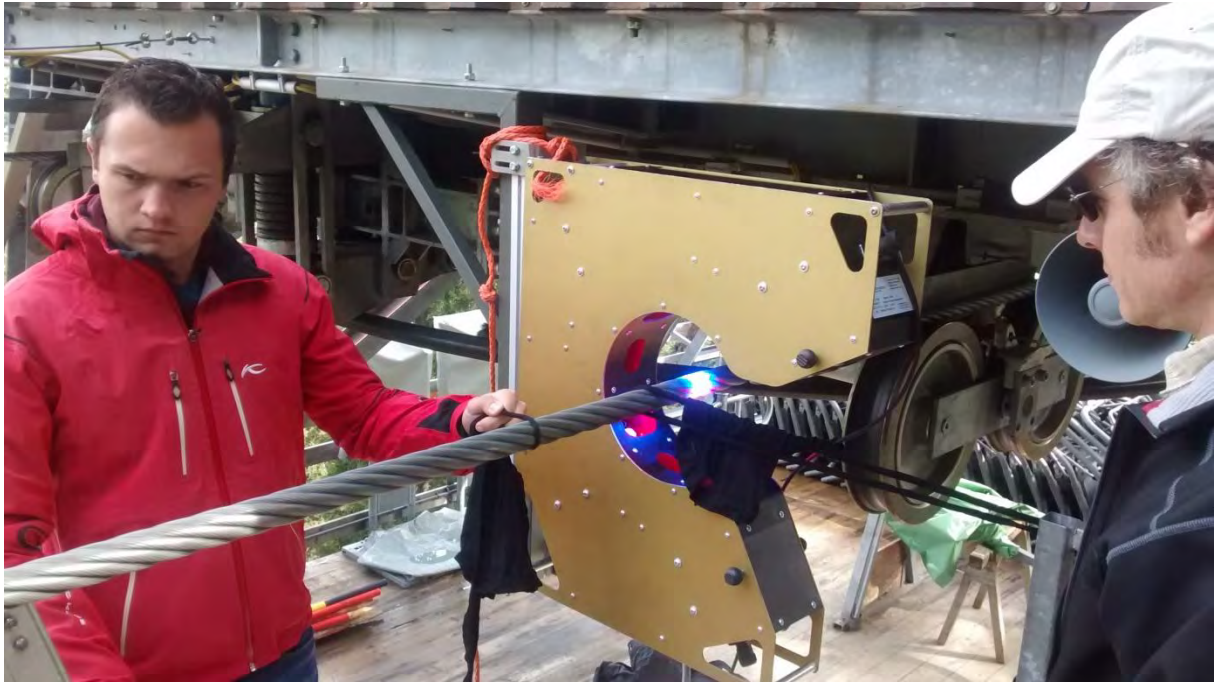
This method is performed at high speeds and especially by ski-tow operators.

Figure 5-18: Inspection with nylon stocking

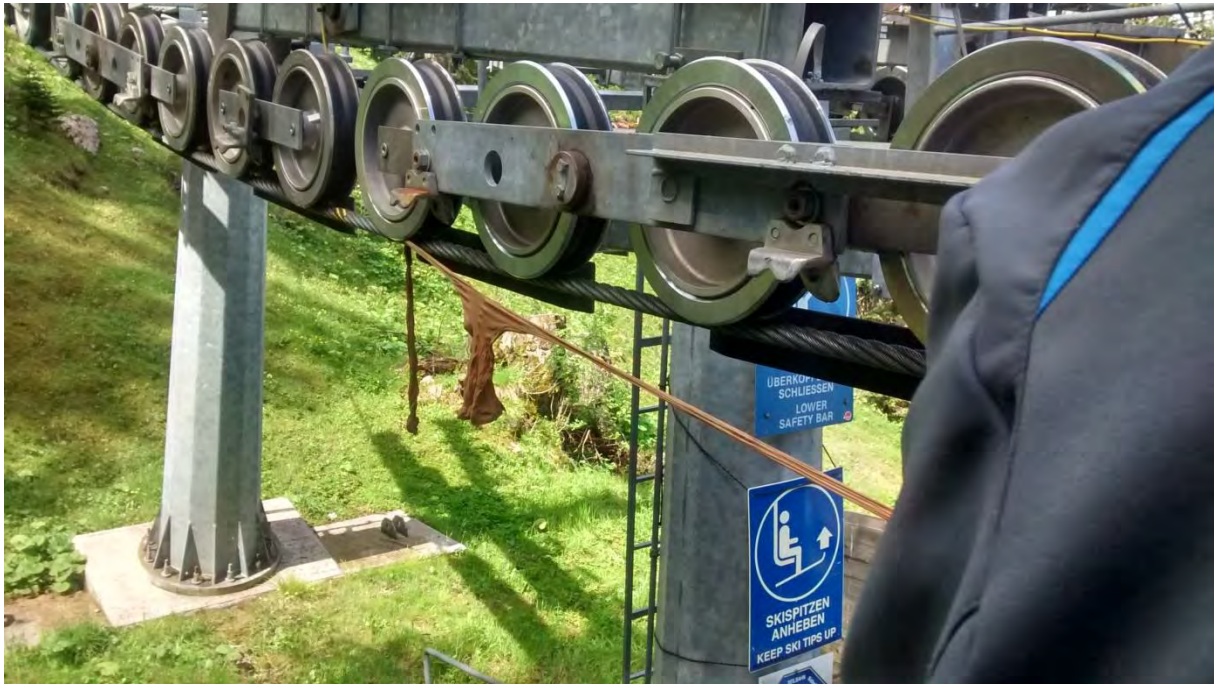
- Holding the stocking is exhausting after some time
- Instable standing position on the ladder, if you have to hold the stocking
- Stocking gets stuck in smallest notches and is dragged into the roller assembly (compare Figure 5-19)
- Stocking has to be held so that the hand does not get dragged along (no wrapping around the arm)
- Damages do not get detected, if one is busy with the stocking

Figure 5-19: Nylon stocking gets stuck on the rope and is dragged into the roller battery

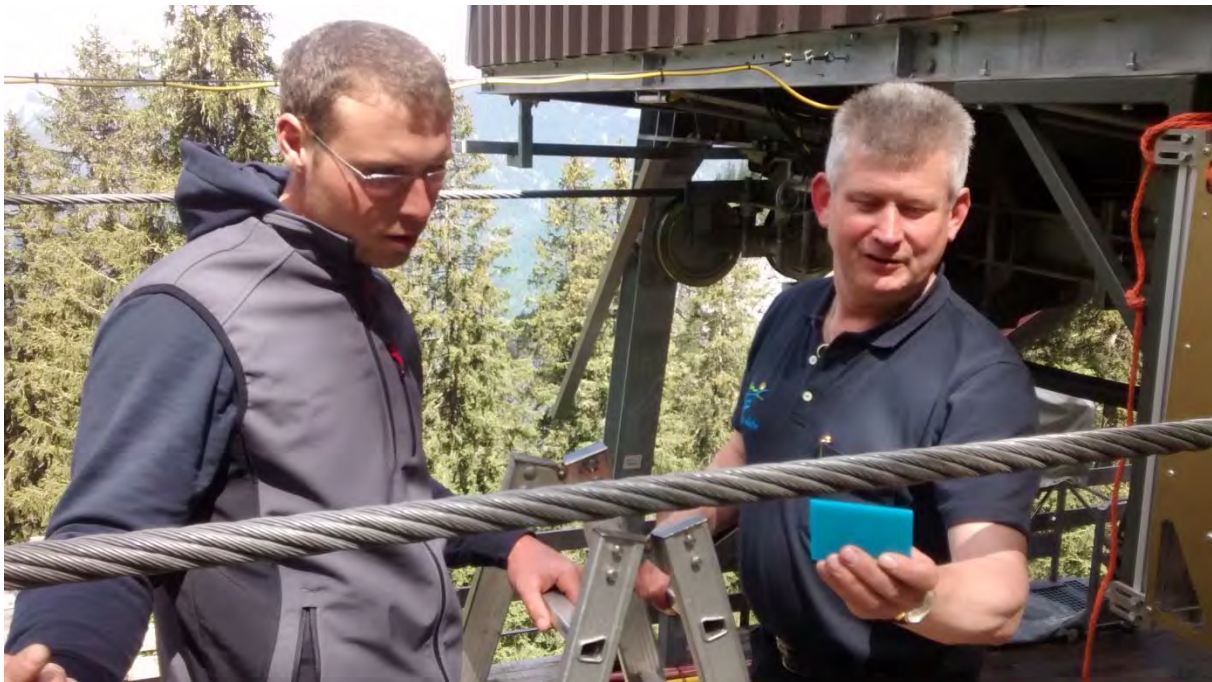
Caused by its size, a hand mirror is unsuitable for visual rope inspection.

Figure 5-22: Inspection with hand mirror

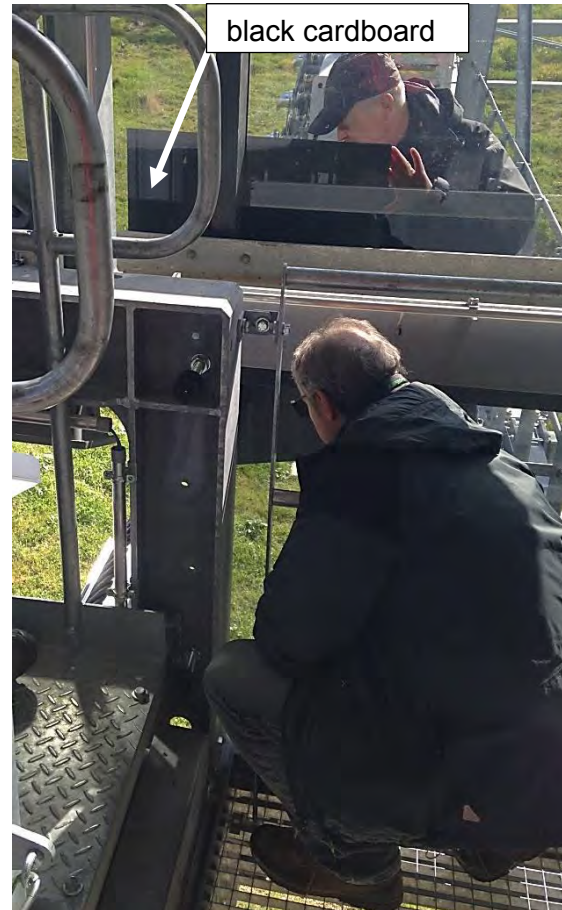
Figure 5-24: Applying black cardboard as sun protection

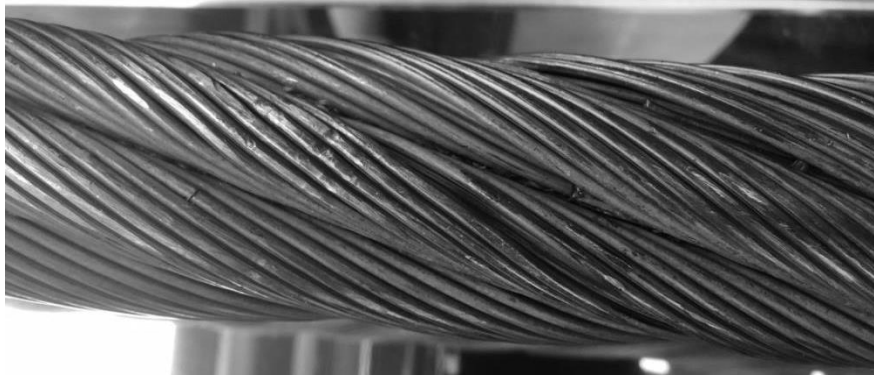
At this inspection the whole rope with a length of about 3 km was inspected. In addition, a mirror underneath the rope was used.

Figure 5-25: Damage which could be found during the inspection

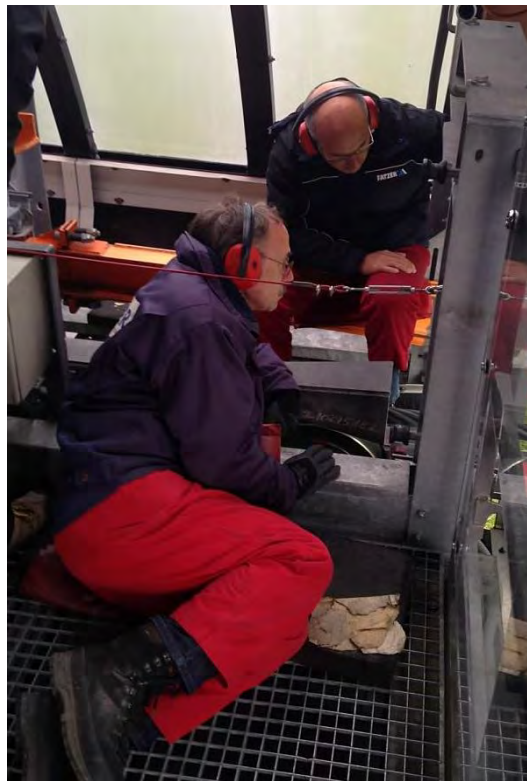
A facility to stop would be helpful so the rope can be stopped independently and immediately.

Figure 5-26: Work station during real inspection

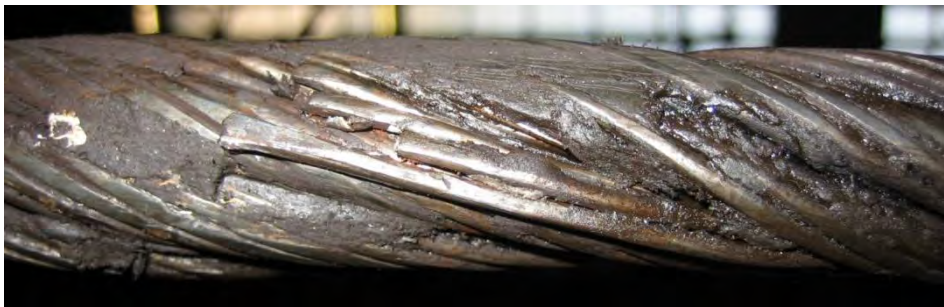
Figure 6-13: Dirty rope - inspection not possible

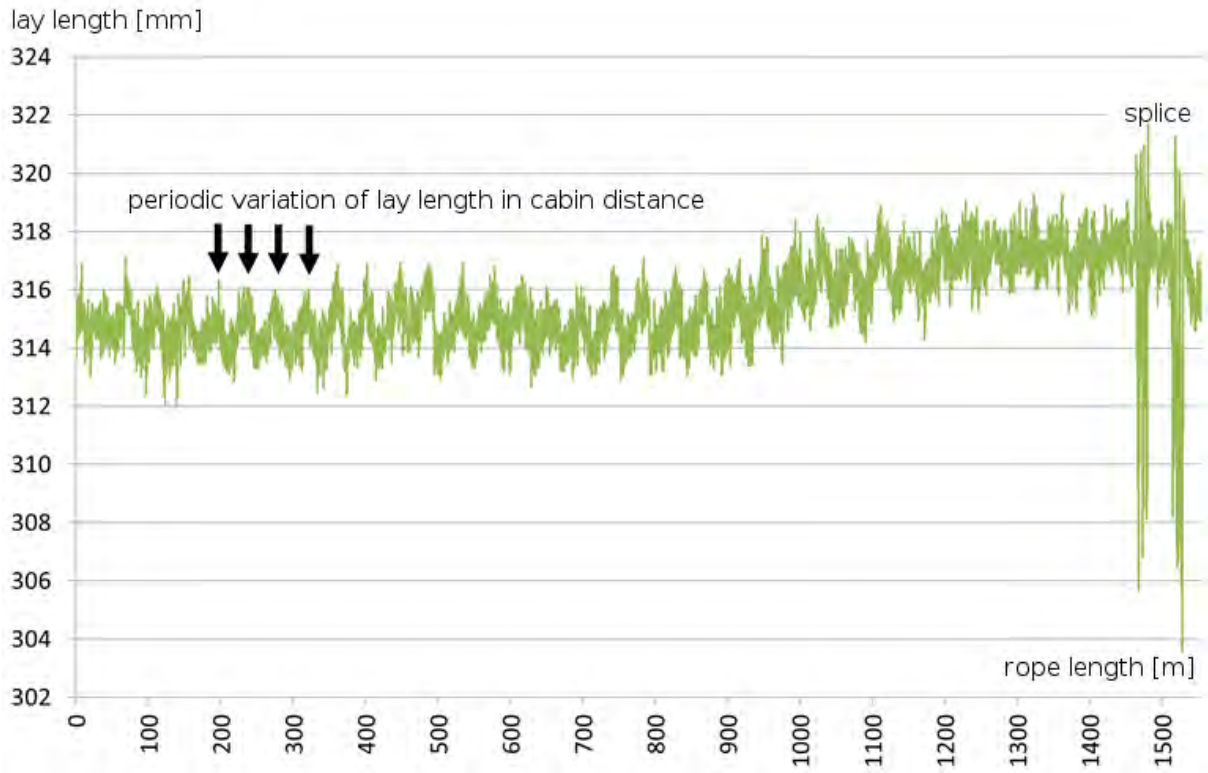
Figure 8-1: Twist at a continuously circulating detachable monocable ropeway station – the lay length shows a periodic variation in distance of the cabins

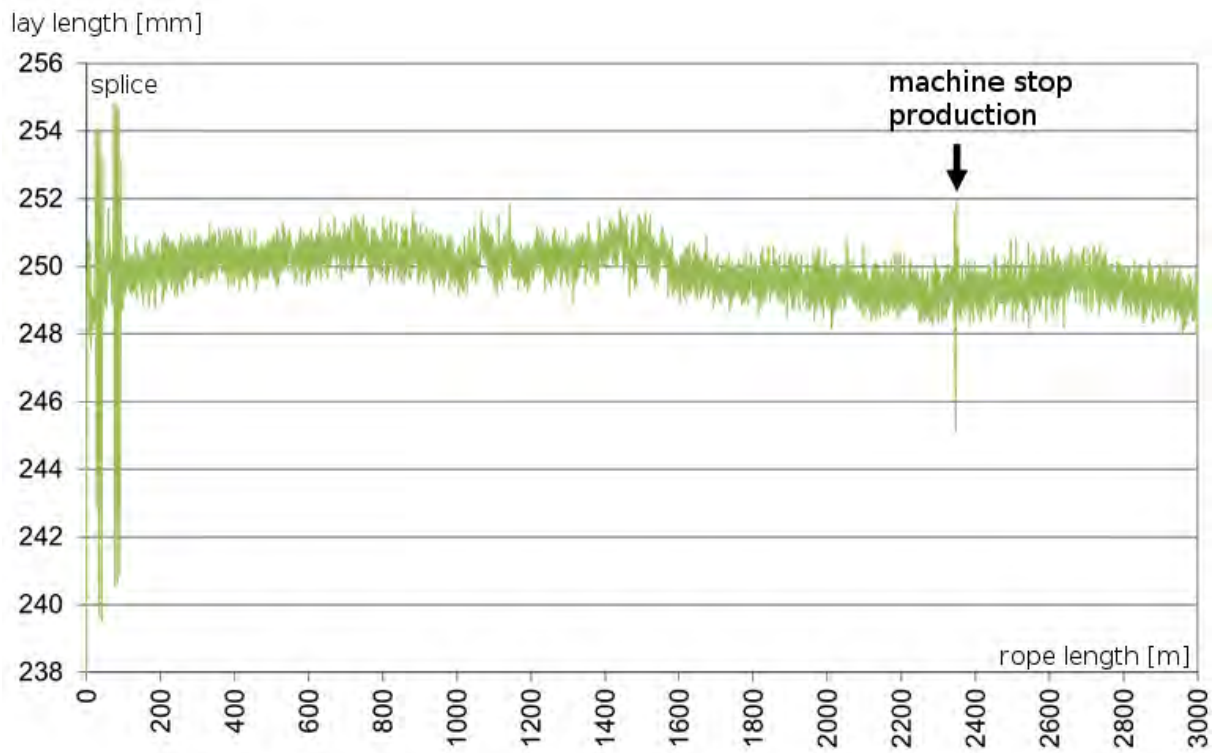
Figure 8-2: Visible machine stop during production of the rope for a continuously circulating detachable monocable ropeway

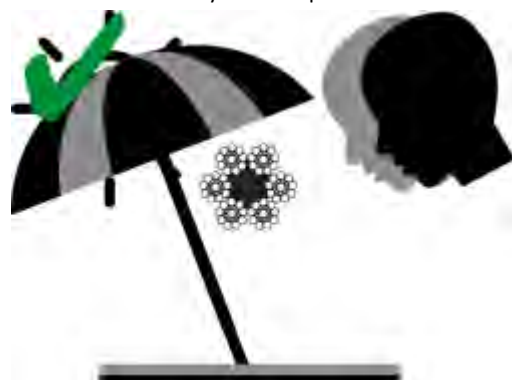
Picture 4: Sun protection prevents reflection

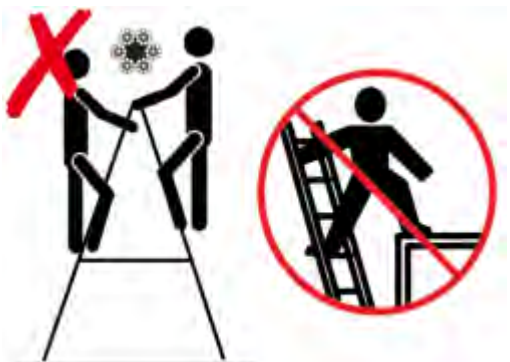
Ladders have to be rated with 0 points.

Picture 9: Not recommended usage of ladders

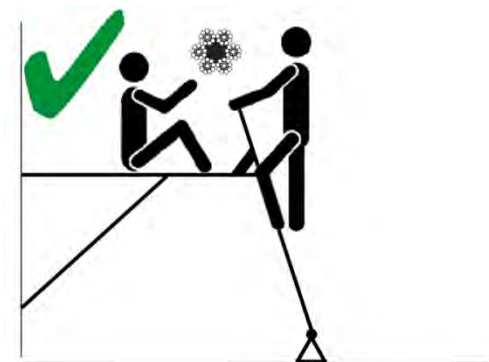
Picture 10: Recommended usage of ladders

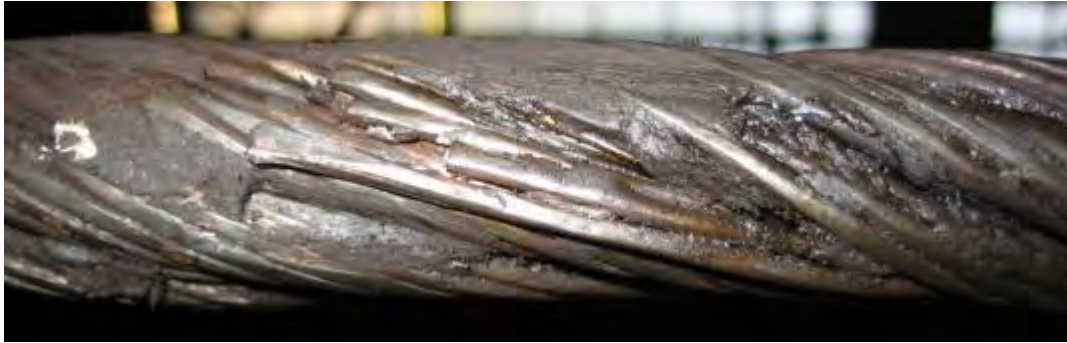
- The rope has to be sufficiently clean to guarantee a successful inspection. It is not possible to inspect a rope that is coated with lubrication and dirt!
- The following pictures show examples of different rope conditions.

Picture 13: Very dirty rope – inspection not possible!

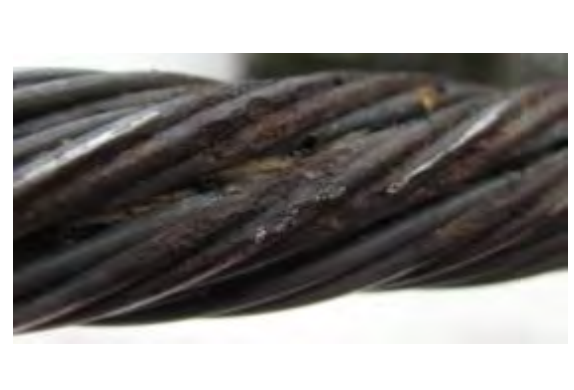
Corrosion

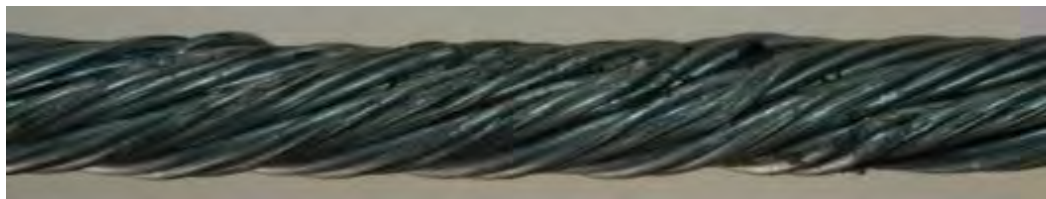
Distortions

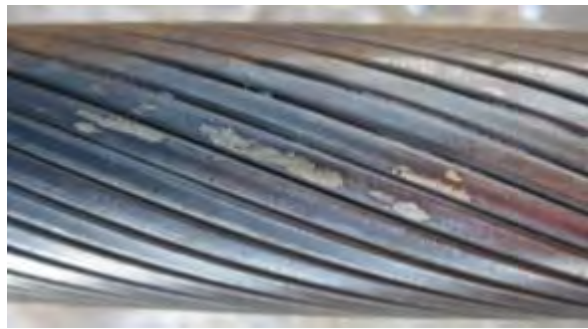
Locked coil rope – hair lines / notches

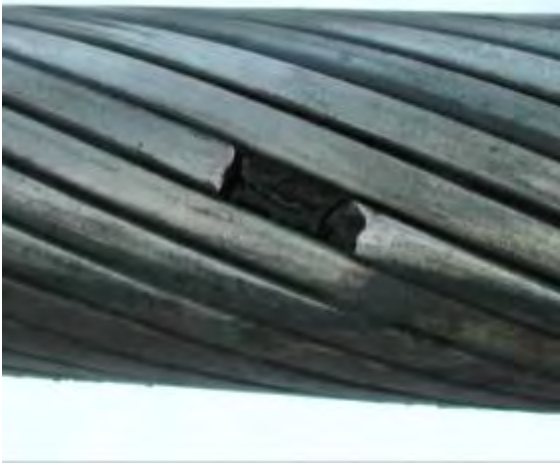
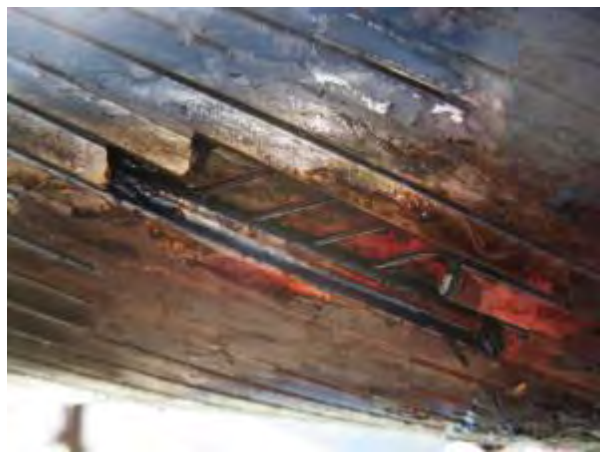
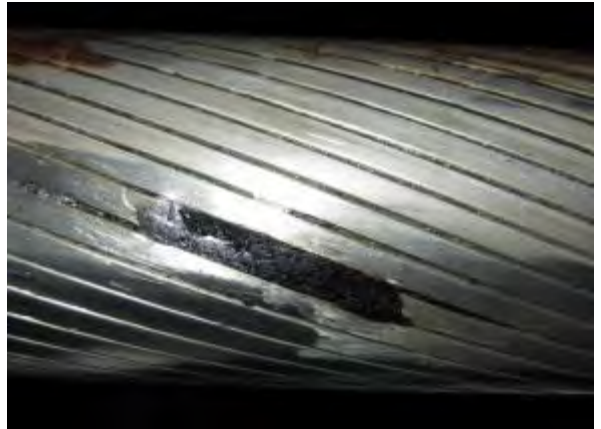
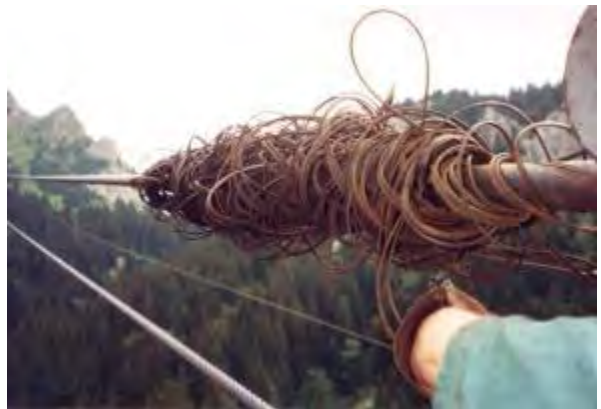
Locked coil rope – wire breaks
