Challenges to design and construction of cable cars in historic sites. Vila Nova de Gaia cable car.

Session 4: Sustainability of ropeways (Access to UNESCO World Cultural Heritage Sites by Ropeway)

Sérgio Oliveira, Civil Engineer, Site Manager

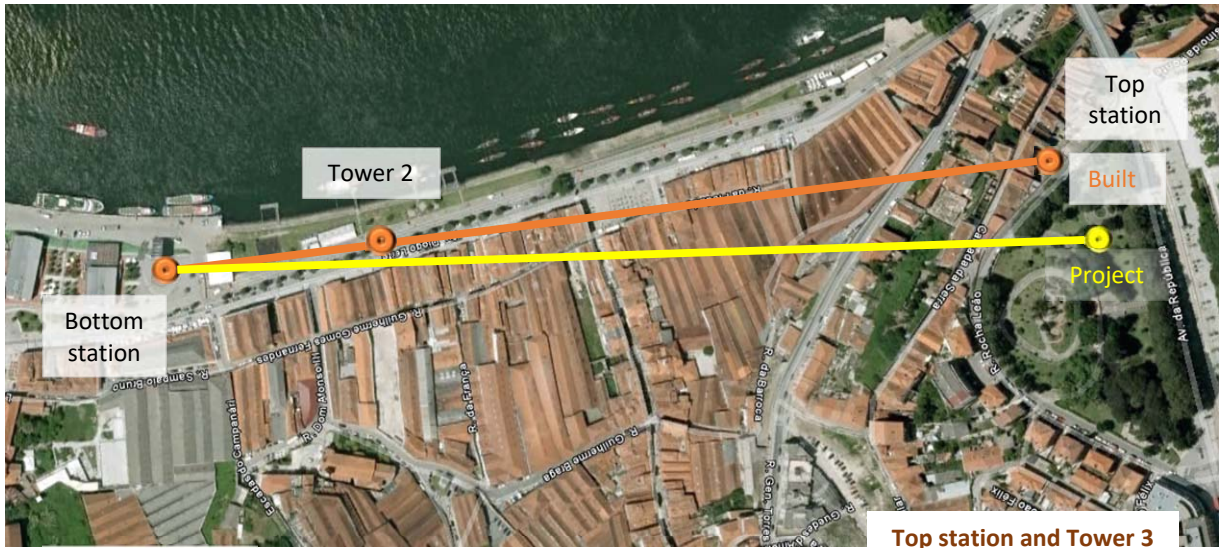
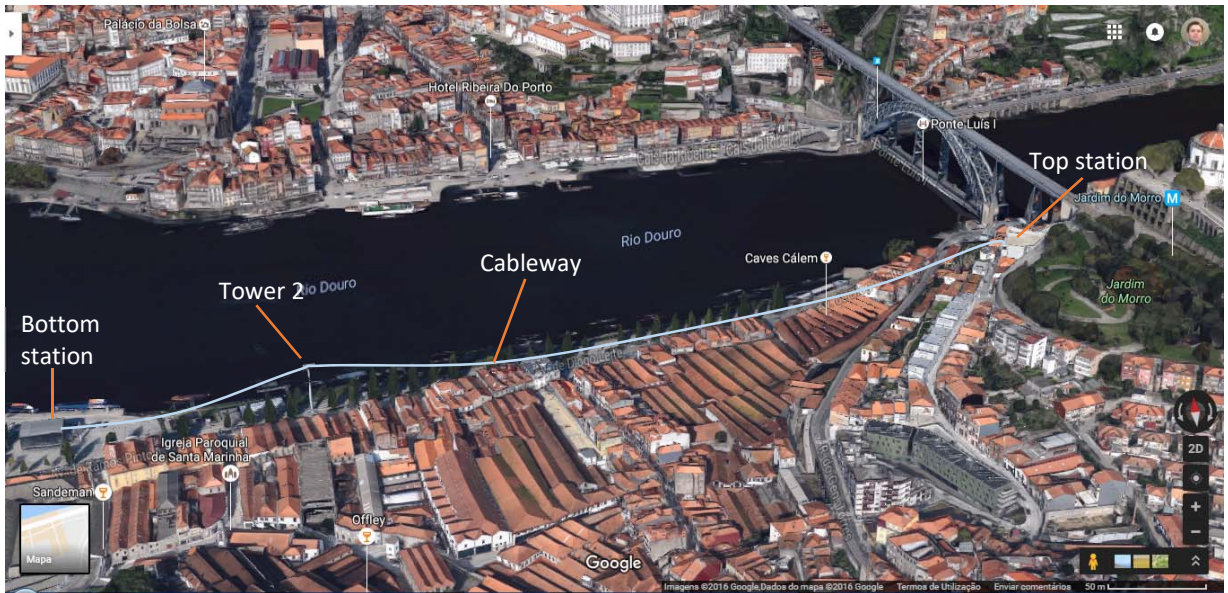
The first and most significant challenge to the project was the need to change the top station's location to the hillside at a lower level compared to the initial one on the top of the Jardim do Morro (Morro Garden), as shown in the pictures below – Plant / Profile and Aerial view of the cable way.

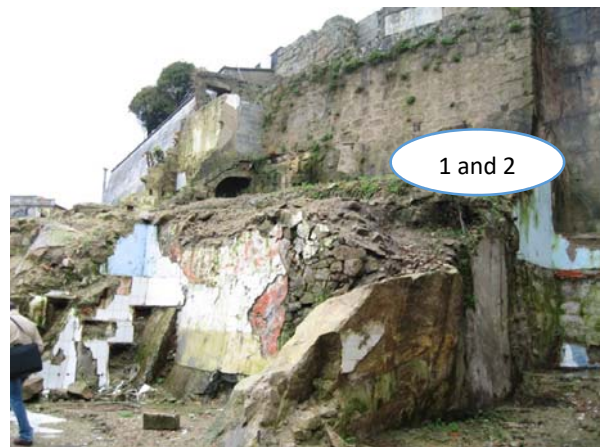
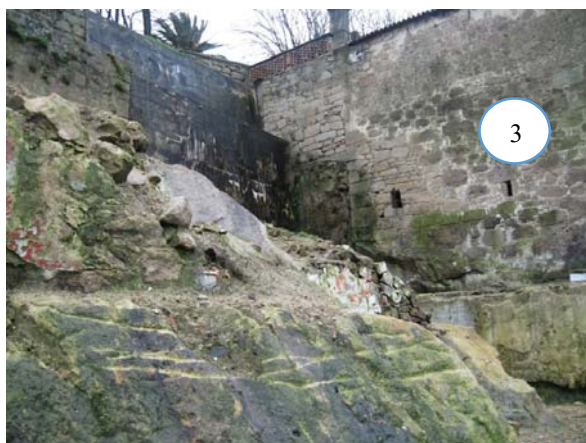
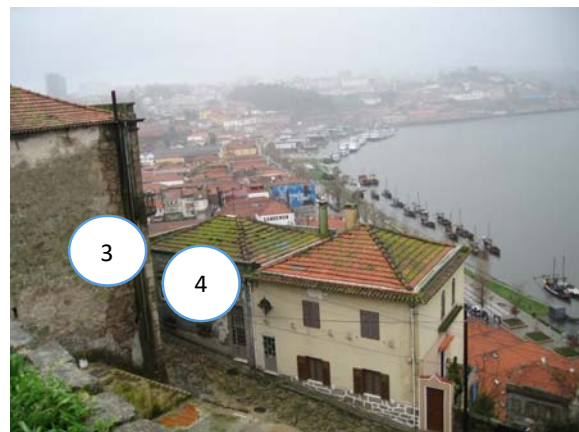
Tower 2 (32m high)

The foundation was design with pile driving (3units with 30m deep), however due to possible vibrations induced to the cellars old buildings and the possibility of ruin, during the construction works, it had to be changed micropiles (6 un with 30m deep).

- Rock excavation. Due to the urban surrounding area with buildings the rock excavation had to be done by non-blasting method (Darda rock splitters and Excavator with Jackhammer);
- Vertical face excavation stabilized with concrete wall, post-tensioned anchors and shotcrete and ground nails;

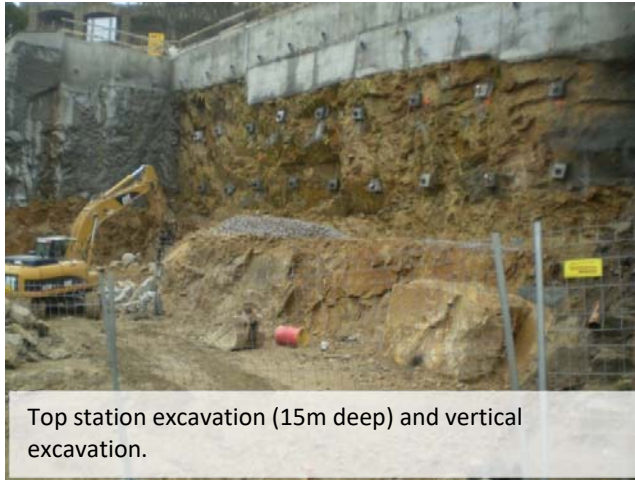
Top station excavation (15m deep) and vertical excavation.

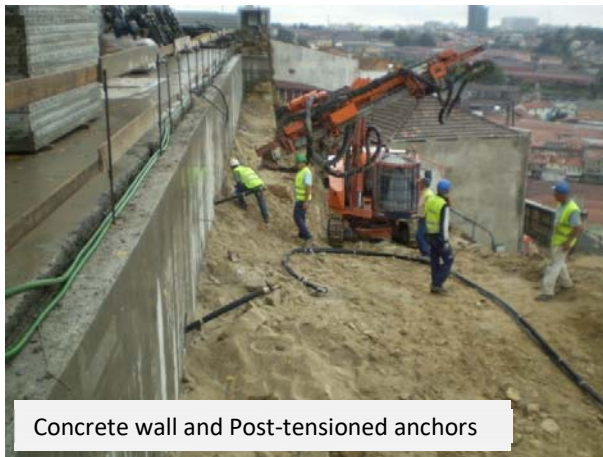
Concrete wall and Post-tensioned anchors

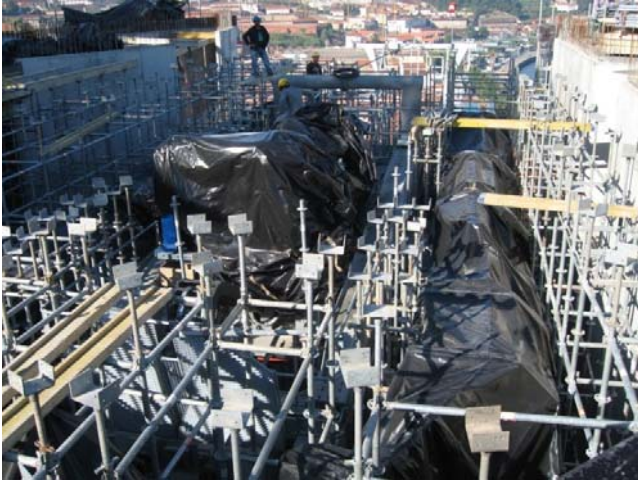
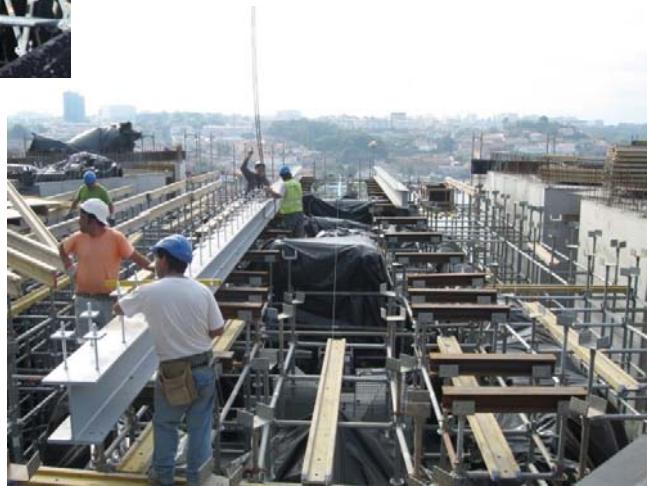
- Concreting the roof after the equipment assembly, become a huge study to plan the flat formwork and support substructure with scaffold towers passing throughout the equipment.

During the excavation works for the implantation of the tower 3, what was supposed to be rock it turned out to be ordinary soil, therefore the foundation was connected to the top station building by 2 concrete beams.

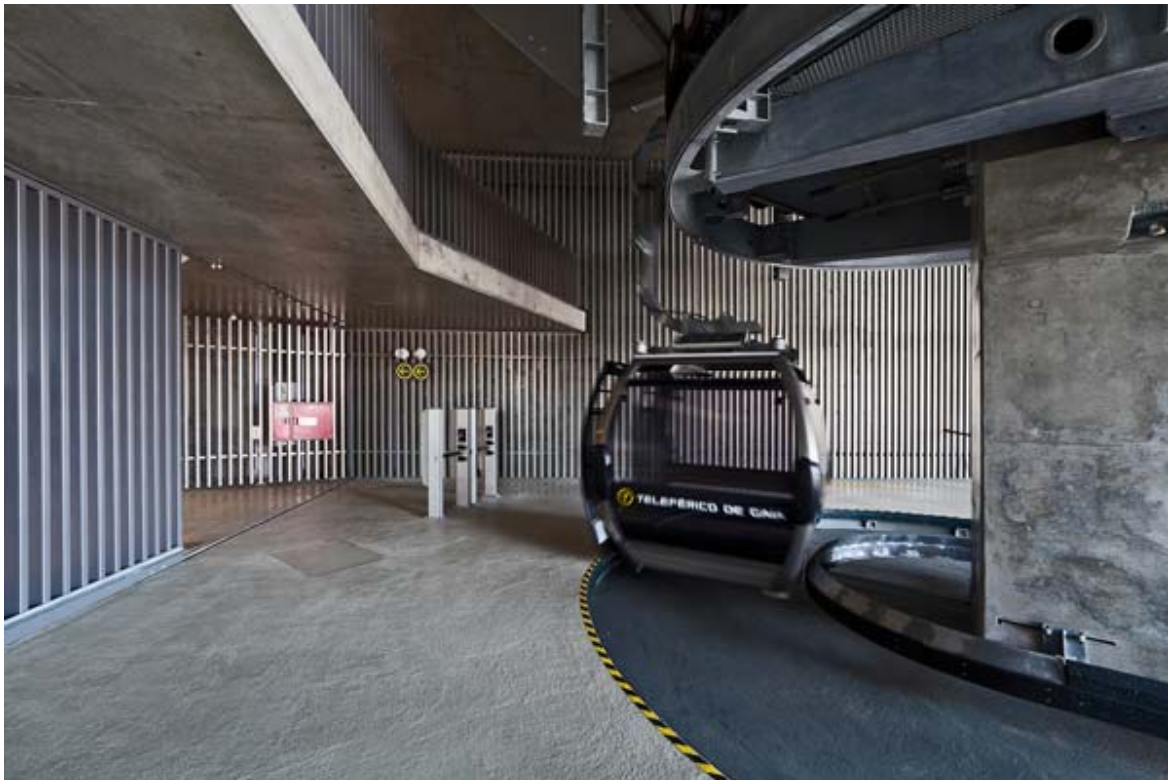
Bottom station

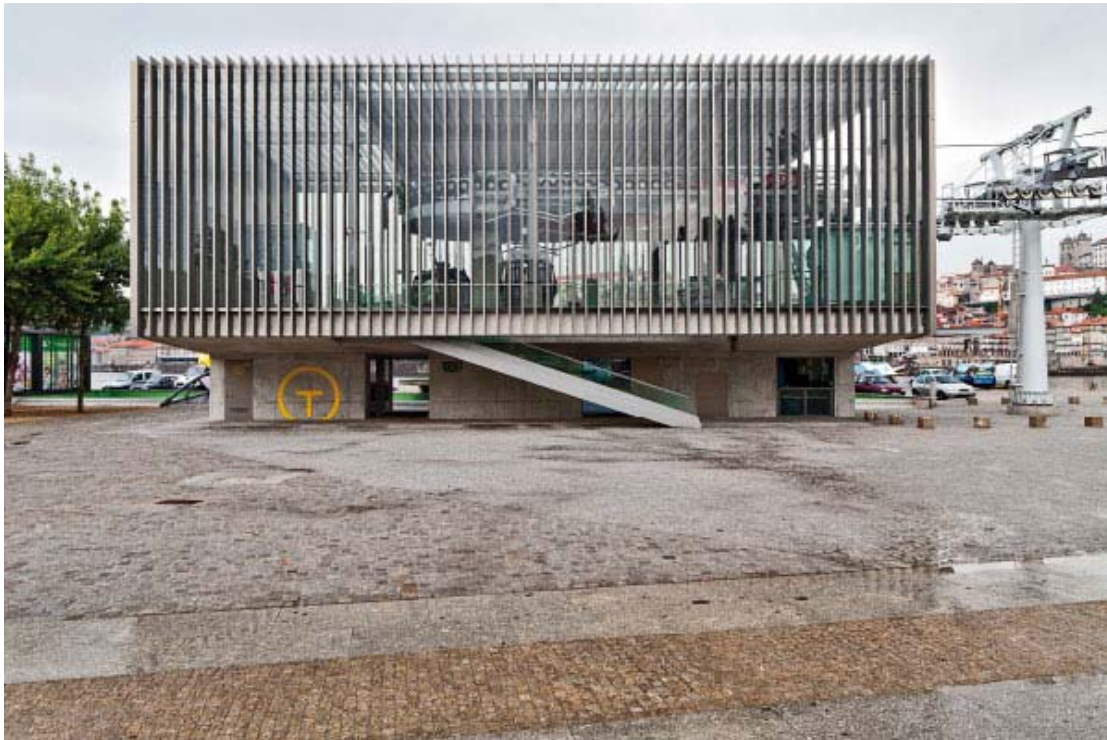
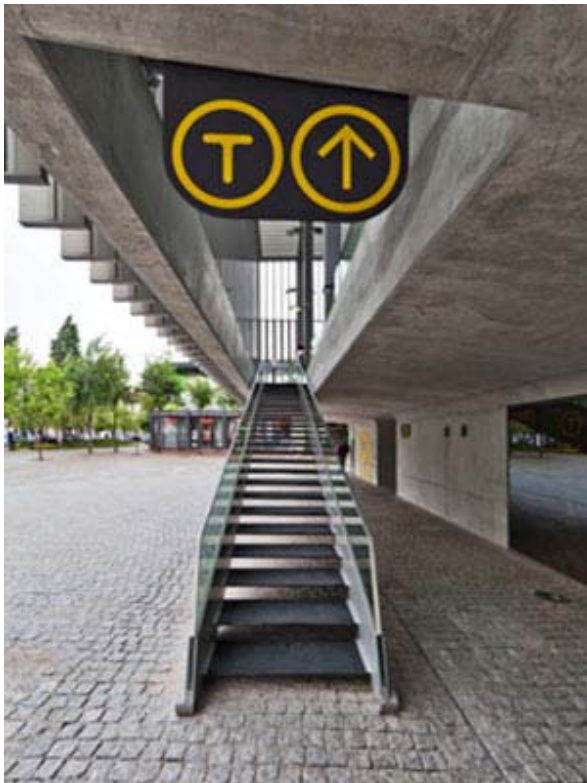
Top station
