Challenges to design and construction of cable cars in historic sites. Vila Nova de Gaia cable car.

Session 4: Sustainability of ropeways (Access to UNESCO World Cultural Heritage Sites by Ropeway)

Sérgio Oliveira, Civil Engineer, Site Manager

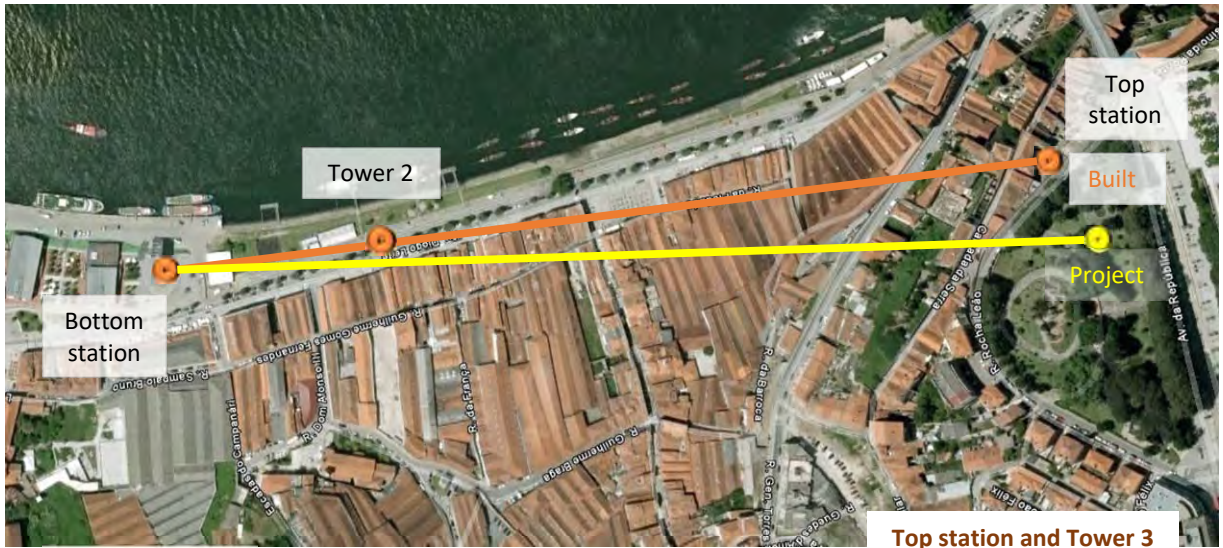
The first and most significant challenge to the project was the need to change the top station's location to the hillside at a lower level compared to the initial one on the top of the Jardim do Morro (Morro Garden), as shown in the pictures below – Plant / Profile and Aerial view of the cable way.

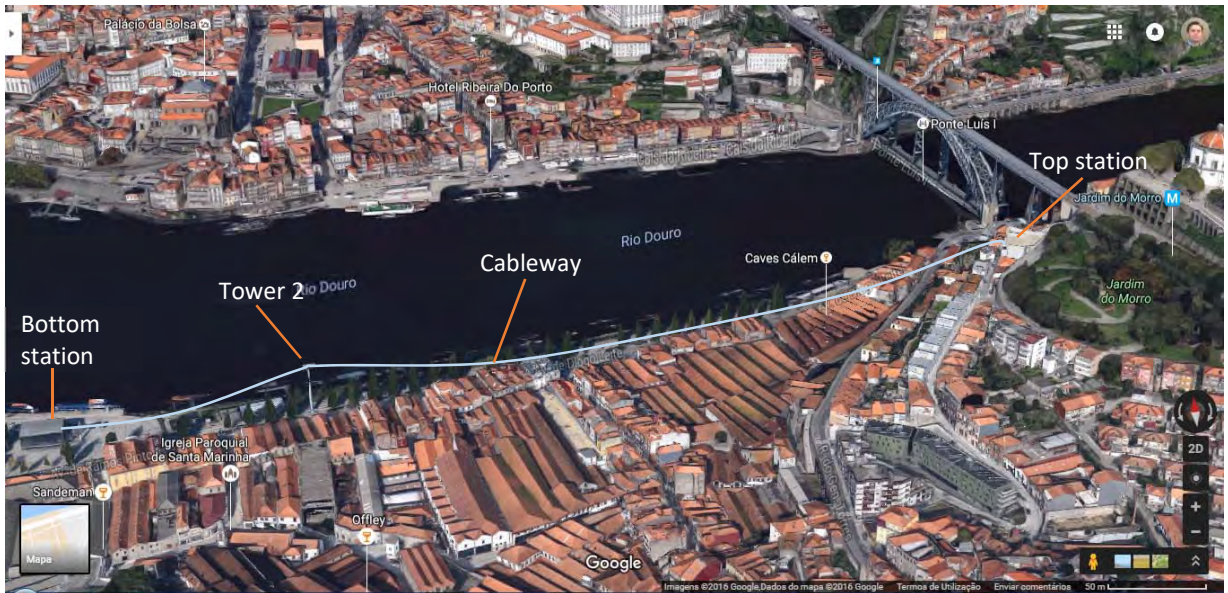
Bottom station and Tower 1

Tower 2

Top station and Tower 3

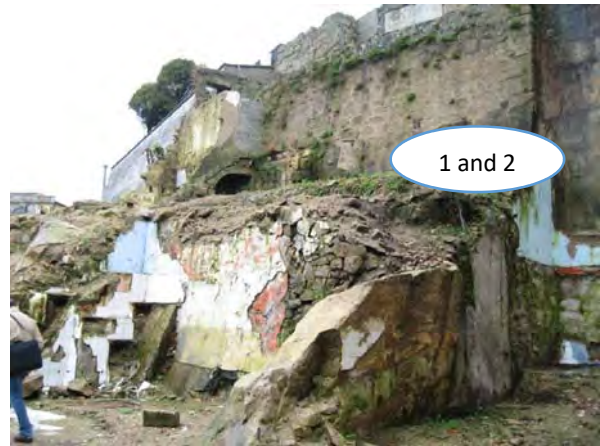
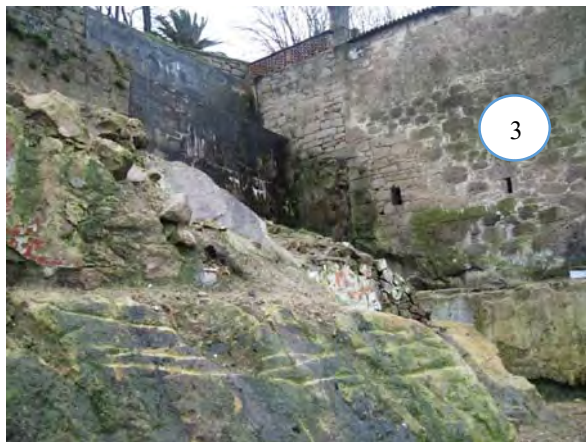
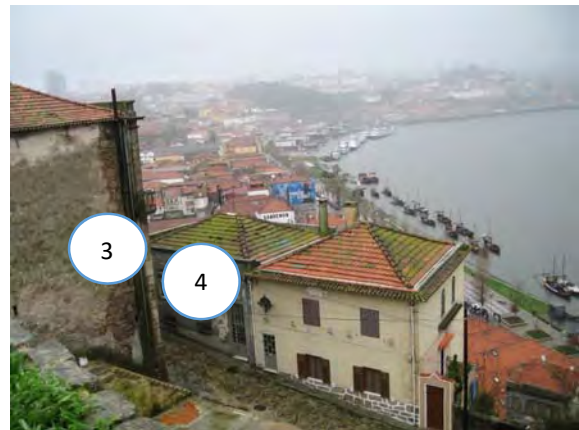
- Rock excavation. Due to the urban surrounding area with buildings the rock excavation had to be done by non-blasting method (Darda rock splitters and Excavator with Jackhammer);
- Vertical face excavation stabilized with concrete wall, post-tensioned anchors and shotcrete and ground nails;
