# OITAF

## Seminar 2015

# Feedback on recent accidents and follow-up

Gaëtan RIOULT – Head of Ropeways Department

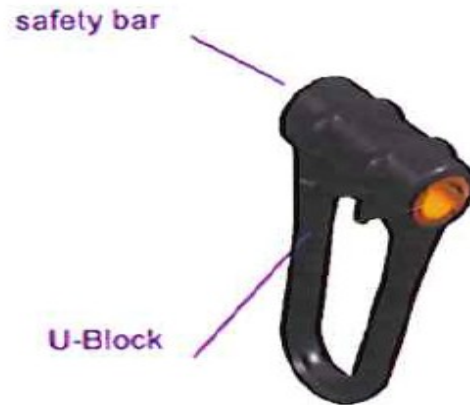
The goal of this function is to fill the present space under the safety bar to minimize the risk of fall (risk of "submarining")

- **Reduction of the space** under the safety bar

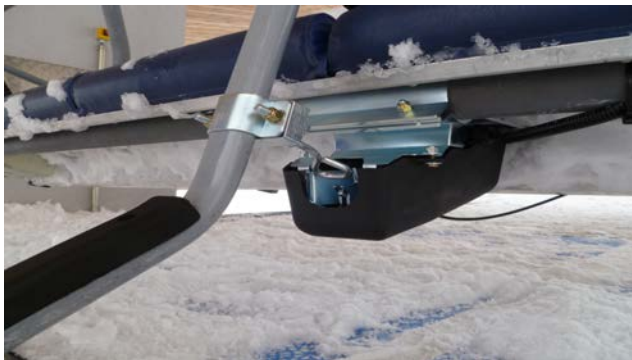
The purpose is to master the moment of operation of the safety bar so as to avoid too-late closings or anticipated openings.

The aim is to forbid the opening of the safety bar during the ride so as to avoid a possible imprudence of the passengers.

- **Handling of safety bar**
- **Blocking of safety bar** during the ride

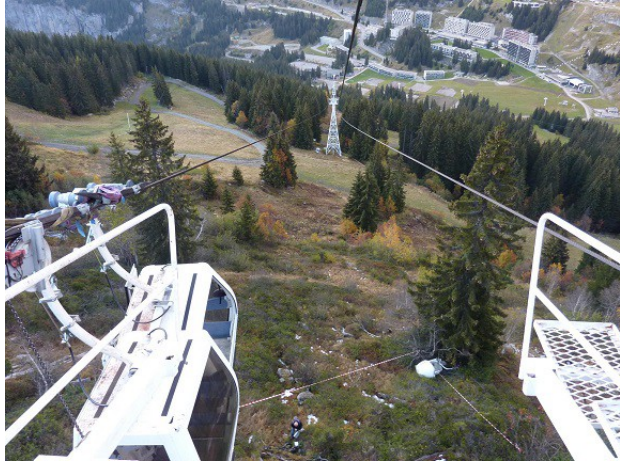
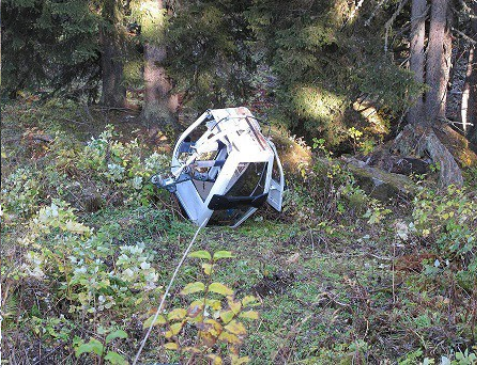
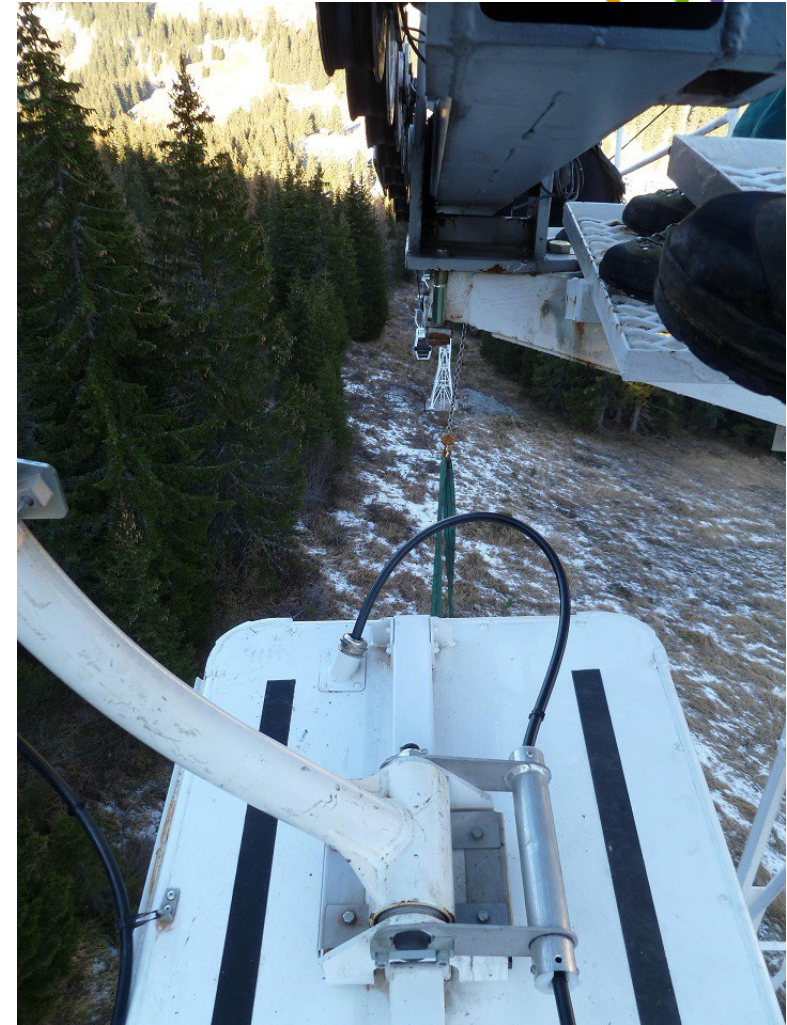
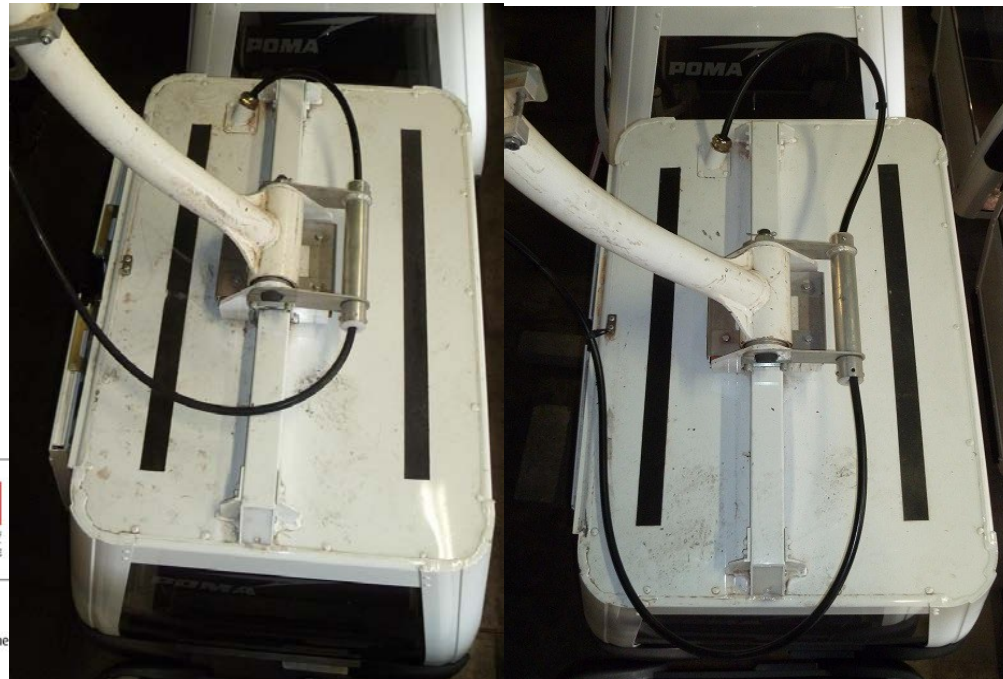
# 3 important incidents in France these last years : Falls of several cabins during annual tests (2011)

- Fall of 5 cabins from a gondola lift during tests outside operating.
- These falls follow from cabins getting stuck to a line support structure. The first blocking was due to the sticking of the door opening cable to a sheave train fixing bolt.
- The STRMTG concluded that 3 elements together could explain the incident :
  - A too long door opening cable
  - A cabin located at the sheave train entrance
  - A longitudinal swinging due to a stopping

- Before winter 2011/2012 campaign of controls on the whole french stock of cabins equipped with door handling control to verify the absence of any unusual geometry of the door opening cable
- Setting-up of a think-tank for longitudinal swinging of the vehicules  
(several test campaigns done but no conclusion yet)

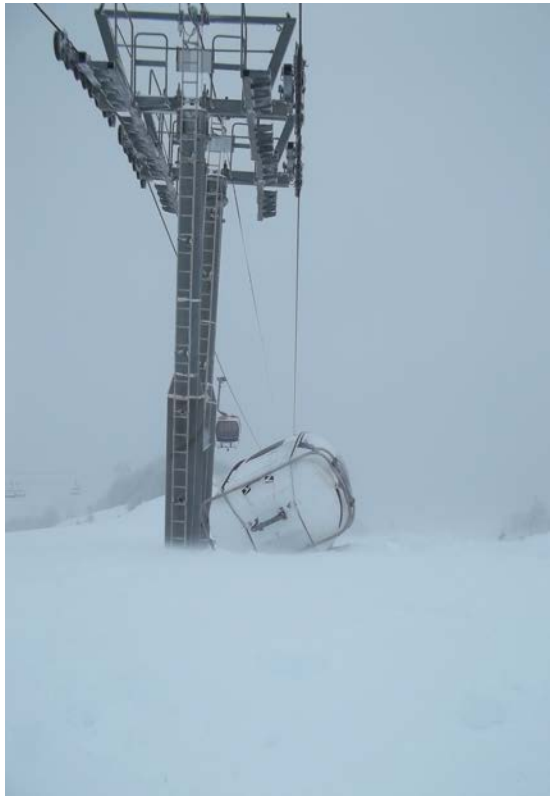
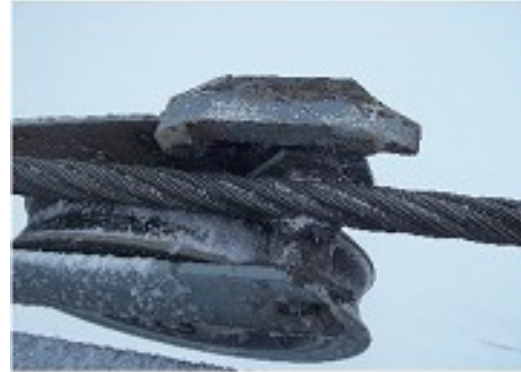
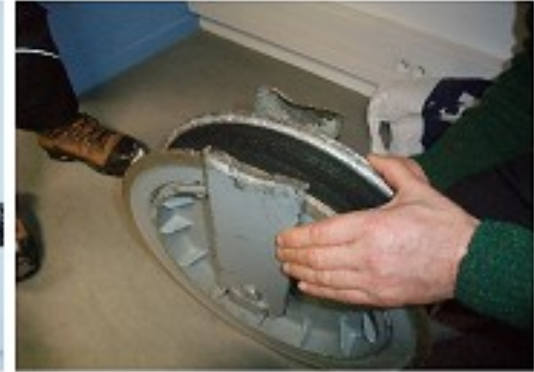
# 3 important incidents in France these last years : Fall of a cabin and its passengers during operation (2013)

- Breaking of two rollers bogie frame on a sheave train support leading to the ripping of a carrier grip at the passing on the sheave train.
- Analysis shows a fatigue phenomenon on horizontal dynamic stress.

- Visual check of all bogies of 2 sheave trains of the same kind (inventory by an independant inspector in 2013, then annually per operator).
- Replacement of bogies of 2 by new designed bogies before the end of 2018

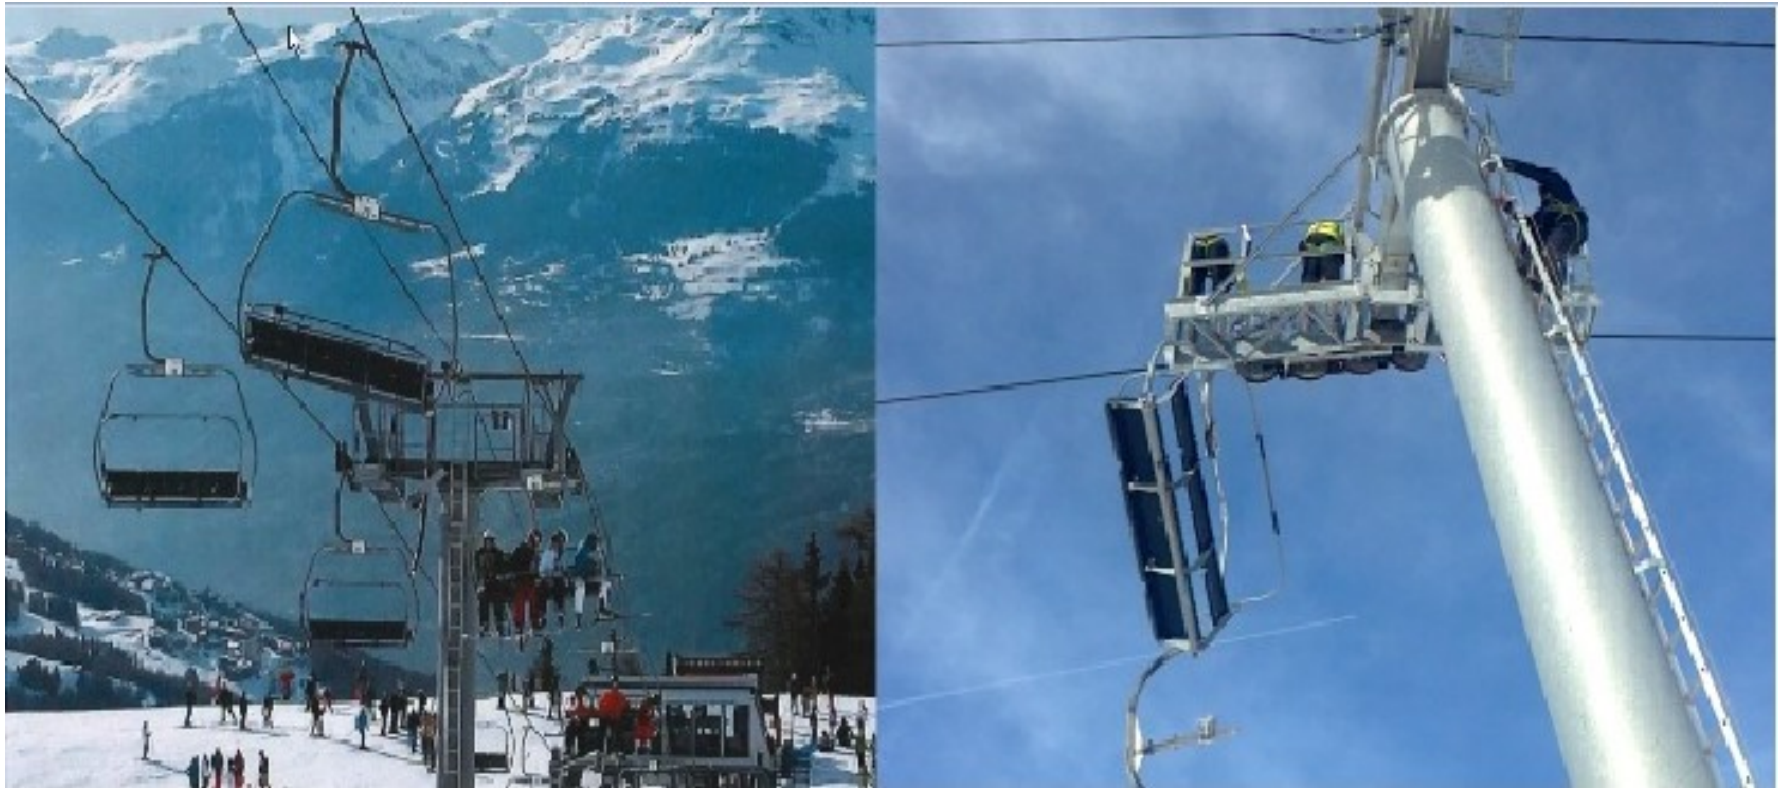
## 3 important incidents in France these last years : Blocking of a chair and fall of its passenger during operation (2014)

- In this case, two causes can lead to the blocking :
  - Guide in the clearance envelope of the vehicle
  - Vehicle with an abnormal behavior (oscillations) at the passage of the guide
- The numerous realized investigations did not allow any conclusion. Main hypothesis probably retained : misadjustment of the guide

- No generic measure but still questions concerning the longitudinal oscillations of vehicles.
