A newer installation as local development way

Session 2: Operation of ropeways: Technical and economic aspects (Ropeways as an instrument to promote regional economic development)

The Fajã dos Padres new cable car is a bi-cable reversible aerial tramway installation to transport both people and cargo, for agricultural and touristic purposes.

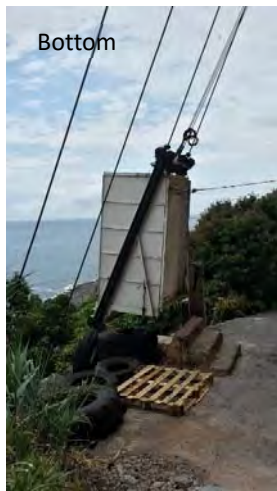
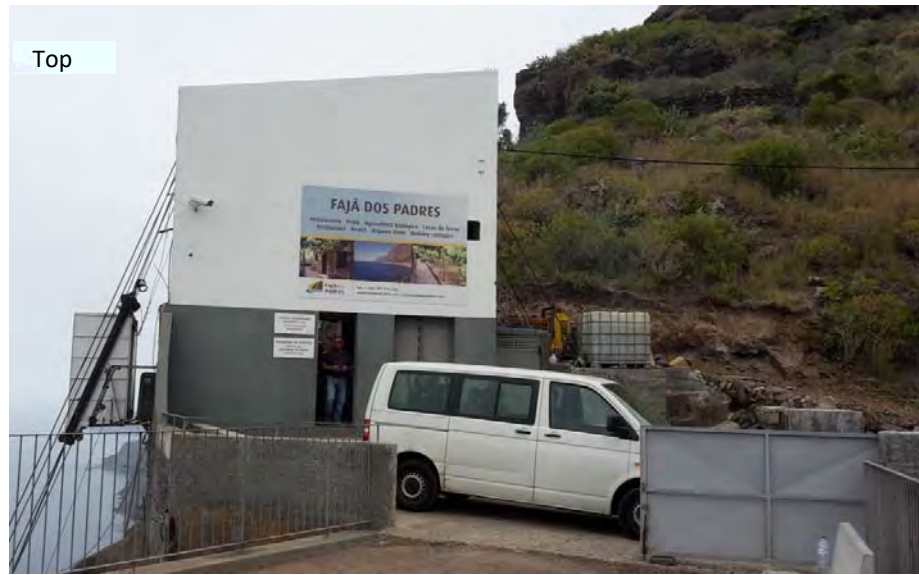
The “Ropeway conveyor”

On site, there was an elevator for people and a "ropeway conveyor" for cargo.

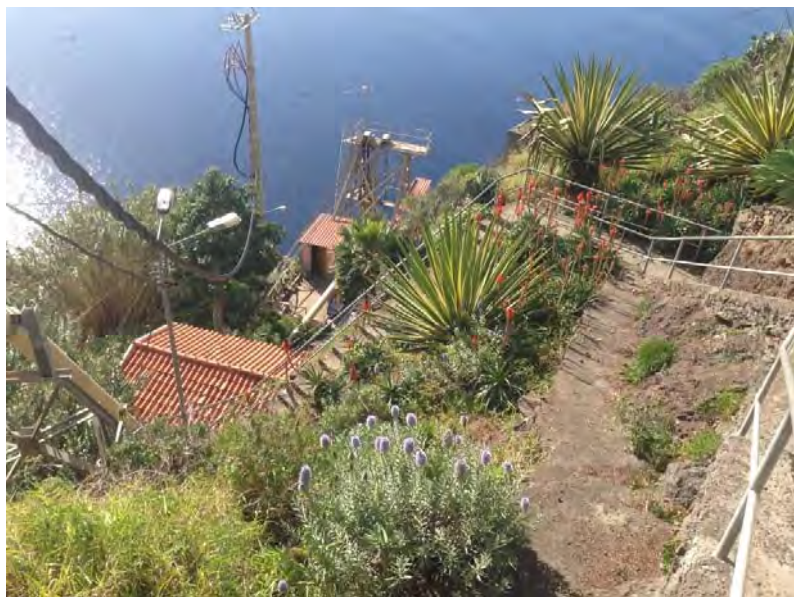
The lift that runs about 250m high and takes 5 minutes. The top and bottom “lift-stations” are located, respectively, about 30m below the road and 50m from sea level by walking several steep flights of stairs and ramps.

Stairs to access the lift / elevator from above ...

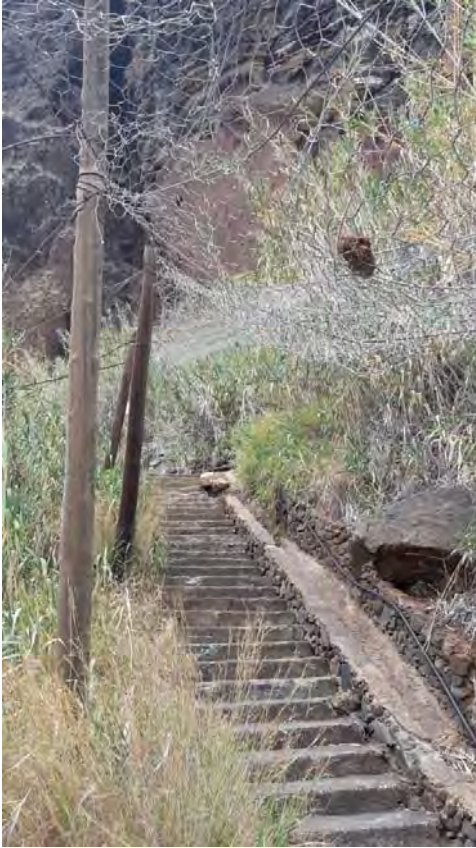
... and the stairs to access the lift / elevator from bellow.

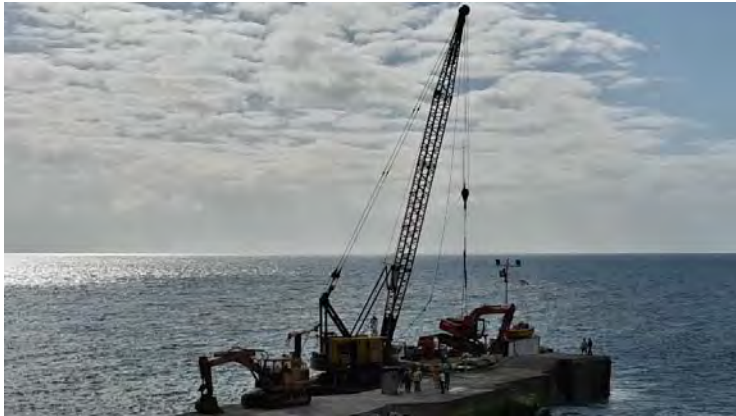
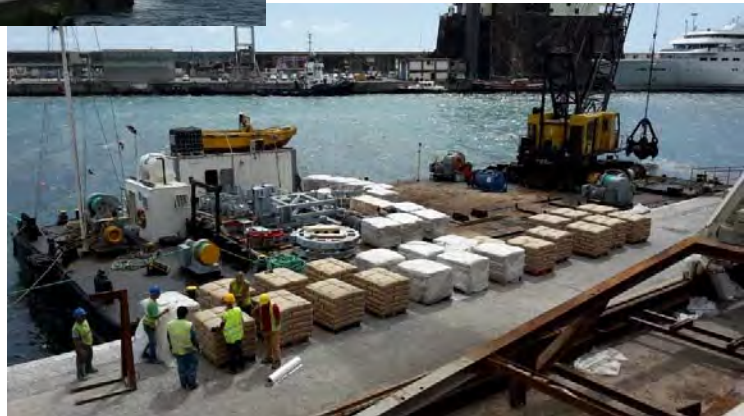
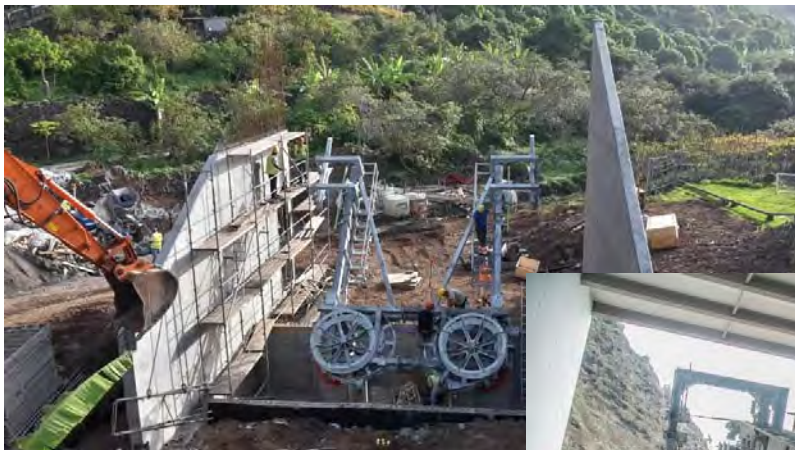
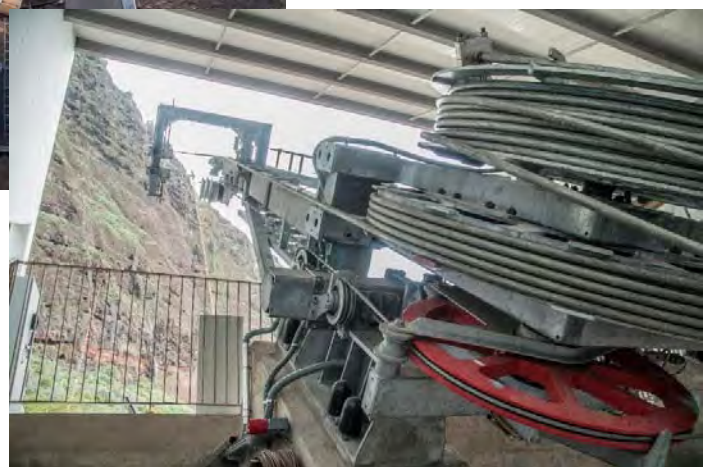
The materials and equipment needed at the bottom station level have had to be transported by sea.

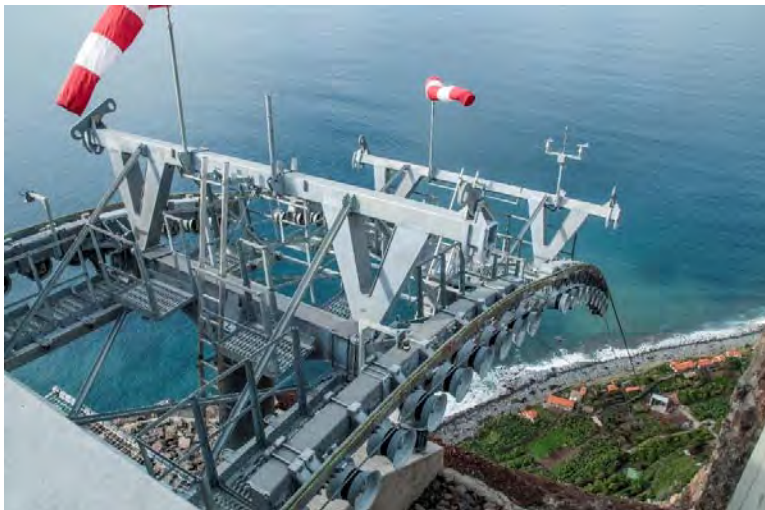
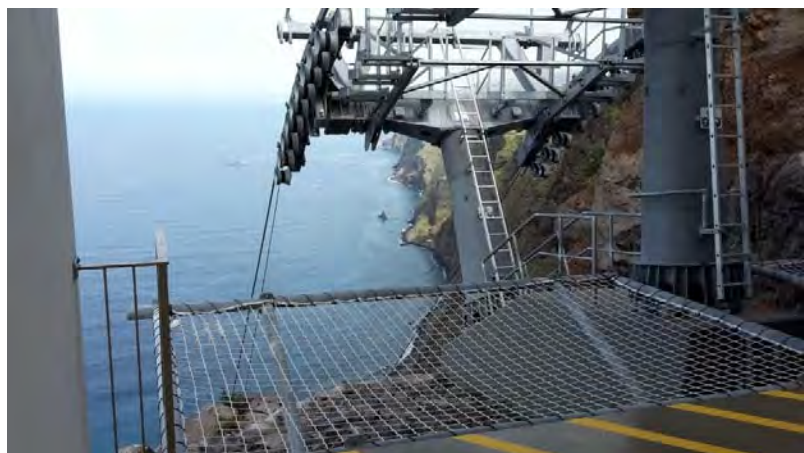
Installation – Technical main data and photos

Anchoring of track rope	Fixed – top station
Drive station	Top station
Vertical rise	316 m
Horizontal length	384 m
Inclined length	500 m
Mean inclination	82 %
Operating speed max.	6 m/s
Capacity	180 pph
Travel time (max. speed)	2,1 min
