O.I.T.A.F.
Work-Committee No II
Characteristics and Inspection of Ropes

Gains and Limits of Magnetic Rope Testing

OITAF Seminar Grenoble

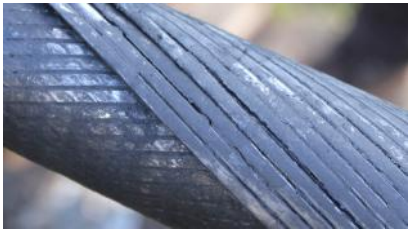
6-month old track-rope

lack of lubricant, indentation of Z wires

Failures of internal layers

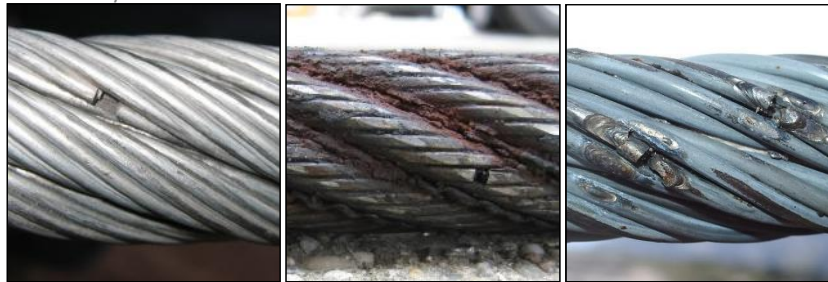
- Bending cycles: rope wear and material aging by repeated flexion over sheaves
- Corrosion: Material surface turns brittle and initiates cracks and wire breaks
- External influences: lightning strokes, accidents within construction works, derailments,...cause deformation, structural changes or wire breaks
- ...and many more reasons

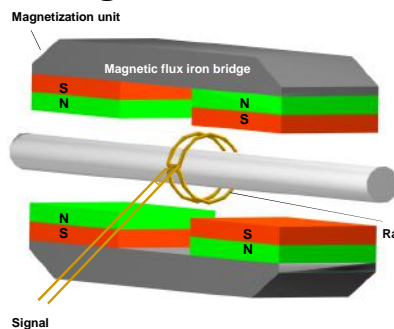
$$U = - n S v \frac{dB}{dx}$$

Lenz-Faraday law

- Permanent magnets create a saturating magnetization of the steel wire rope
- Resulting leakage field generates a voltage in the measurement coil

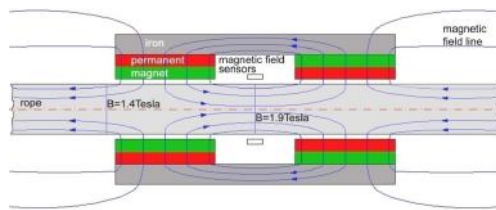
Magnetic field circuits forming homogeneous magnetic flux all over the rope's cross section. The wire material has to be magnetically saturated by at least 1.9 up to 2.3 Tesla.

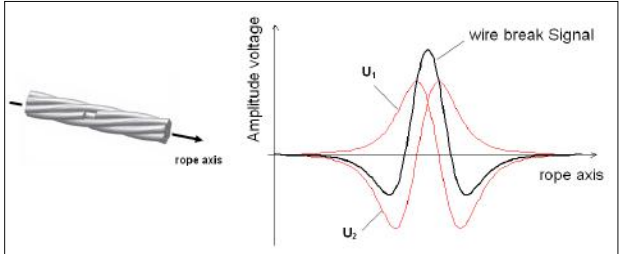
Theory:

Damage Signals:

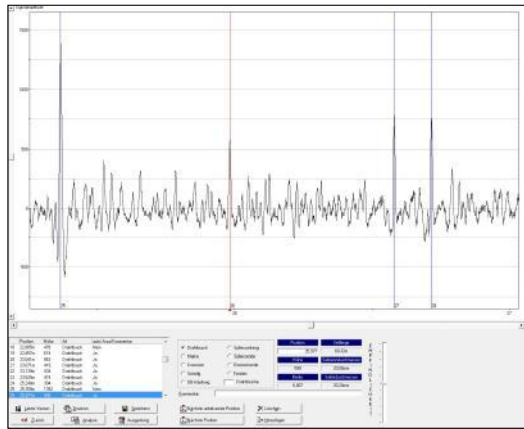
Software-Application:

- Automated labelling of suspicious patterns
- Evaluation by expert user
- Automated report creator
- Relating of damages to discard criteria (loss of tensile capacity on specific reference lengths)

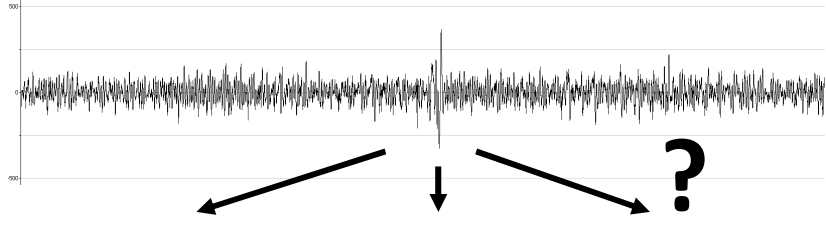
Magnetic signals are only a 1D image of the real damage. Signals can be ambiguous, so every pattern of doubt has to be clarified by visual inspection:

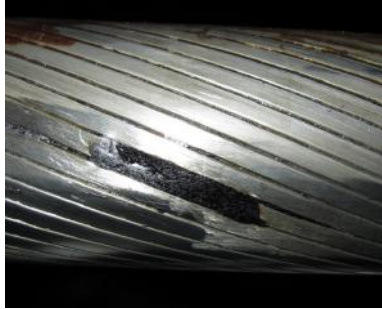
Fill-up of wire break gap using plastics:

- Protection of inner layers against moisture
- Stabilizing of surface wire compound

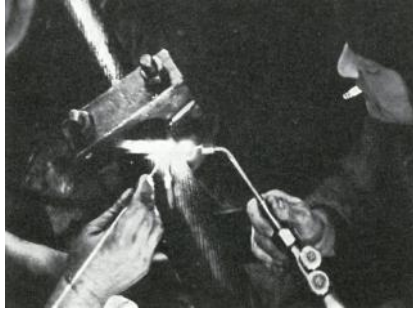
Shifting of wire breaks by brazing:

- Separation of two neighboring wire breaks
- Creation of distance to discard criteria

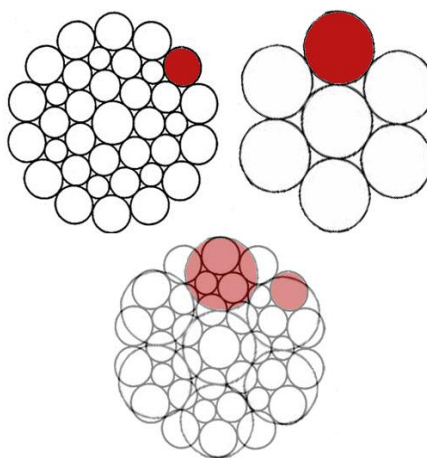
Example: number of broken outer wires at point of discard on 6xd according to EN 12927-6:

Rope Type	Number broken outer wires
6x7	3
6x19 Seale	4
6x36 Warr.-S	9

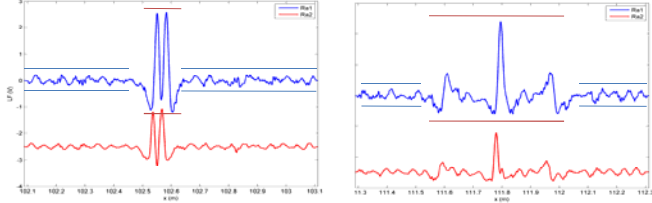
WB signals:
LF 1 / LF2

WB's

Ground signal

- a) Unknown → MRT history is required to analyze the development of WB's during rope operation
- b) WB ? Missing wire ? : No → splice knot
→ rope visual verification is required

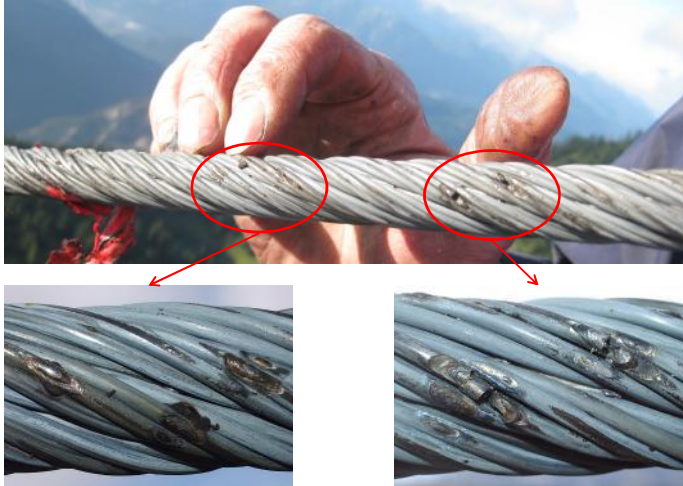
6x7 stranded trackrope : material tramway

Melted adjacent wires **Broken melted wires**

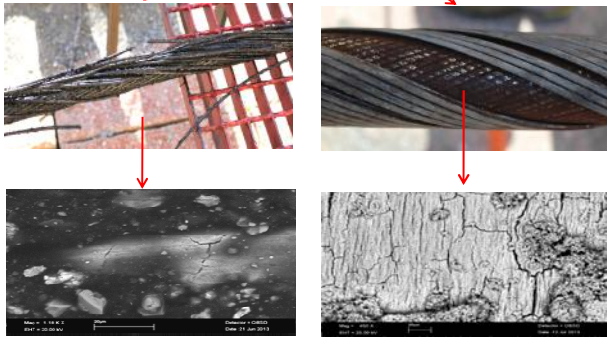
TrpH Ruillans, La Grave : 51 mm tension rope, section over a sheave
 rope : 1 – 7/7 – 7 – 14 – 24 – 30 – 33 Z – 38 Z
 opening: 1 – 7/7 – 7 – 14 – 23 – 2 – 33 Z – 38 Z

○ wb
rusty - dry

Konstantin Kuehner Fatigue-cracking corrosion Microfractures 24. April 2014
 Stephane Pernot Slide 41 (60) OITAF Seminar Grenoble

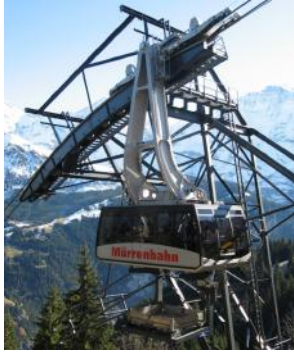
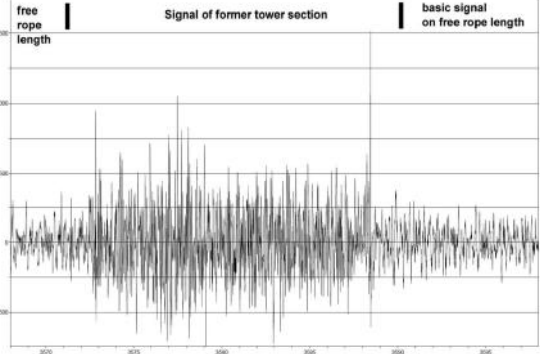
Magnetic high resolution test

Problem: Corrosion-/wear-signals can cover wire break signals, e.g. in former tower sections
 → Another more-dimensional inspection-method is needed to clarify the state of the rope

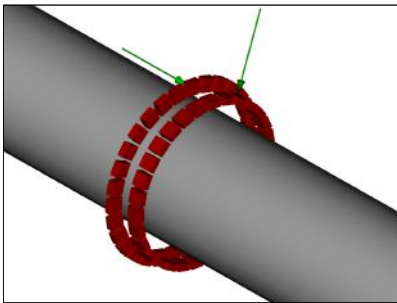
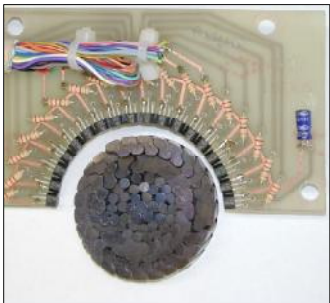
- Instead of an averaging coil, a large amount of hall-effect sensors is installed around the rope
- By recording each sensor as a measuring channel, the defect can be better localized in the cross-section of the rope
- This allows to separate wire breaks from wear or corrosion
- Cheaper, less dangerous alternative to x-ray examination

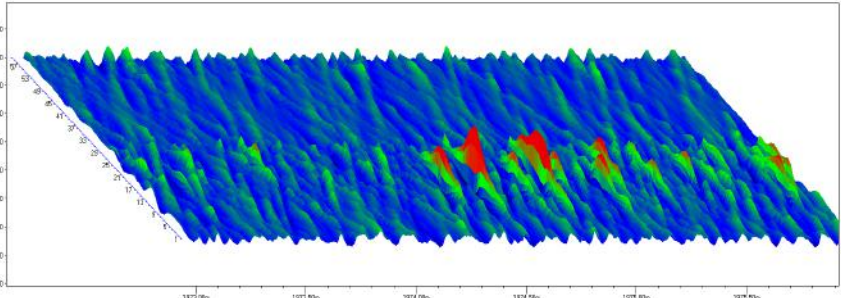
- Software-Application allows to rescale color-scheme and amplification to work out points of interest
- Damage can be closely localized and evaluated to plan further special treatment, inspection and repair

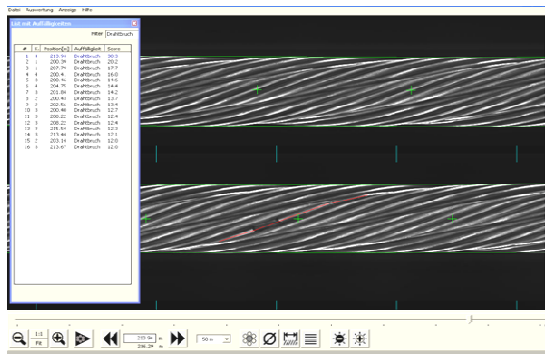
Analyze of the wires and rope surface:

Diameter and rope lay length along the rope

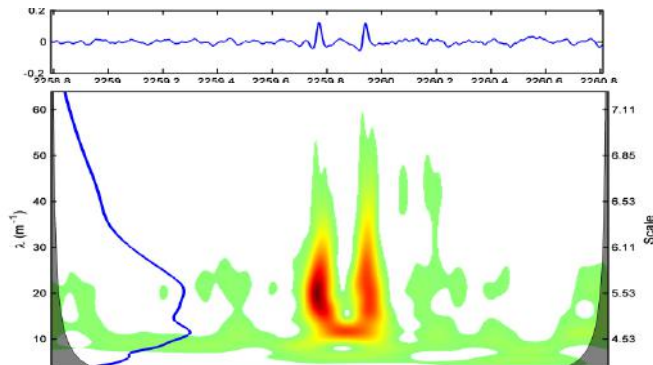
MRT signal : splice knot

Scalogram : colormap of wavelet representation

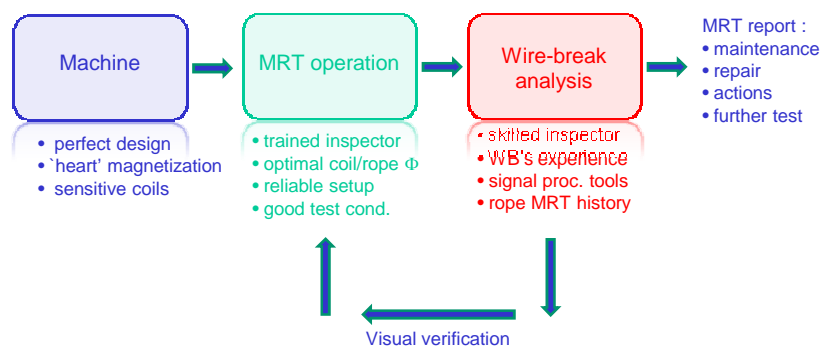
Prerequisites for efficient MRT

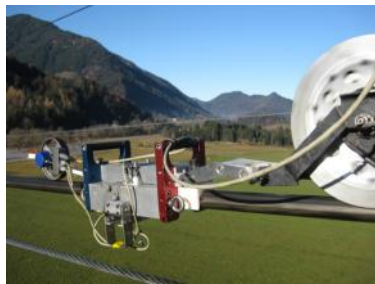
MRT

Heavy corrosion	inner wire breaks
Heavy wire damage	
Outer wire breaks	Wire breaks in strand touching zone
Former clamping areas	
Lightning strokes
