**O.I.T.A.F.**  
Work-Committee No II  
Characteristics and Inspection of Ropes

## Gains and Limits of Magnetic Rope Testing

24. April 2014  
OITAF Seminar Grenoble

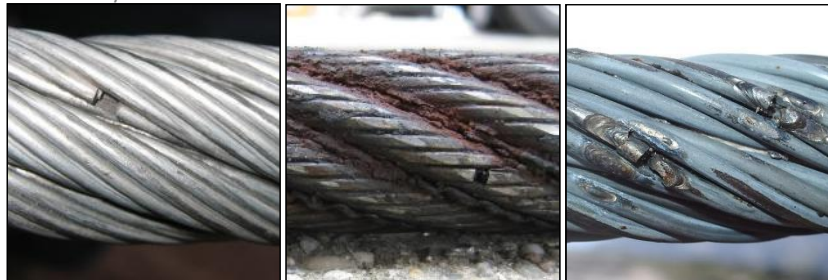
## Typical damages in ropeway wire ropes

- Bending cycles: rope wear and material aging by repeated flexion over sheaves
- Corrosion: Material surface turns brittle and initiates cracks and wire breaks
- External influences: lightning strokes, accidents within construction works, derailments,...cause deformation, structural changes or wire breaks
- ...and many more reasons

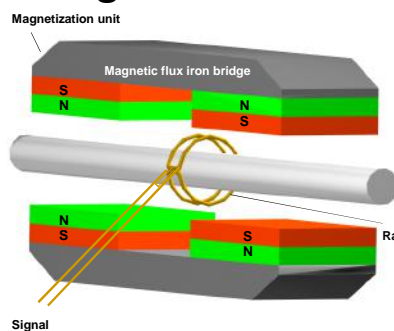
$$U = - n S v \frac{dB}{dx}$$

Lenz-Faraday law

- Permanent magnets create a saturating magnetization of the steel wire rope
- Resulting leakage field generates a voltage in the measurement coil

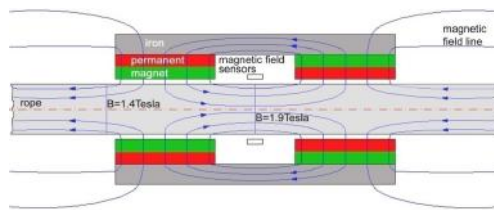
Magnetic field circuits forming homogeneous magnetic flux all over the rope's cross section. The wire material has to be magnetically saturated by at least 1.9 up to 2.3 Tesla.

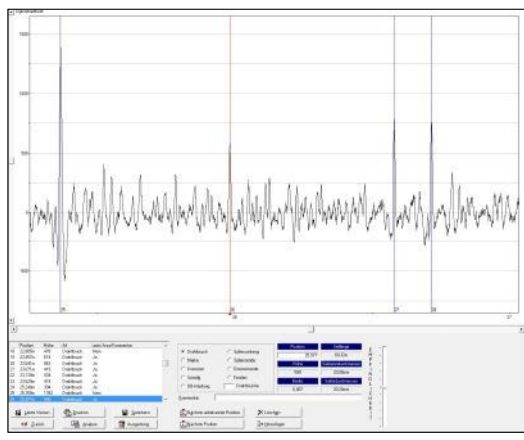
**Software-Application:**

- Automated labelling of suspicious patterns
- Evaluation by expert user
- Automated report creator
- Relating of damages to discard criteria (loss of tensile capacity on specific reference lengths)

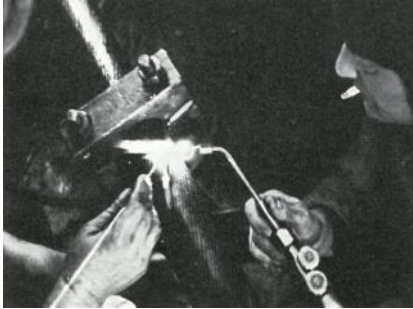
Shifting of wire breaks by brazing:

- Separation of two neighboring wire breaks
- Creation of distance to discard criteria

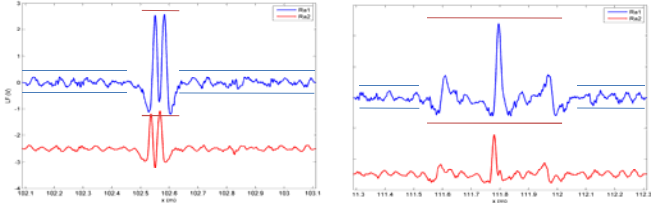
WB signals:  
LF 1 / LF2

- a) Unknown → MRT history is required to analyze the development of WB's during rope operation
- b) WB ? Missing wire ? : No → splice knot  
→ rope visual verification is required

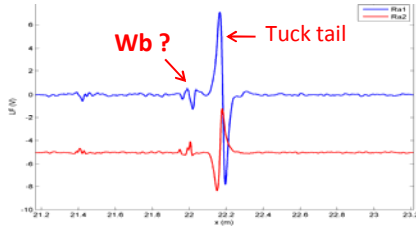
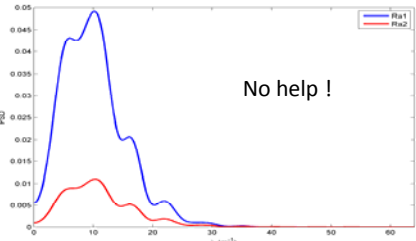
MRT Signals  
LF 1 / LF2

Splice section: **tuck tail masking eventual neighbouring wire break**

Droset 2013  
carrying-hauling  
rope

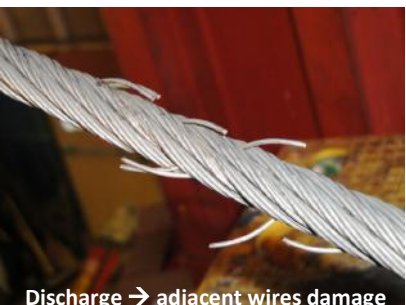
Strike spot

Discharge → adjacent wires damage

Discharge → bullwheel liner

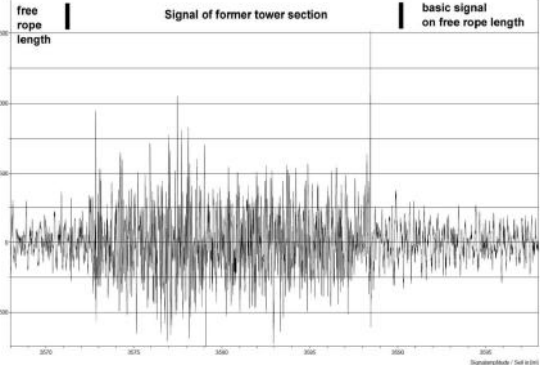
**Problem:** Corrosion-/wear-signals can cover wire break signals, e.g. in former tower sections  
 → Another more-dimensional inspection-method is needed to clarify the state of the rope

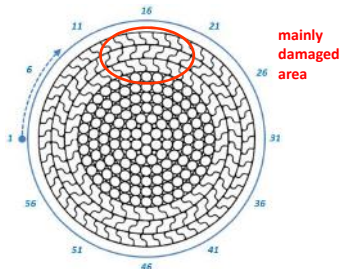
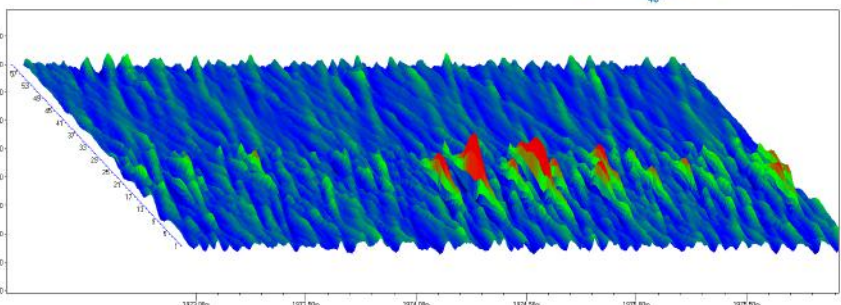
- Software-Application allows to rescale color-scheme and amplification to work out points of interest
- Damage can be closely localized and evaluated to plan further special treatment, inspection and repair

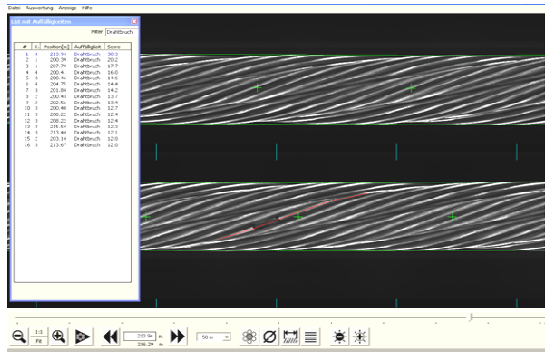
Analyze of the wires and rope surface:

Diameter and rope lay length along the rope

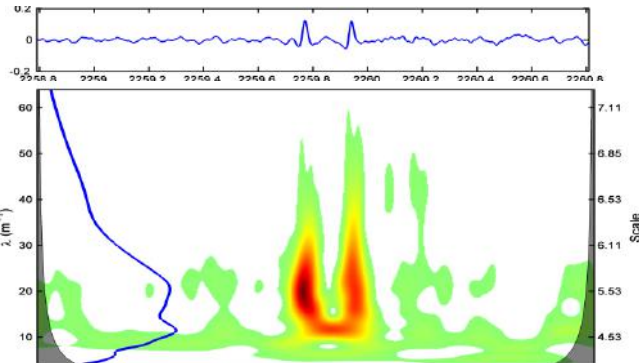
**MRT signal** : splice knot

**Scalogram** : colormap of wavelet representation
