Challenges to design and construction of cable cars in historic sites. Vila Nova de Gaia cable car.

Session 4: Sustainability of ropeways (Access to UNESCO World Cultural Heritage Sites by Ropeway)

Sérgio Oliveira, Civil Engineer, Site Manager

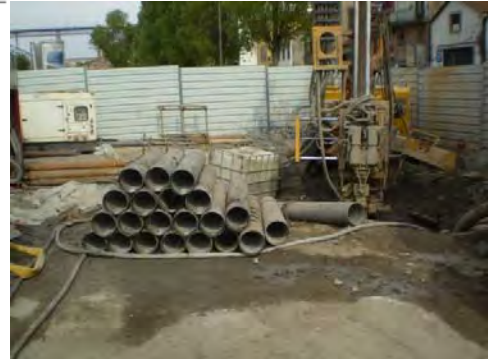
TORRE2
1:50

Tower 2 (32m high)

The foundation was design with pile driving (3units with 30m deep), however due to possible vibrations induced to the cellars old buildings and the possibility of ruin, during the construction works, it had to be changed micropiles (6 un with 30m deep).

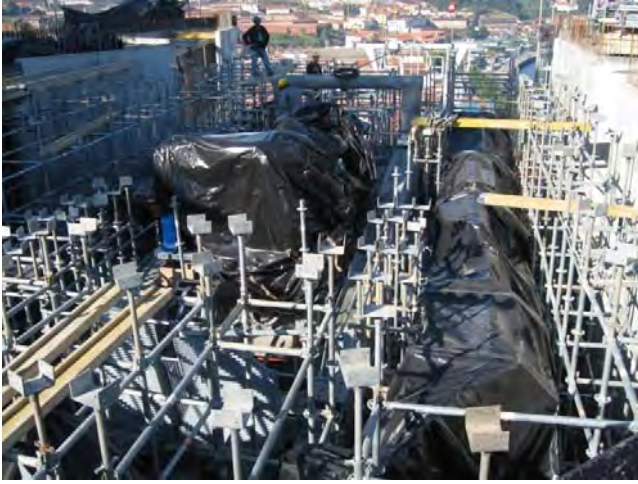
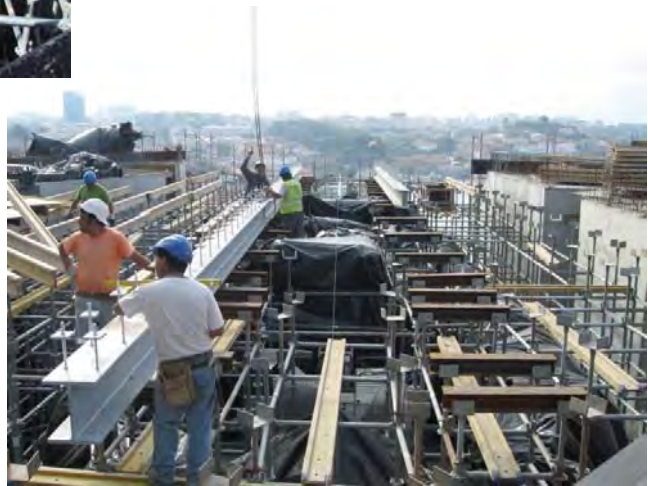
- Rock excavation. Due to the urban surrounding area with buildings the rock excavation had to be done by non-blasting method (Darda rock splitters and Excavator with Jackhammer);
- Vertical face excavation stabilized with concrete wall, post-tensioned anchors and shotcrete and ground nails;

During the excavation works for the implantation of the tower 3, what was supposed to be rock it turned out to be ordinary soil, therefore the foundation was connected to the top station building by 2 concrete beams.

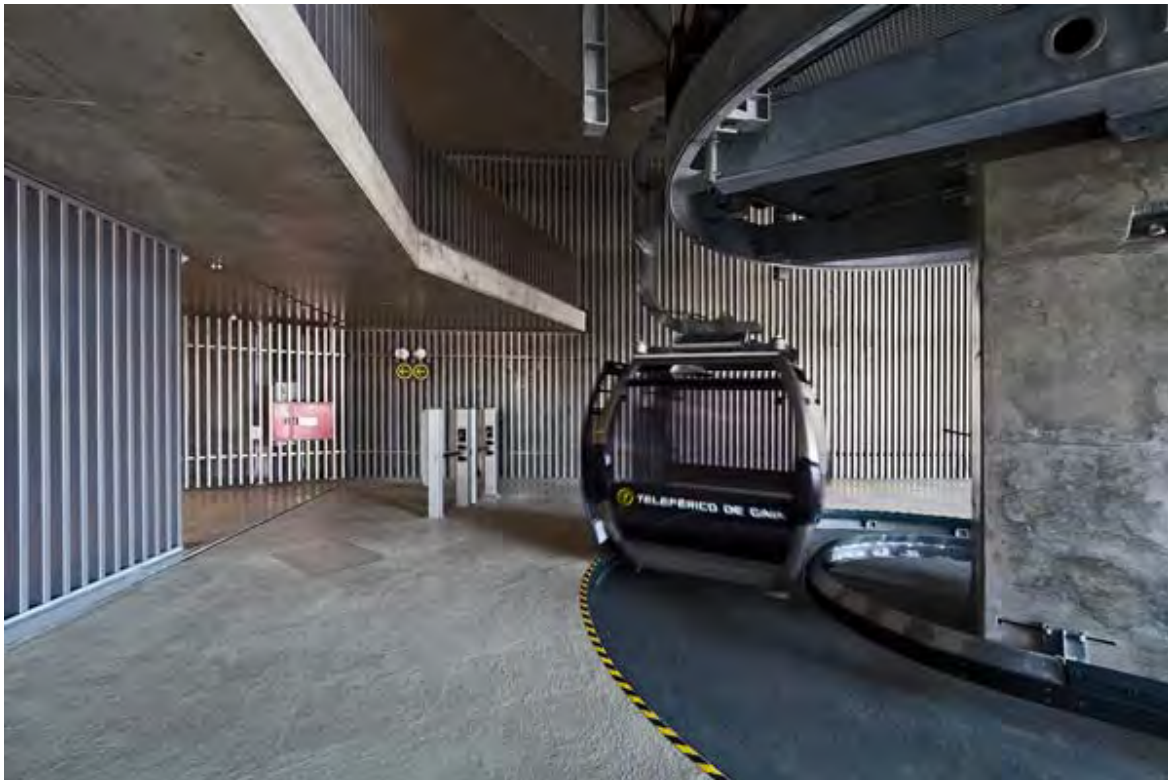
Technical main data:

Drive station	Top station
Return station	Bottom station
Horizontal length	562 m
Vertical rise	49,6 m
Operating speed max.	4,0 m/s
Capacity	940 ppp
Travel time (max. speed)	3,5 min
Number of cabins / carriers	12 un
Cadence cabins	30 seg.
