**O.I.T.A.F.**  
Work-Committee No II  
Characteristics and Inspection of Ropes

## Gains and Limits of Magnetic Rope Testing

OITAF Seminar Grenoble

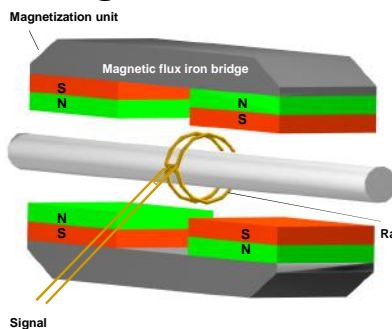
$$U = - n S v \frac{dB}{dx}$$

Lenz-Faraday law

- Permanent magnets create a saturating magnetization of the steel wire rope
- Resulting leakage field generates a voltage in the measurement coil

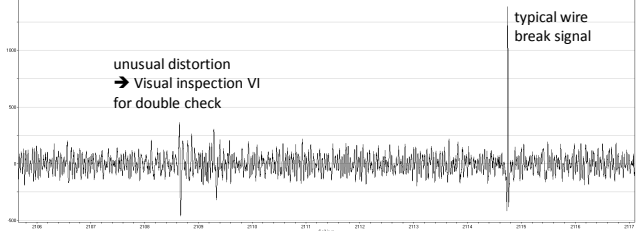
**Practical experience:**

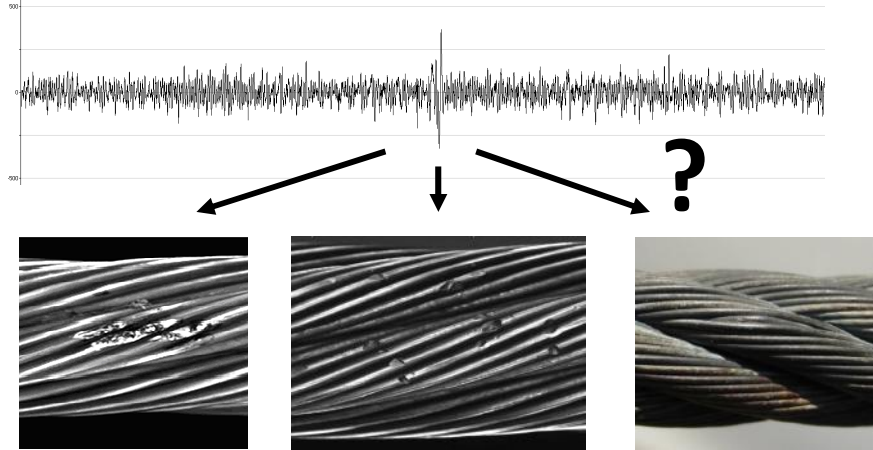
Magnetic signals are only a 1D image of the real damage. Signals can be ambiguous, so every pattern of doubt has to be clarified by visual inspection:

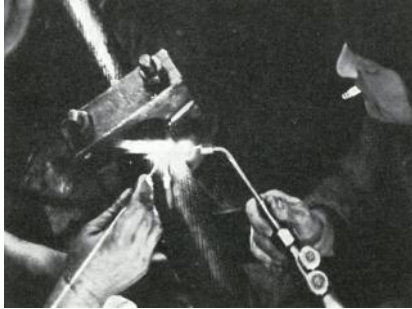
Shifting of wire breaks by brazing:

- Separation of two neighboring wire breaks
- Creation of distance to discard criteria

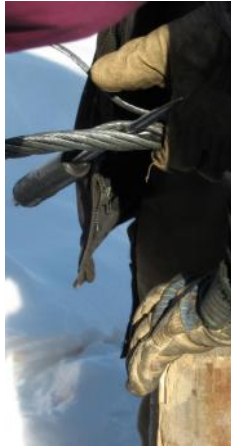
Strand repair / Splice-in part

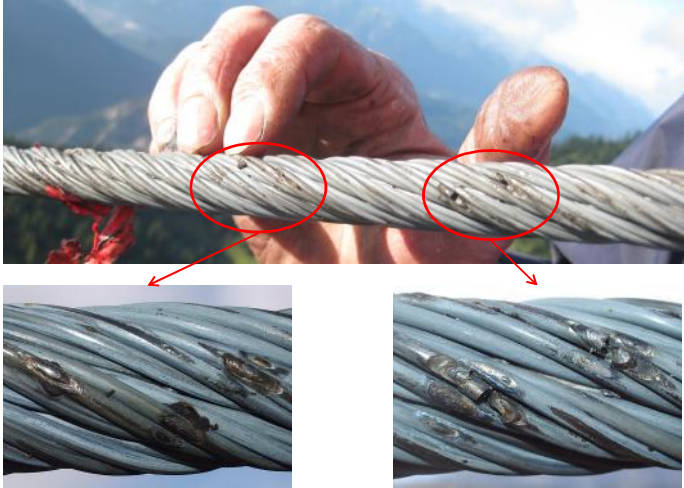
**6x7 stranded trackrope : material tramway**

**Melted adjacent wires**      **Broken melted wires**

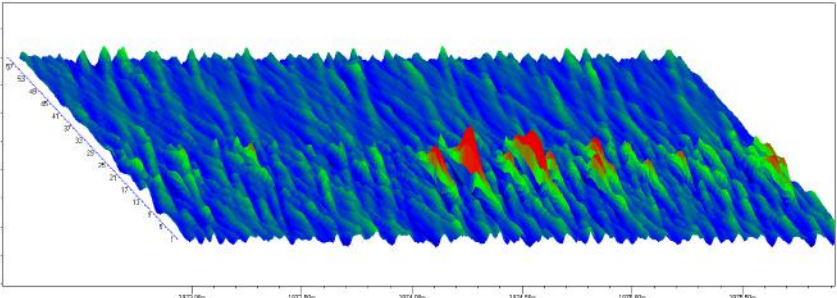
- Software-Application allows to rescale color-scheme and amplification to work out points of interest
- Damage can be closely localized and evaluated to plan further special treatment, inspection and repair

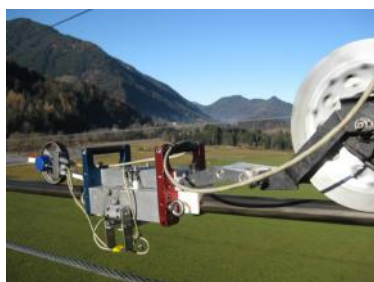
**MRT**

Heavy corrosion	<b>inner wire breaks</b>
Heavy wire damage	
Outer wire breaks	<b>Wire breaks in strand touching zone</b>
Former clamping areas	
Lightning strokes
